Chugoku Regional Development Bureau Planning Department

# Occupational hazard

## **Case 1: Construction worker accident (occupational hazard) [Falls]**

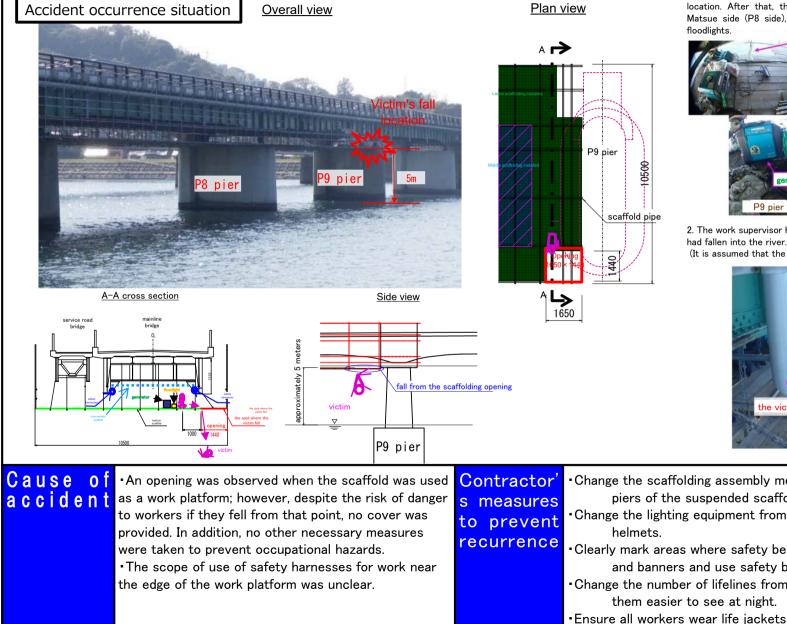
# Accident During bridge repair work, a worker fell from the work platform into a river while installing a suspended scaffold, summary resulting in death. [One fatality]

1.The work supervisor moved one floodlight and one generator to the victim's location. After that, the supervisor instructed the victim to illuminate the Matsue side (P8 side), as the supervisor was relocating the remaining two for the transmission of the supervisor was relocating the remaining two for the transmission.

2. The work supervisor heard a splash and turned around to see that the victim had fallen into the river.

(It is assumed that the victim somehow went under the girder and fell.)

•Change the scaffolding assembly method to prevent openings from occurring near the piers of the suspended scaffolding.

•Change the lighting equipment from one system to two and install headlights on the helmets.

•Clearly mark areas where safety belts (harnesses) must be used with restraint ropes and banners and use safety belts when working within those areas.

•Change the number of lifelines from two to five and use fluorescent lifelines to make them easier to see at night.

•Ensure all workers wear life jackets when working on scaffolding.

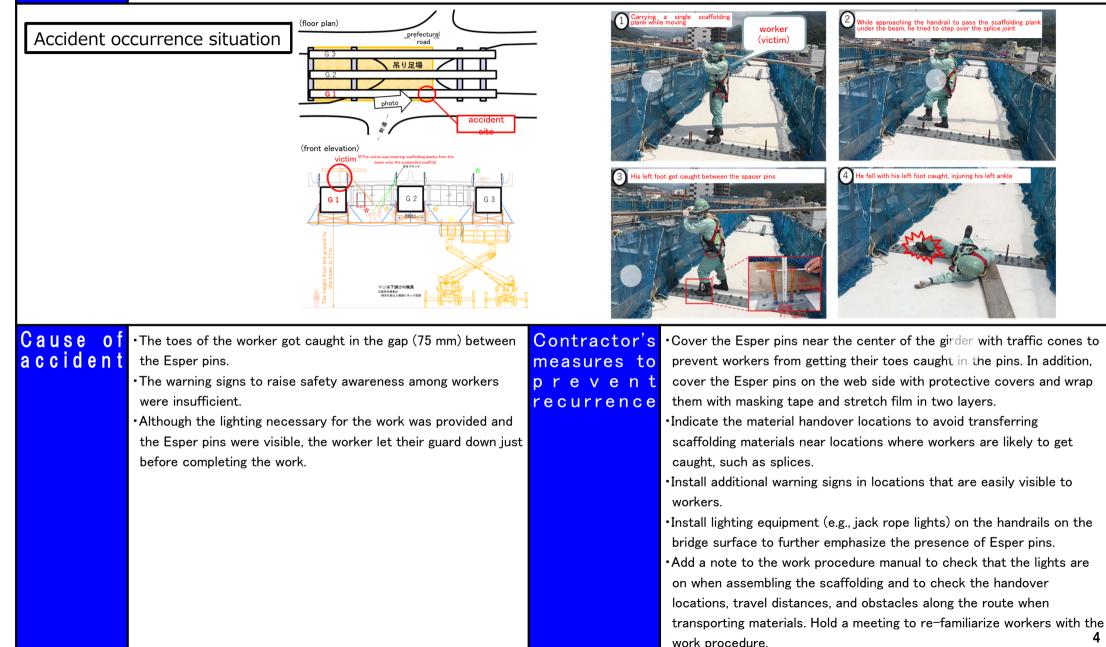
Accident The left foot of a worker got caught between two Esper pins at the top joint of a steel box girder. The worker summary lost balance and fell, leading to an ankle injury. [One injury]

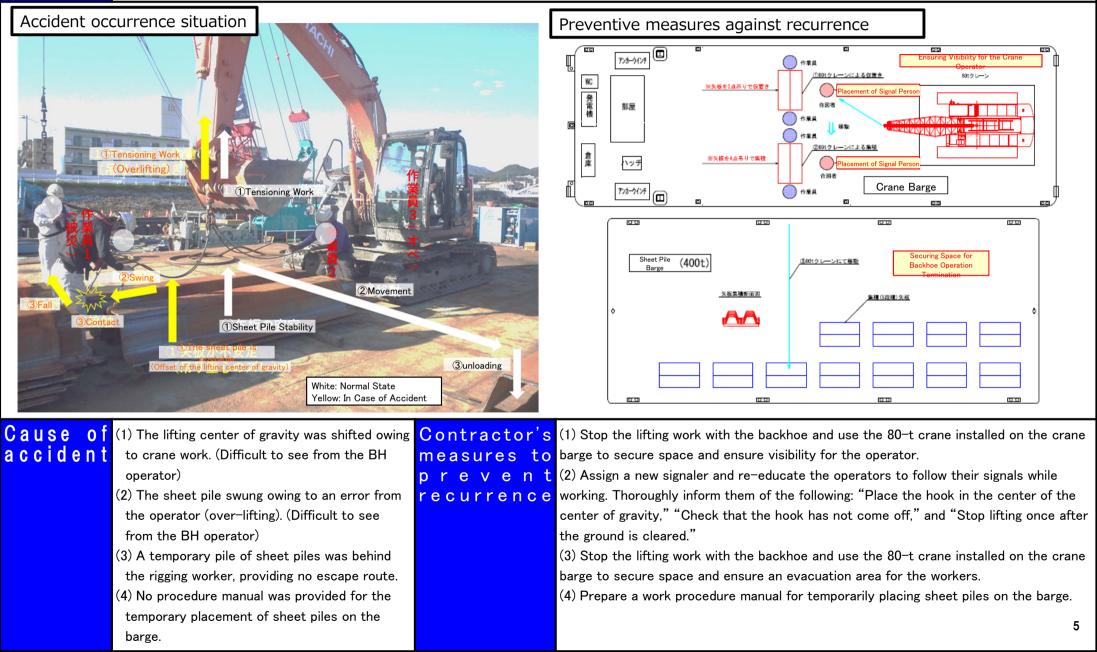
A sheet pile swung while being hoisted, causing the rigging worker to get caught between the pile behind them Accident summary and fall, resulting in injury to the back of their left hand. [One injury]

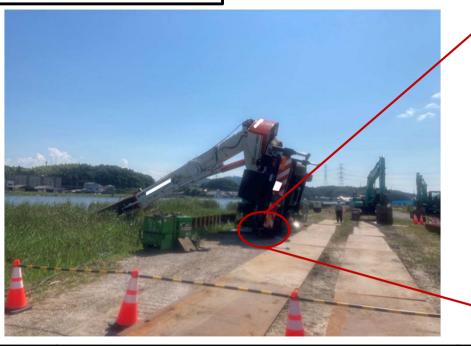
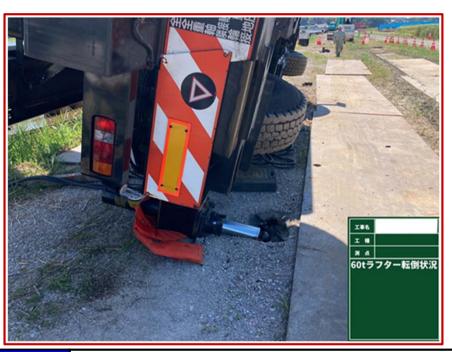
Accident occurrence situation

Work to change a setup was being conducted without laying a steel plate. This caused the ground beneath the Accident outrigger on the riverside to sink while the load was being turned, resulting in the 60-t crawler crane tipping summarv over. [No injuries]

Cofferdam sheet piles were being driven owing to parallel construction work involving the revetment. The accident occurred while driving the sheet piles with a 60-t crawler crane. The setup was being changed (moving  $5 \times 10$  steel plates weighing about 900 kg) to drive the sheet piles in the next area.

The changeover work was conducted without laying the steel plate, which caused the ground under the outrigger on the riverside to sink while the load was being turned, causing the 60t crawler crane to tip over.

•Add "crawler crane relocation work" to the work procedure manual. measures to (i) Assign controllers during the steel plate relocation work. prevent (ii) Use a crane-equipped backhoe for the steel plate relocation work. recurrence • Add the construction plan for the work to the work procedure manual

and read it over again with the relevant workers to raise awareness of the importance of using the steel plate. In addition, always educate new entrants.

Check the construction plan during on-site KY activities before starting work.

•As with the main sheet pile work, ensure the main contractor is present for each task during the steel plate relocation work, and keep an inspection record in the daily inspection report.

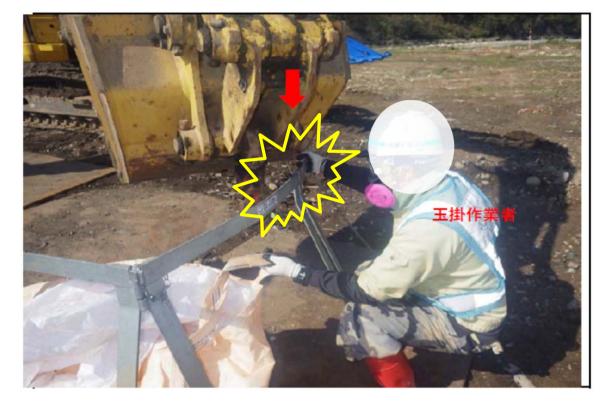
Accident occurrence situation

Accident An injury occurred when the right hand of a worker was caught between a sandbag-making auxiliary tool and a summary backhoe bucket while making a large sandbag. [One injury]

•This accident occurred while making a sandbag, in which **accident** the sandbag-filling aid suddenly came off. The right hand of the rigging worker got caught between the backhoe bucket and the sandbag-filling aid while placing the sandbag on the crane device again on the backhoe, resulting in injury. This occurred in the process of reinstalling the sandbag.

•The accident is believed to have occurred because the controller neglected to take the necessary precautions to guide the backhoe, despite the rigging worker being within the working radius of the heavy equipment.

**Contractor's** I have event of an unforeseen incident, stop the work measures to immediately and do not resume until safety is confirmed. In **prevent** addition, contact the supervising engineer immediately. Resume **recurrence** construction after reviewing and adding any necessary notes. · Conduct checks to see if the position of the controller has a blind spot, such as at the bucket. The controller should only signal to resume work after ensuring that no workers are within the working radius, including the blind spot.

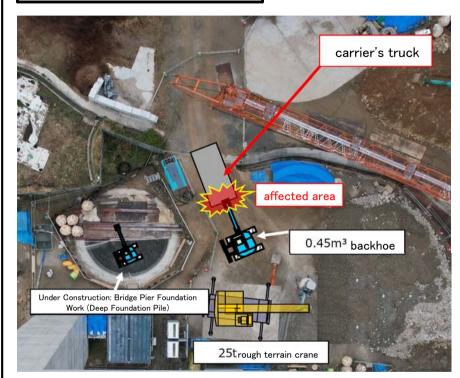
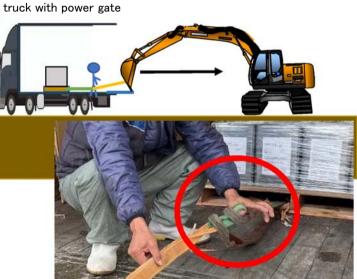
#### Accident occurrence situation

Accident A sling was placed on materials being unloaded by pulling using heavy machinery. The hand of a worker was summary caught, trapping their fingers, which resulted in injury. [One injury]

(1) An attempt was made to hook a nylon sling onto a backhoe to pull out the materials; however, the sling did not reach the backhoe.
\*Using a backhoe for an unintended purpose

(2) As the sling did not reach the backhoe, the hand holding the nylon sling was caught in the backhoe when the bucket was pulled to move the backhoe, resulting in the thumb being severed.

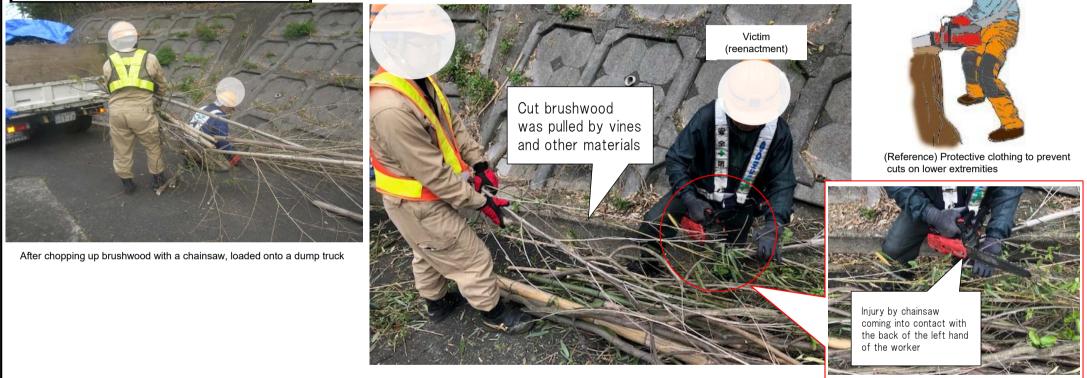
Accident occurrence situation (image)

Accident summary While cutting brushwood into small pieces with a chainsaw, with another worker was loading it manually, the brushwood became entangled with vines and other materials. The resulting movement of the brushwood caused the chainsaw blade to hit the hand of the worker cutting it, which resulted in injury. [One injury]

•When the worker was loading the brushwood after the chopping work was completed, they tried to load it without checking that the brushwood undergoing cutting was entangled with vines and other materials.

•The main contractor did not provide the necessary guidance to subcontractors, such as precautions to take when using chainsaws and wearing protective clothing.

Separate the task of tree-cutting from that of transporting accumulated
 brushwood for safety considerations.

**prevent** • Require that all workers undergo hazard awareness training to improve **recurrence** safety awareness.

Establish specific work procedures for felling trees with chainsaws and review the procedures during morning assemblies before work begins.
Wear cut-resistant gloves and protective clothing for the lower extremities when felling trees with chainsaws.

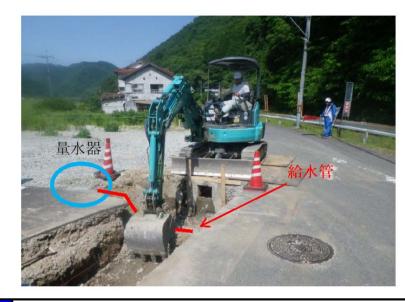
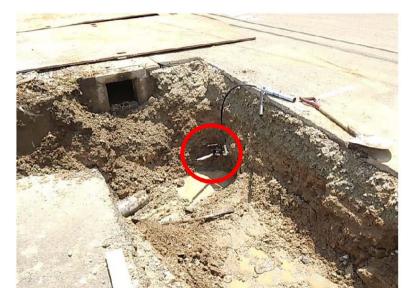
### Accident occurrence situation

Accident Damage to buried water pipes (one store) during floor digging using a small backhoe. [Buried pipe damage]

**accident** the location and depth of the pipes were not explicit. · Although the construction was carefully conducted, the water supply pipe was installed shallower than expected, causing it to come into contact with and be damaged by the backhoe bucket.

·During a prior consultation with the waterworks manager, Contractor's ·Add items for buried objects and overhead lines to the checklist measures to for internal safety patrols. Confirm and warn site personnel during

> ·Manually excavate near the buried object and make a thorough visual confirmation of buried objects.

·Post signboards and actual objects at the location of the buried object to make it "visible."

·In addition, collect information from residents near the site to confirm the presence or absence of buried objects and consider the data.

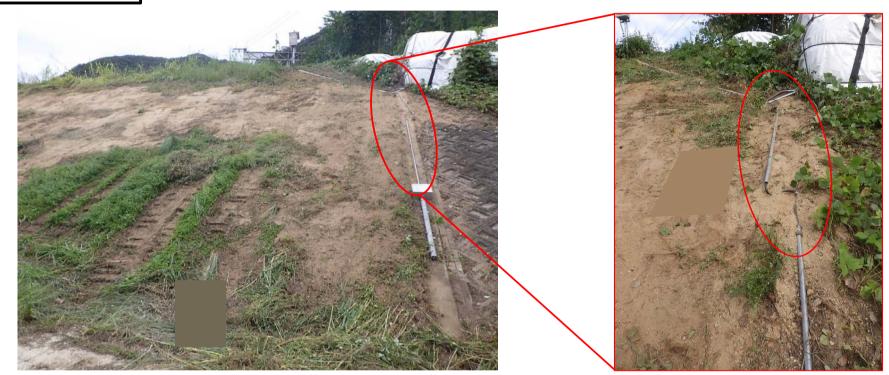
Accident occurrence situation

Accident The protective pipe of a water level gauge buried in the ground got caught and damaged when repairing the summary slope of a levee by filling holes and shaping the slope with a backhoe. [Buried pipe damage]

Obstacles and piping were not checked in advance using ledgers, and the location of the piping was unknown.
An obstacle (water level gauge) was observed on site, and the main body of the water level gauge was also on the levee; however, the water level gauge pipe was not noticed when checking the repair area on site before conducting the repair.

Check for obstacles in advance using the ledger provided by the client.

**prevent** ·Report to the supervisor and obtain information if details about **recurrence** the obstacle are unclear.

Have the supervising engineer and work chief of the subcontractor check the surrounding area to confirm the presence of any obstacles and the repair procedure when inspecting the repair area before conducting repair work.
If the heavy equipment operator has difficulty seeing the end of the bucket while working, have a supervisor stationed to eliminate blind spots and guide the operator.

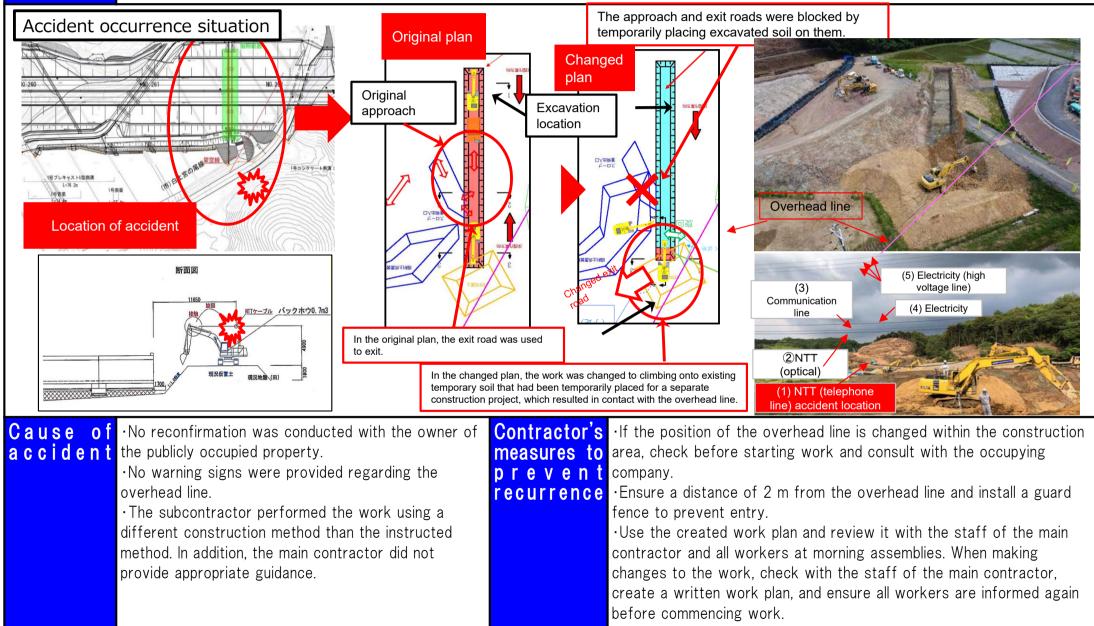
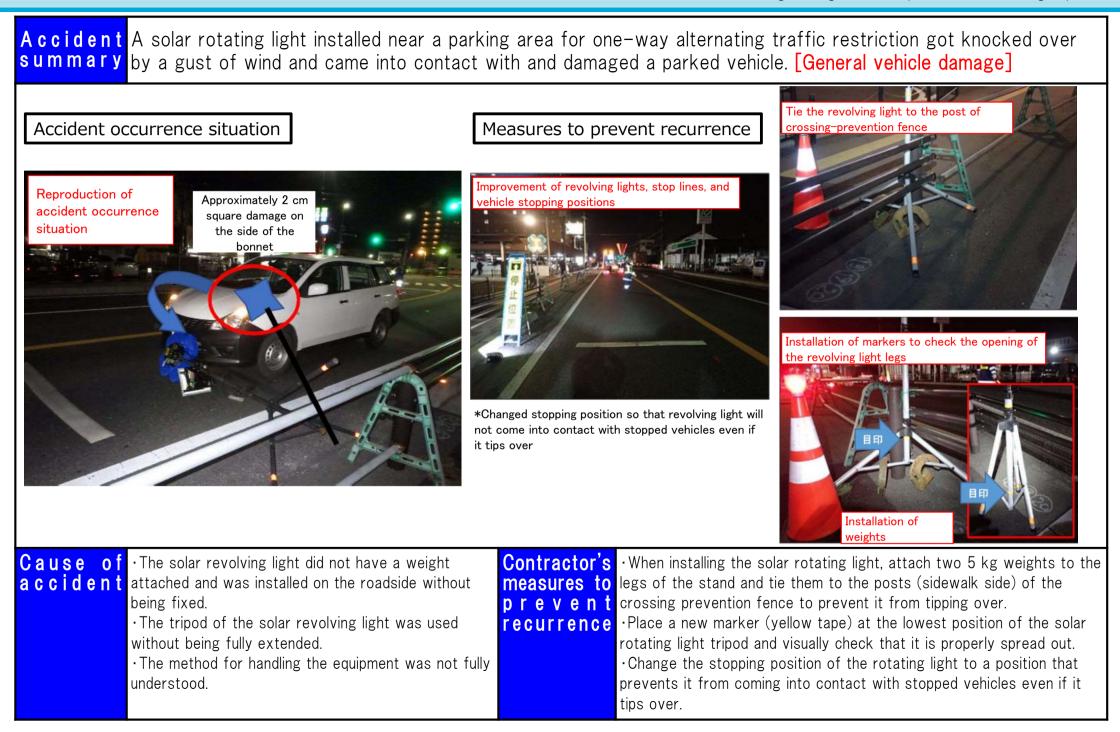
Accident summary The arm of a backhoe came into contact with an overhead line (NTT) during a turn, damaging the cable fixing passing vehicle. [General vehicle damage]

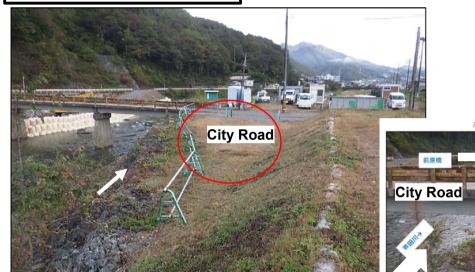
Accident occurrence situation

Accident The victim (third party) got injured after tripping over a step on the business site, falling over a single-pipe summary barricade, and then under the bank with the single-pipe barricade. [One injury]

1) Regarding the victim "tripping over" Cause of accident •The contractor removed the traffic rope that the river administrator had installed as a measure to prevent entry before the start of construction to provide a waiting area for vehicles and installed a single-pipe barricade closer to the riverside bank than the original position, enabling third parties to approach the steps on the business site.

> •Barricades were installed to make it safer: however, tripping over the steps was unexpected.

•The victim was startled by the headlights of a car and hurriedly tried to escape, tripping over a step, crashing into a single-pipe barricade, and falling under the bank (H = approx. 4.4 m) along with the barricade.

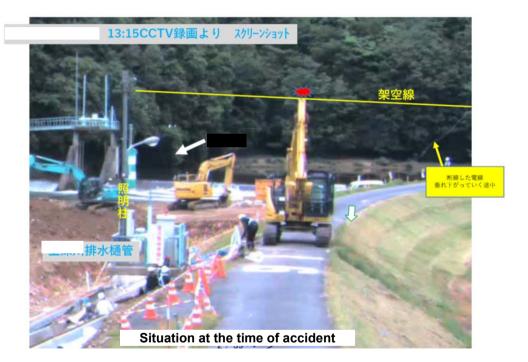
Accident occurrence situation

Accident While pouring crushed stone for the foundation of a staircase under construction, a backhoe came into contact summary with and damaged the power line of the sluice gate during a turn. [One overhead line cut]

While the backhoe was moving along the top of the embankment to pour and level the foundation of the staircase, the arm of the backhoe came into contact with the power lead-in line (for powering the culvert) that crosses above the top of the embankment, and the power line was cut.

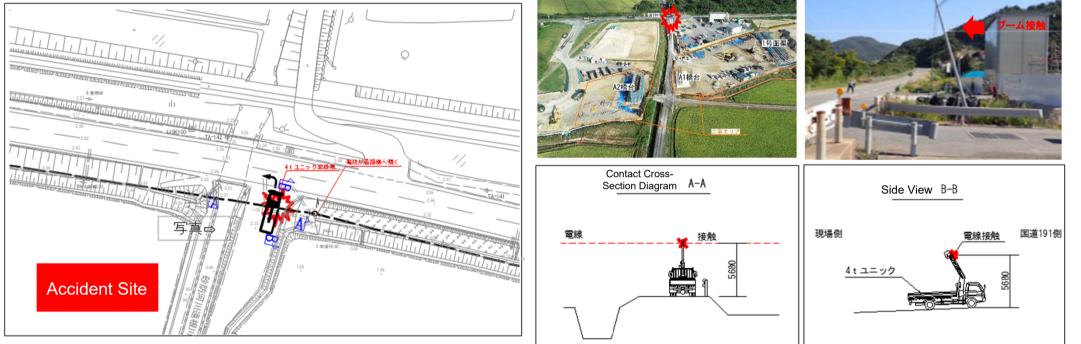
Workers forgot to store the boom of the crane when transporting scaffolding materials loaded onto a crane truck (4 t). Consequently, the boom came into contact with the overhead line and tilted the utility pole. [One utility pole tilted] Accident occurrence situation

<ul> <li>Contractor's measures to p r e v e n t recurrence</li> <li>Place a "boom storage/check surroundings" reminder in a position that will be noticeable when opening and closing the door.</li> <li>Install a gate-type gate. (H = 3.8 m)</li> <li>Establish and create awareness surrounding exit rules (passing through a gate-type gate/checking the state of the package in a full-length mirror).</li> <li>Install a stop line in front of the gate.</li> <li>Place an overhead line reminder flag near the overhead line.</li> </ul>
--	---

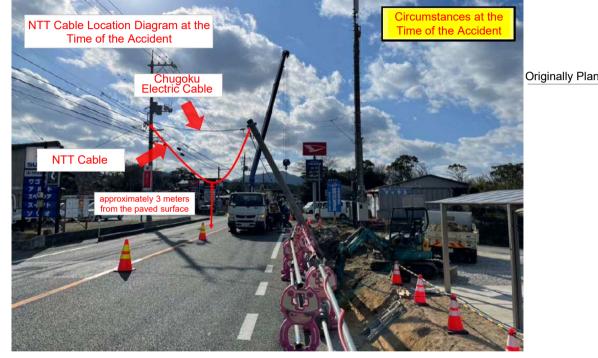
### Accident occurrence situation

Accident summary cable/communication line). [One overhead line cut]

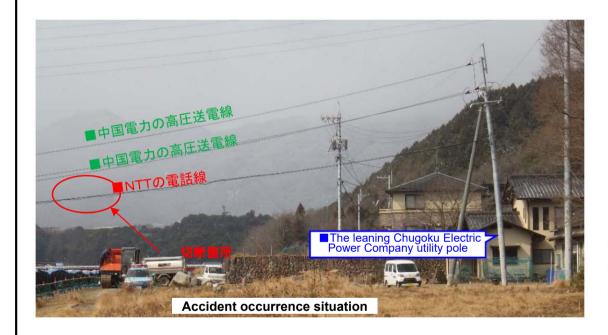
Accident occurrence situation

Accident While moving, the boom of the backhoe came into contact with the communication line, tilting the utility pole and summary cutting the hoisting wire of the communication line. [Utility pole tilted; one overhead line (hoisting wire) cut]
