Summary of Accidents in FY2023

Construction accidents due to inadequate safety management measures by prime contractors, excluding the Government Buildings Department and the Port and Airport Department

Planning Department, Chugoku Regional Development Bureau

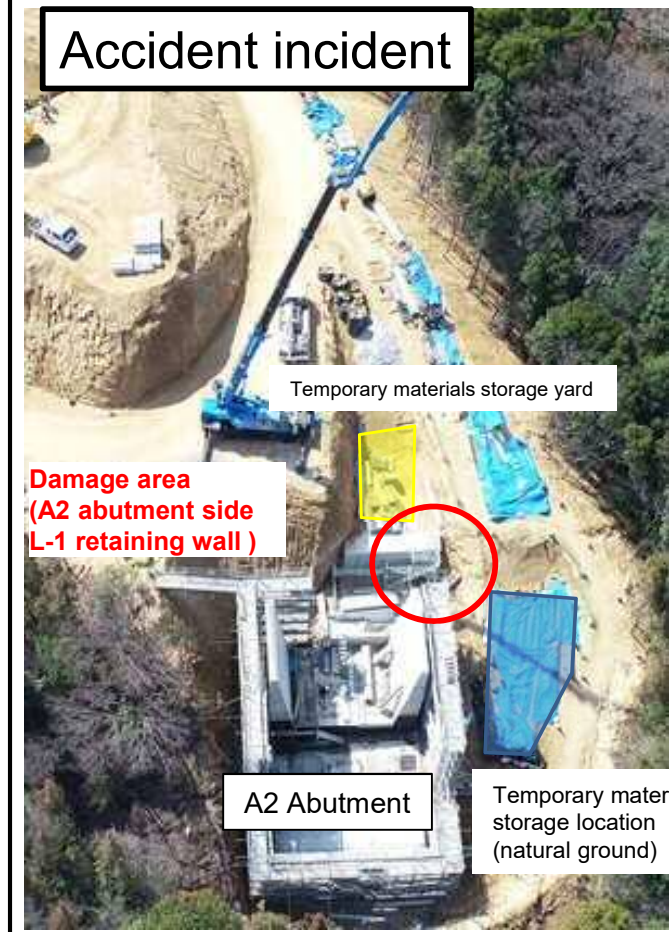
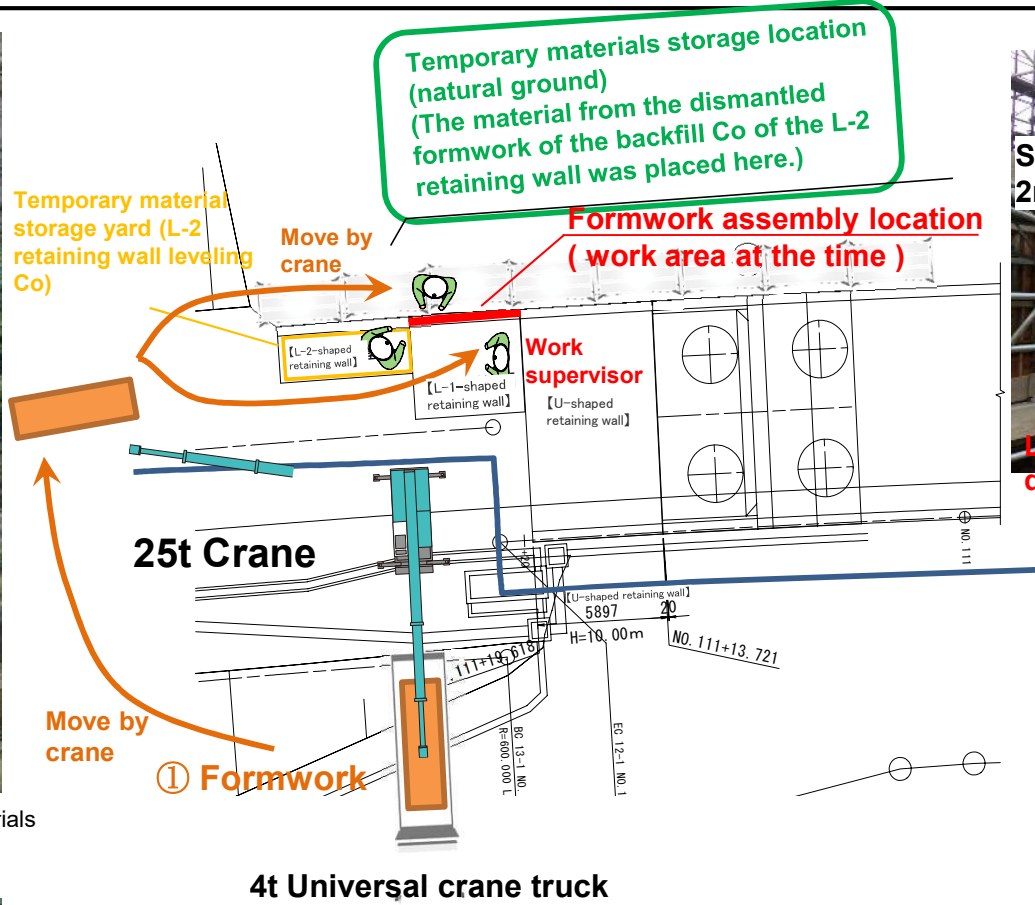
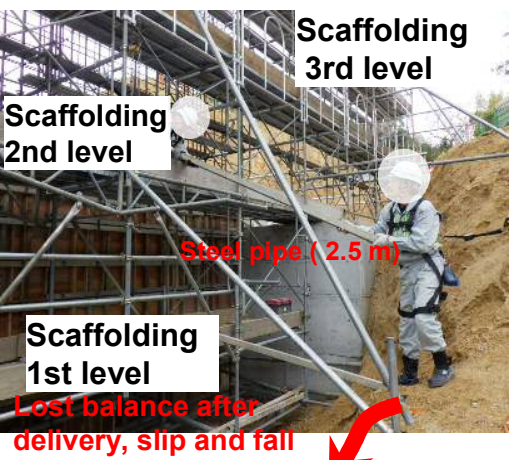
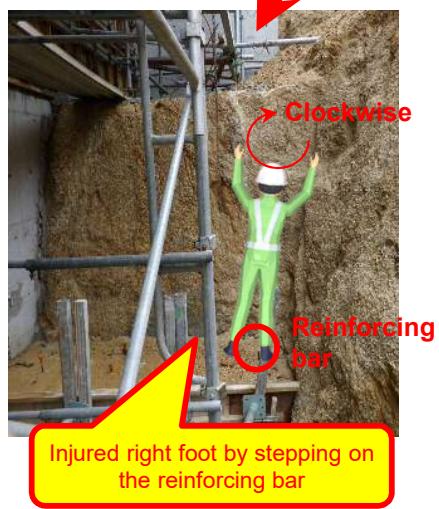
During the assembly of formwork for a cast-in-place retaining wall, a worker removed the safety ropes marked at dangerous points and continued to work. The worker lost his balance and fell down a slope, injuring his right leg. **[Victims]**

- Although a work procedure manual had been prepared in advance, instructions regarding the work were given verbally to all subcontractors and detailed work content was not communicated to all workers. As a result, workers performed unplanned work at their own discretion.
- Dangerous areas were surrounded and clearly marked with safety ropes; however, despite the risk of a worker falling, the ropes were removed and materials were handed to workers on the scaffolding.

- To avoid unscheduled actions, any changes work changes will be discussed with the prime contractor. The work procedures will be changed, and work will resume after a meeting is held. Explanation shall be given at the time of KY on the day of work and posted at various locations on the work site.
- The workers will be re-trained to never remove equipment that is marked as off-limits without authorization. As a further measure, single pipes will be installed in areas with a high risk of falling to prevent their easy removal. Moreover, dangerous areas will be clearly marked.

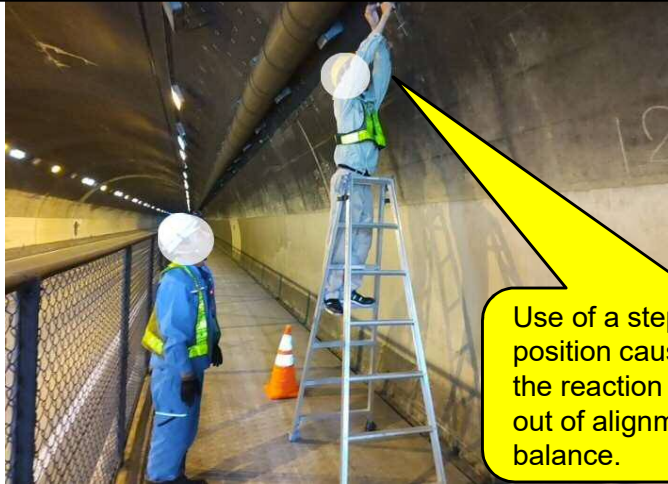
Working conditions at the time of the accident

During installation of intermediate support hardware for laying underground cables, a worker lost his balance while using a stepladder in an unstable position, jumped from the stepladder, and fractured his right heel.
[Victims]

- When the subcontractor suggested changing the work to use stepladders, the prime contractor approved it without performing any safety checks or providing any guidance.
In addition, the work was carried out without reviewing the construction plan and work procedures.

Both the prime contractor and subcontractors will be thorough in not carrying out any work that is not included in the construction plan.
- Include details of the construction method for the work in the construction plan and ensure that everyone is aware of it.
- Safety education for stepladders and other scaffolding work, KY activities, new entrant education, safety training, etc.
This will be carried out to raise awareness of danger and ensure safety.
- Select a work scaffold suitable for the site to prevent work from being performed in an unstable condition, and increase the number of safety patrols and the frequency of patrols to ensure the safety of work conditions.

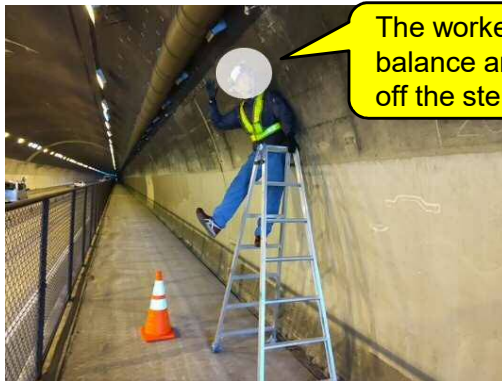
Use of a stepladder in an unstable position caused misalignment, and the reaction of the ratchet spinning out of alignment caused loss of balance.

The worker lost his balance and jumped off the stepladder

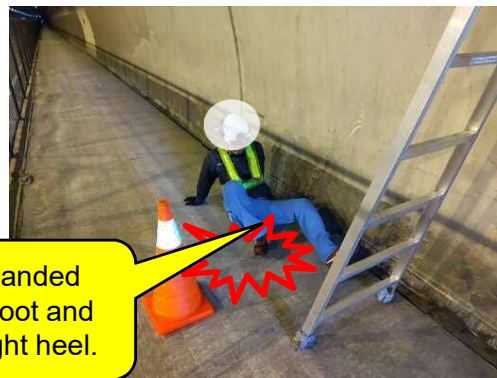
The worker landed on his right foot and struck his right heel.

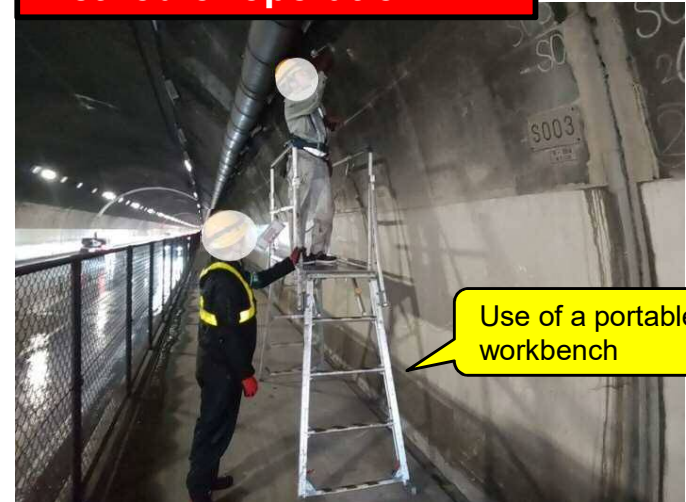
Originally planned method of operation

Use of a portable workbench

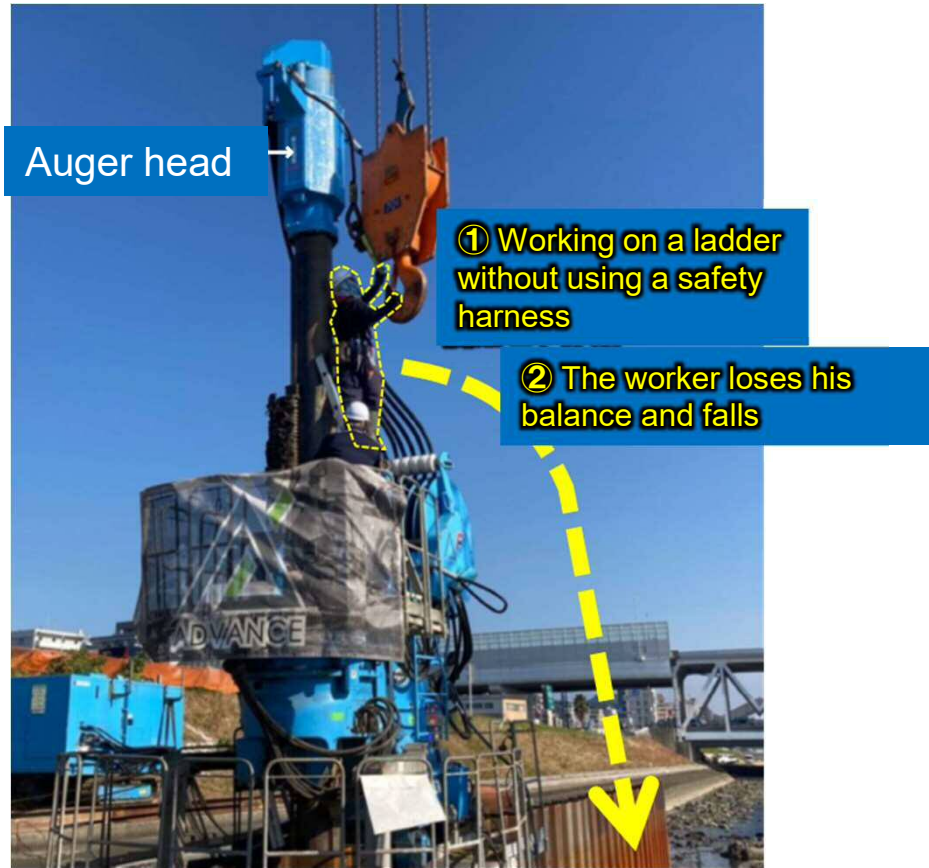
During sheet pile pressing work, when attaching the crane hook to the hoisting hardware on the auger head for hard ground, the worker lost his balance and fell without using a safety harness **[1 injured person]**

- Working on a ladder without using a safety harness.

- Shorten the auger rod and set the working height for hooking at 1.5 m from the scaffolding. Do not use a ladder.
- Re-enforce the use of safety belts.

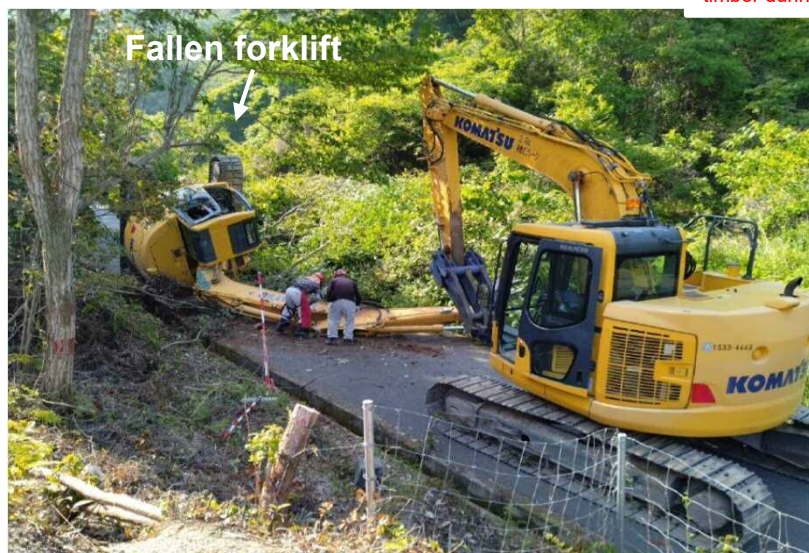
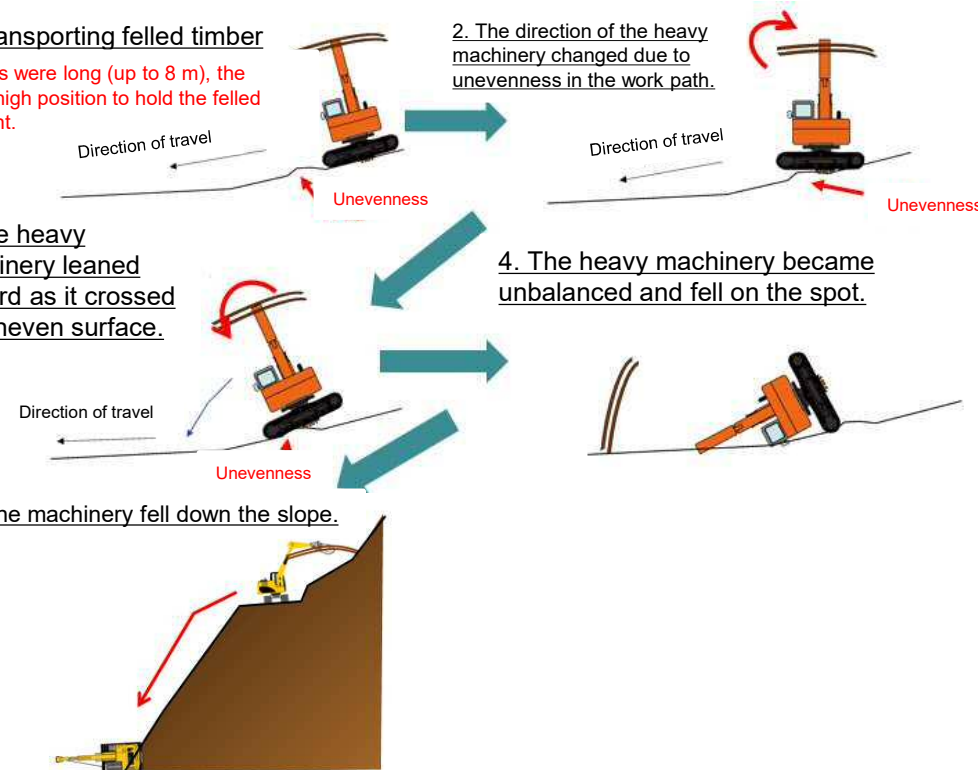
During tree felling work, while the felled timber was being removed using a forklift (demolition machine), the length of the timber (up to 8 m) required the boom holding the timber to move at a high position to avoid contact with the mountain slope. However, the heavy machinery work path became uneven, causing the forklift to lose balance, lean forward, and then topple over and fall approximately 15 m to the ground below, resulting in injury. **[1 injured person]**

1. Transporting felled timber

Because the felled trees were long (up to 8 m), the boom was placed at a high position to hold the felled timber during movement.

2. The direction of the heavy machinery changed due to unevenness in the work path.

3. The heavy machinery leaned forward as it crossed the uneven surface.

4. The heavy machinery became unbalanced and fell on the spot.

5. The machinery fell down the slope.

- Felled trees were transported in long lengths without being cut into short logs in advance, resulting in an unstable position that made the heavy machinery prone to tipping over.
- Unevenness in the work path was overlooked and work was carried out without correcting it.
- Although the machine being used had changed and the required qualifications were for the operation of a different machine, the qualifications were not checked and unlicensed operation was overlooked.

- The work procedures (plans) should include that logs should be cut such that they will not lose balance when transported using heavy machinery, and the supervisor should ensure that work is carried out in accordance with these procedures.
- During safety inspections, inspect the site together with the subcontractor's work supervisor, carefully checking for defects such as unevenness in the work passageways; these defects should be corrected to ensure a safe condition before starting work.
- Thoroughly check the qualifications for the machinery and operations to be used. If there are any changes to the planned machinery or work, promptly use the checklist to reconfirm the qualified vehicles. The foreman should directly hand over the keys to the heavy machinery to be used that day only to those who are qualified to prevent unqualified operation.

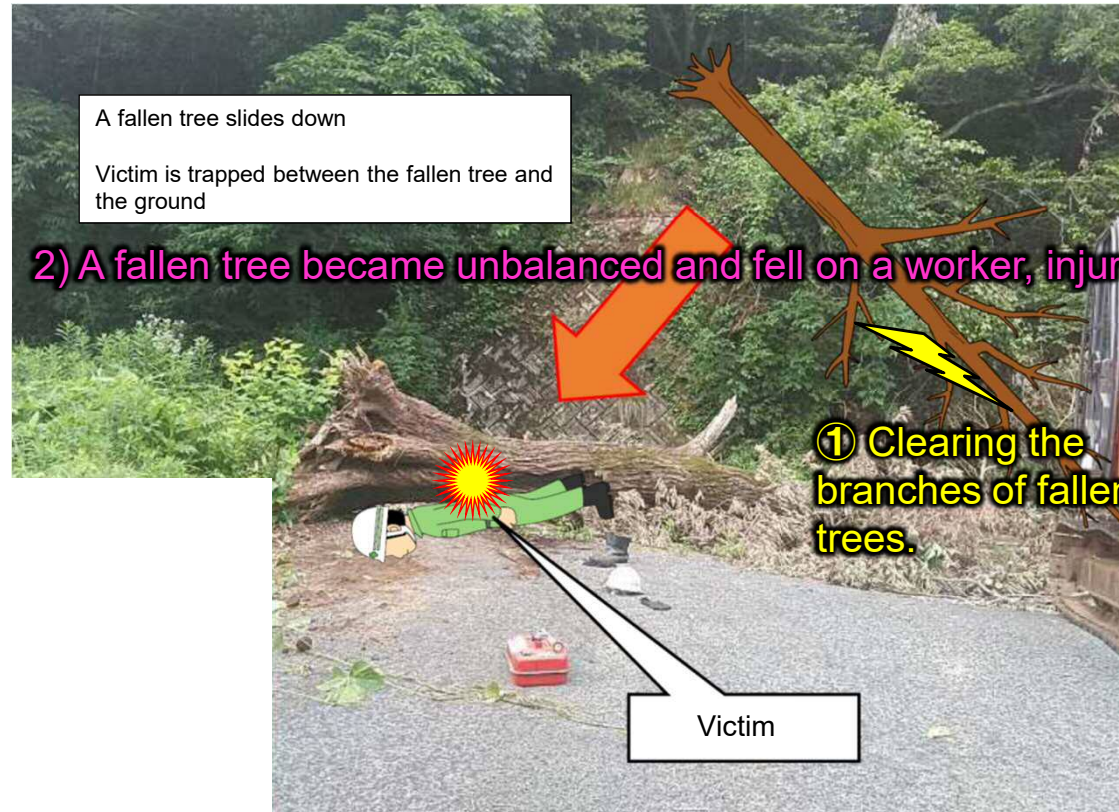
During removal of a fallen tree leaning against a slope, a worker was removing nearby scattered trees to allow heavy machinery to approach the fallen tree. While removing the tree's branches, the tree became unbalanced and fell on the worker, injuring him. **[1 injured person]**

- ① A worker pruned branches without following work procedures.
- ② During the hazard prevention activities on the day, workers were advised not to enter the direction of the fallen tree, but they still performed work near the fallen tree.
- ③ Workers who had not received the safety and health training required by Article 59 of the Industrial Safety and Health Act used chainsaws to perform tree felling work.

- ① Re-education on compliance with work procedures
- ② Implementation of entry ban measures
- ③ All workers are informed of their roles and the prohibition of the use of machinery and other equipment by anyone other than the scheduled workers; a control engineer will check compliance when the work is performed.

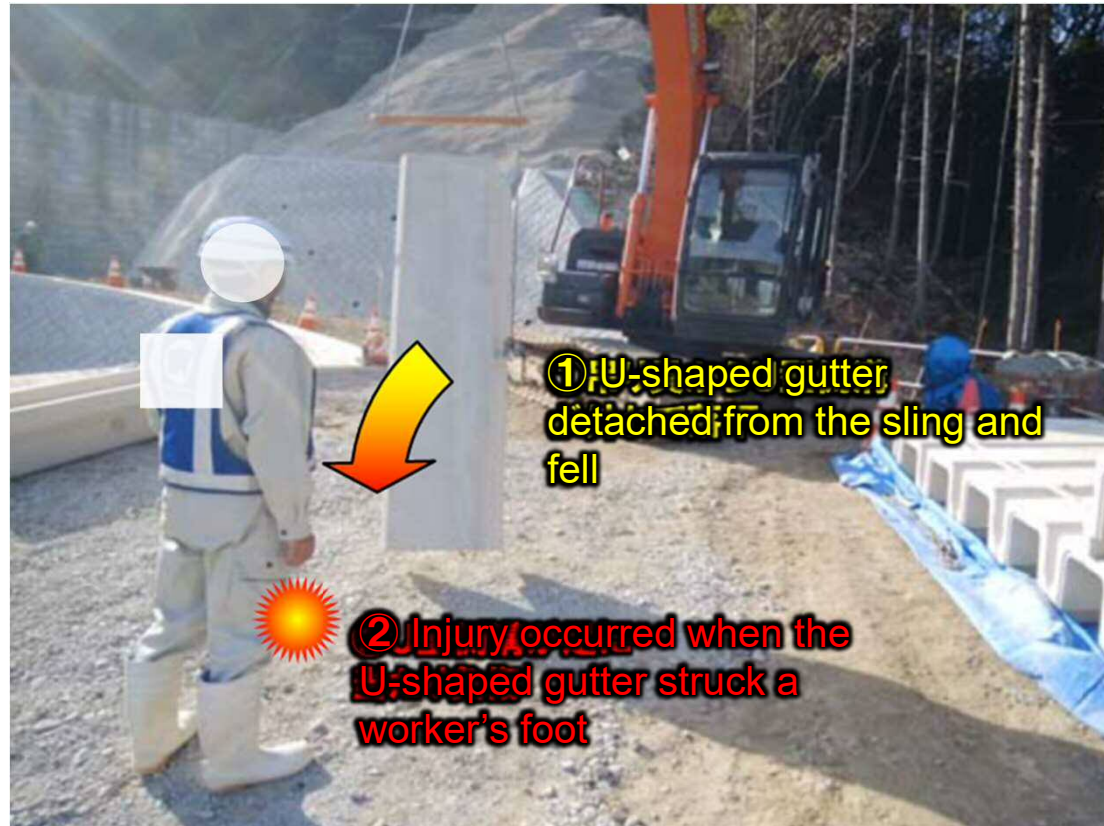
A U-shaped gutter brought in for maintenance was being lifted using a special lifting tool to turn it over, the U-shaped gutter detached from the lifting tool and fell, striking the foot of a worker and causing injury. **[1 injured person]**

- The screw holes of the special hanging tool were filled with soil and sand; thus, the screws could not be fully inserted and the U-shaped gutter was hung in an incomplete state.

- Ensure all the screws on the hanging fixtures are tightened until they are fully inserted. If the screws do not fit, do not use the U-shaped gutter and treat it as an unsuitable item.

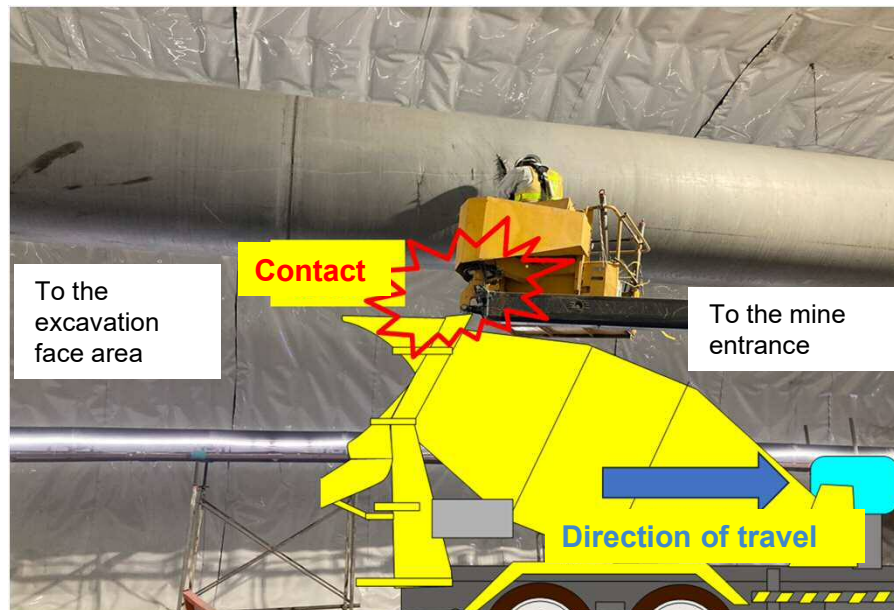
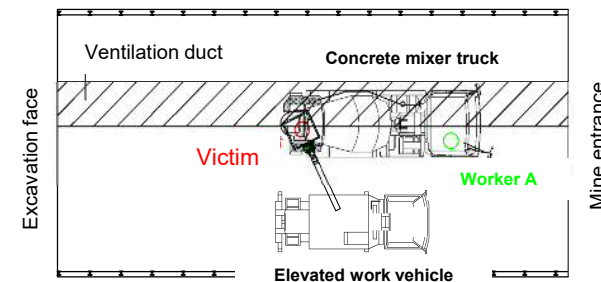
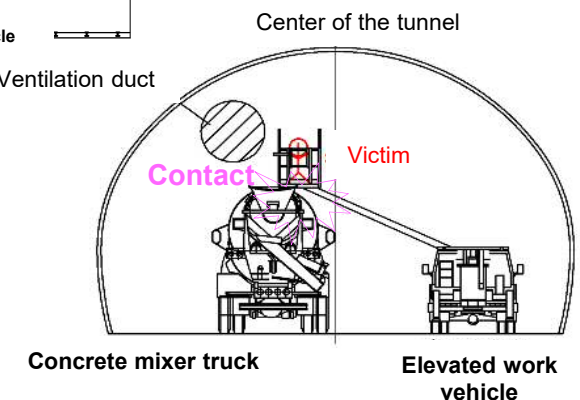
During tunnel construction, after supplying the first sprayed concrete load to the excavation point, a concrete mixer truck leaving the tunnel passed under the bucket of an elevating work vehicle that was performing tunnel repair work. The top of the concrete mixer truck's hopper came into contact with the bottom of the elevated work vehicle's bucket, injuring a worker in the bucket. **[1 injured person]**

- ① It is known that the air duct had been damaged when the seat cart was moved; however, a repair date had not been determined. Consequently, the repairs were rushed on the afternoon of the accident, leading to inadequate safety instructions and an insufficient KY (hazard prediction) process.
- ② The driver noticed an elevating work vehicle operating ahead, honked the horn, and slowed down. However, he misjudged the vehicle's clearance under the bucket and proceeded without stopping, resulting in contact with the bucket.
- ③ It was commonly understood on-site that vehicles should not proceed until the bucket of the elevating work vehicle was retracted and a signal was given. However, this rule was not explicitly established and was not widely recognized.

- ① When using an elevating work vehicle, set up traffic cones and bars before working.
- ② Install a rotating light and plastic chain on the bucket so that it can be recognized from a distance.
- ③ Establish checklists for compliance with on-site rules and strengthen company patrols (including unannounced inspections).
- ④ Revise the work procedures to clearly state the rule prohibiting passing directly under the bucket when using elevating work vehicles, and conduct retraining.
- ⑤ Install warning signs at locations where vehicle contact accidents are anticipated, such as at elevating work vehicle locations, centering, and seat trolleys.
- ⑥ Install cushioning material where the seat trolley, centering, and air duct come into contact.
- ⑦ Plan repairs. If sudden work is unavoidable, ensure that KY is performed on the additional work before carrying it out.

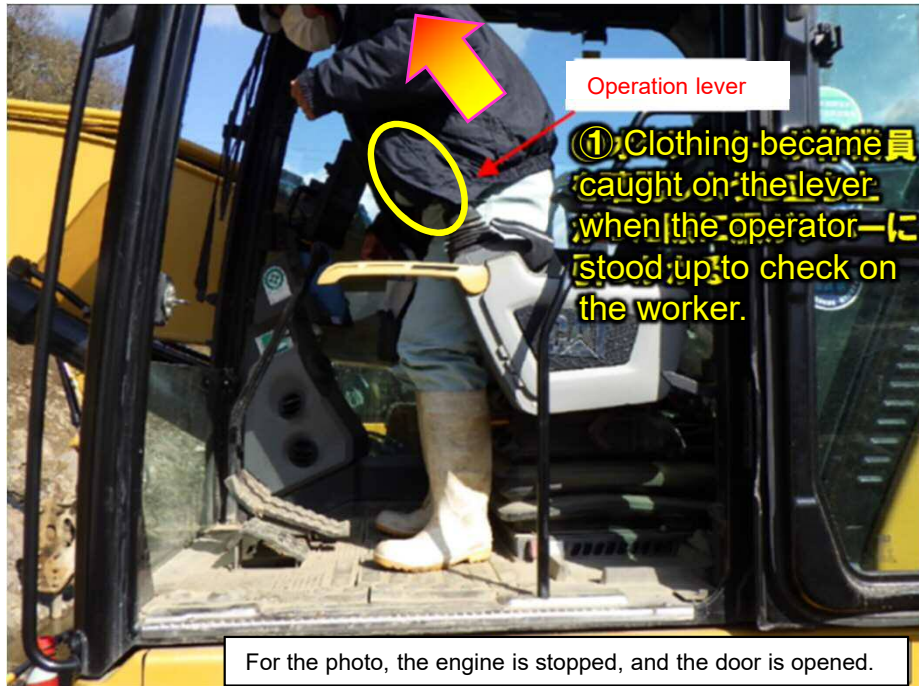
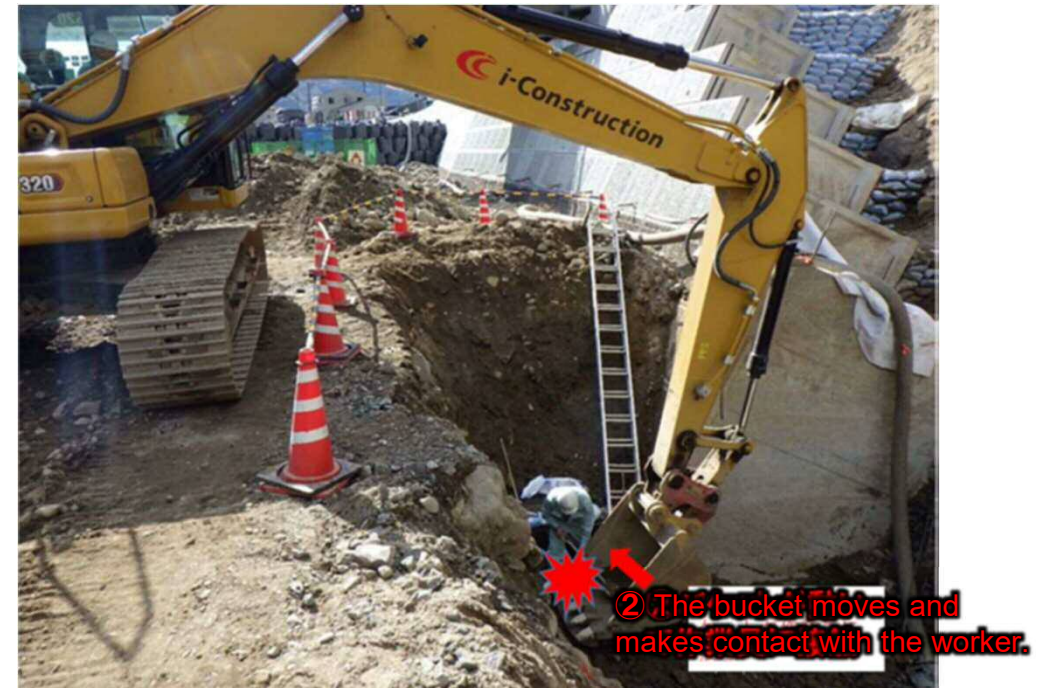
A backhoe was supplying sand and soil to a worker making sandbags at the foundation of a block pile. When the backhoe operator stood to check on the worker, his clothes became caught on the control lever and the backhoe bucket moved, striking the worker's leg and injuring him. **[1 injured person]**

- The zipper on the operator's winter clothing was not fastened and got caught on the operating lever, causing an unintended activation.
- The backhoe was in working condition when the operator left his seat.
- The worker also acted as the signaller and was not visible to the operator.

- Inform employees about safe ways to wear work clothes, such as fastening zippers, and conduct checks.
- Make it known that employees should use the safety lock when standing up from the driver's seat of a backhoe.
- Install a separate signaller.

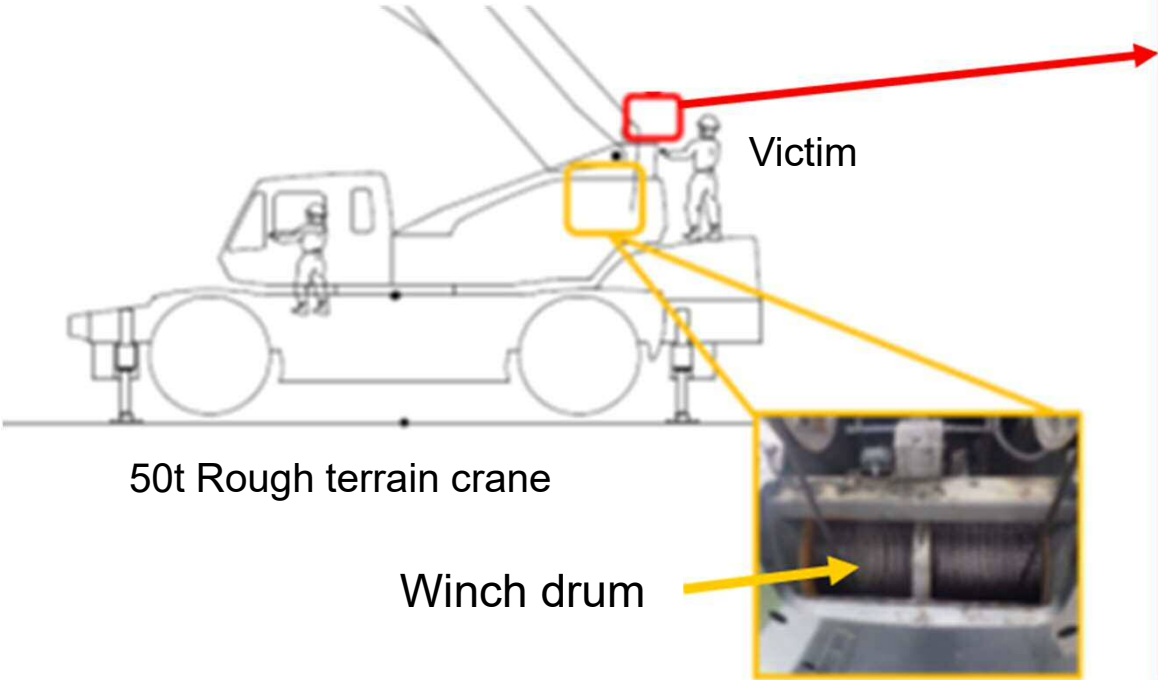
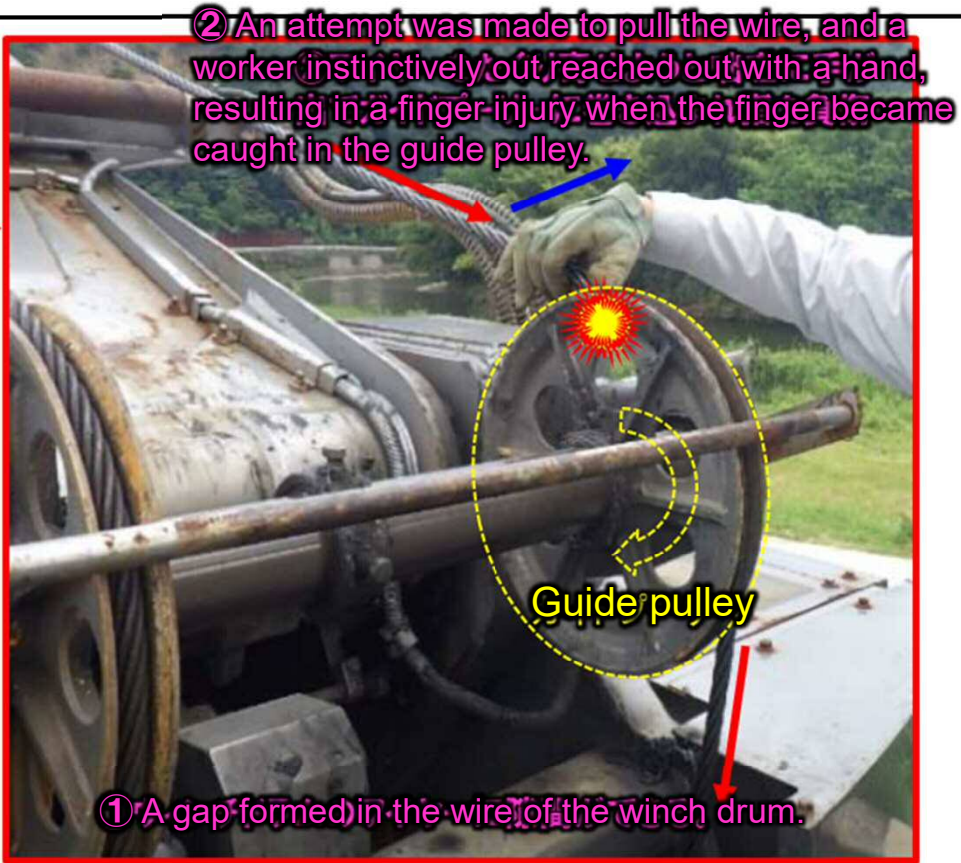
During crane inspection and maintenance, while visually checking the state of the wire being wound onto the winch drum, the worker noticed a gap in the wound wire and instinctively placed his hand on the wire to fix the gap, resulting in his right index finger being caught between the wire and the guide pulley and injuring the finger. **[1 injured person]**

- The worker knew the wire should not be touched, but the worker reached out for it instinctively.
- Crane maintenance was not included in the work procedure manual, and there was insufficient awareness among workers about work procedures and safety points.

- Be sure not to touch any moving parts of the machine, and ensure the wire winding status is visually inspected from the ground where the wire cannot be touched.
- Establish work procedures and safety measures for machine inspection and maintenance.

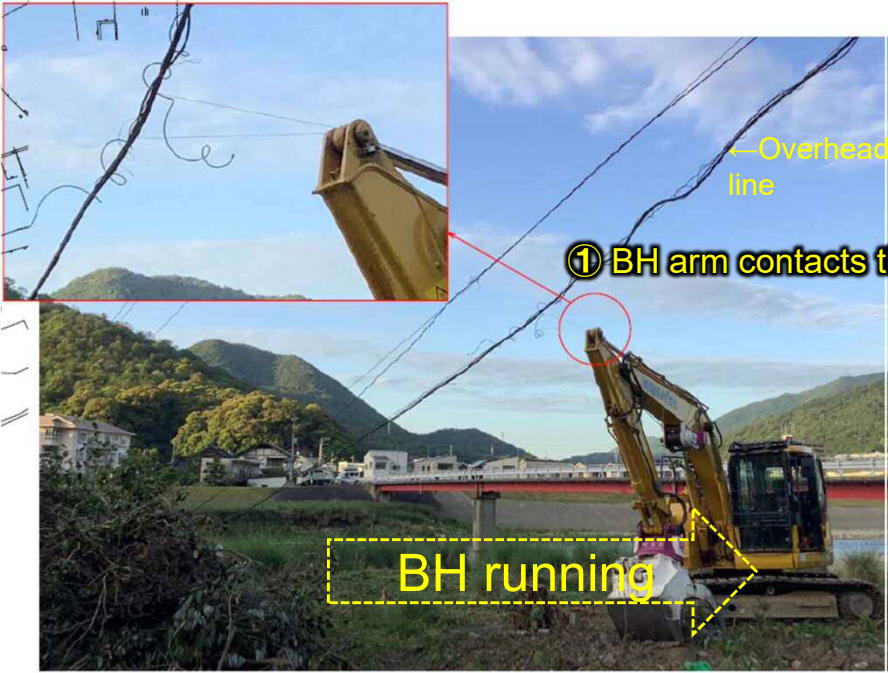
<div> <div>① BH arm contacts the wires</div> <div>Overhead line</div> <div>BH running</div> </div> </div> </div> </div>	<div> <div> <div>After felling work was completed, a backhoe passed under overhead wires while moving, and the arm of the backhoe came into contact with the wires while the vehicle continued to move, pulling the wires and breaking two electric poles on the opposite bank. The broken poles then struck the walls and roofs of private homes, damaging the homes.</div> <div>

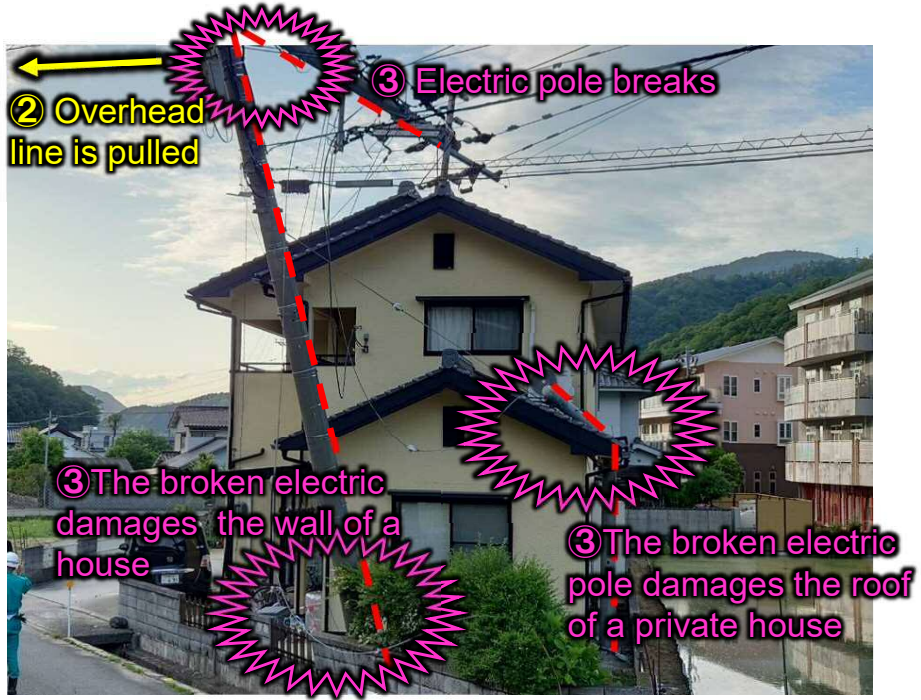
<div> <div>② Overhead line is pulled</div> <div>③ Electric pole breaks</div> <div>③ The broken electric damages the wall of a house</div> <div>③ The broken electric pole damages the roof of a private house</div> </div> </div> </div> </div>		
<div> <div>Cause of accident</div> <div> <div>- Protective measures such as height limit gates were not in place.</div> <div>- Procedures for working near overhead lines to prevent contact had not been established.</div> <div>- The driver did not remember the overhead wires and drove off without lowering the boom.</div> </div> </div>	<div> <div>Contractor's preventive measures</div> <div> <div>- Install protective measures for overhead lines (such as height restriction gates).</div> <div>- Establish rules for operation near overhead lines.</div> <div>- Hold a meeting to inform all workers before restarting work; the information will also be disseminated during training for new entrants and KY activities to ensure thorough implementation.</div> </div> </div>

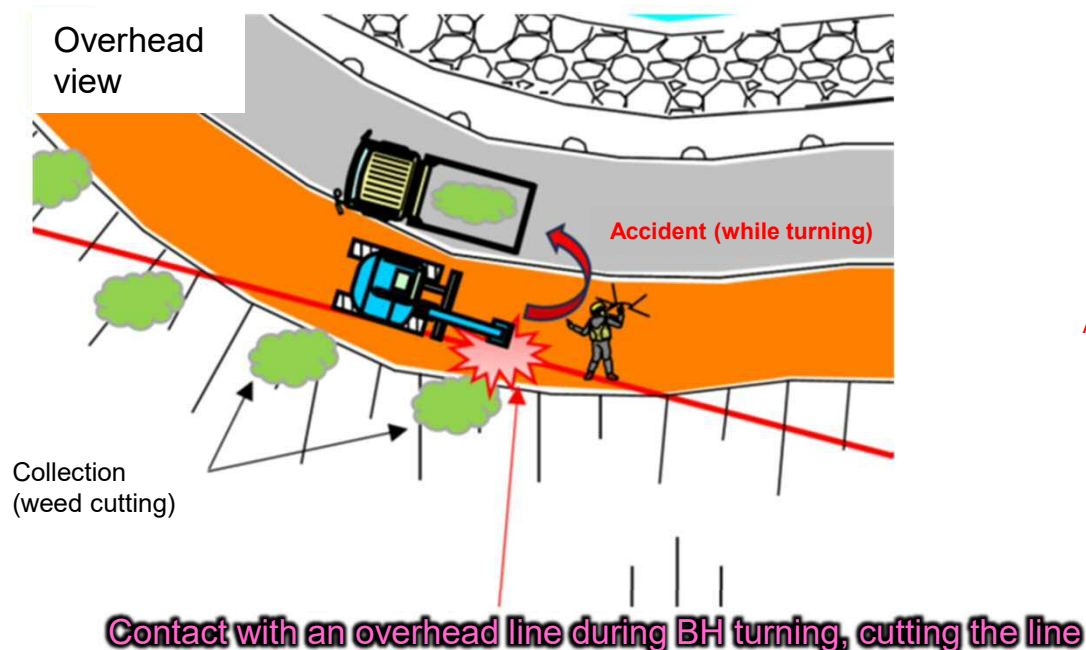
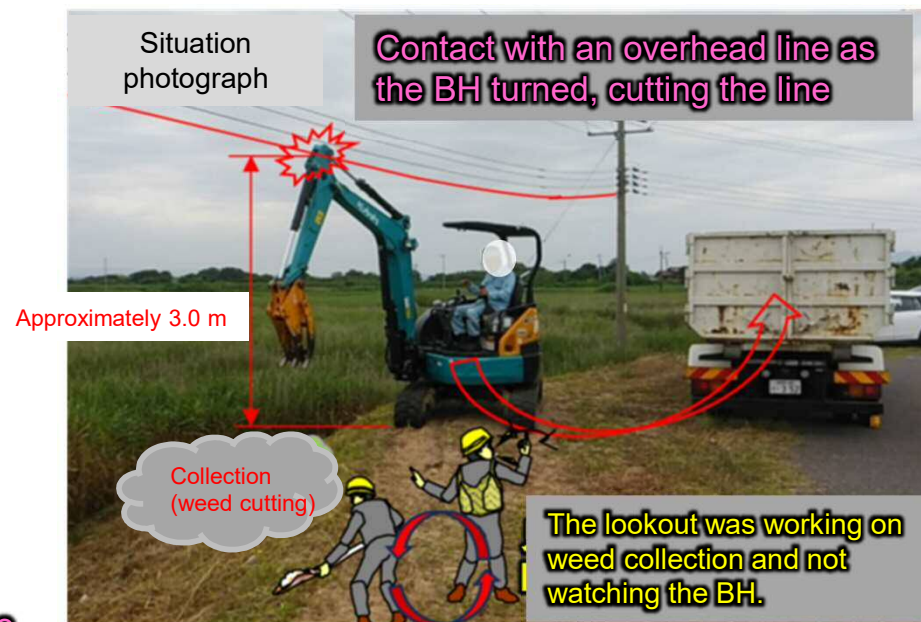
During weed removal, a BH turned to load the weeds onto the truck. The arm of the BH came into contact with the overhead line, cutting the line.

- No specific contact prevention measures were implemented.
- The lookout was performing another task and not keeping watch.

- When the height of the overhead lines is less than 4.5 m, work should be carried out manually.
- Appoint a dedicated lookout officer and ensure that they do not perform any other tasks besides watching the work.

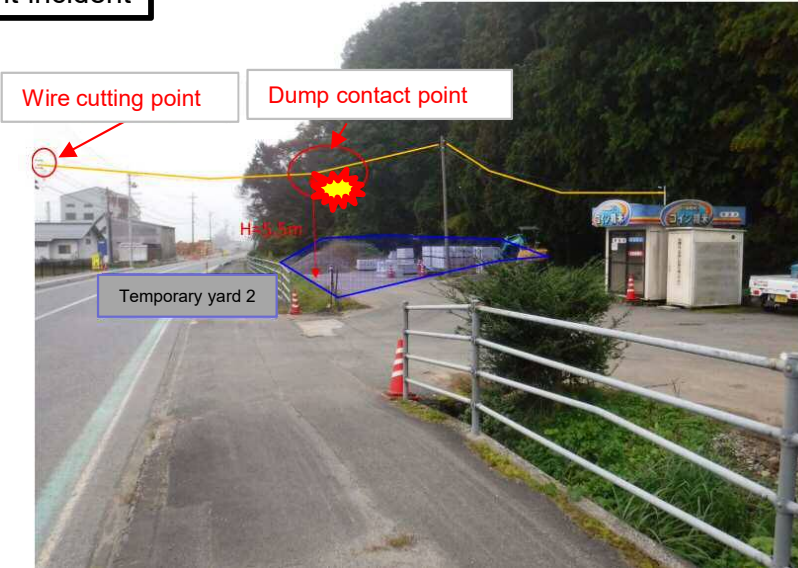
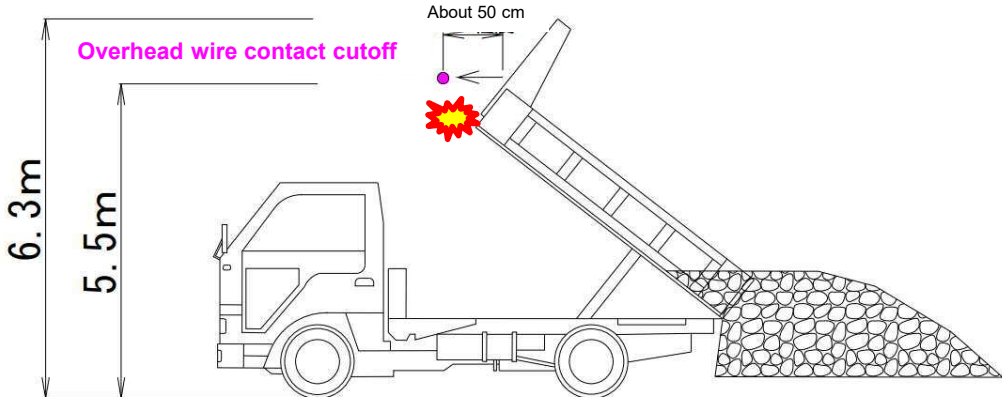
Accident overview	<p>A10t dump truck was transporting crushed stone to a temporary yard for storage. When the truck moved forward about 50 cm to dump the remaining crushed stones, the truck's loading platform came into contact with an electric wire, cutting the wire. [Property damage]</p>
Accident incident	<div data-bbox="389 320 692 352">[Photos from the site]</div> <div data-bbox="163 357 958 927">

Cause of accident	<div data-bbox="264 1171 931 1506"><p>- There was no thorough awareness or clear guidance given regarding the prohibition on subcontractors delivering using the dump truck. Furthermore, the general contractor was not aware of the stock situation in the temporary yard.</p><p>- For unplanned work, do not rely solely on the workers to make decisions, but ask for the contractor's decision.</p><p>- Although the company had prepared a prior investigation report and a plan for measures to prevent accidents such as collisions and disconnections on the main site, it had not prepared a prior investigation report or plan for measures to prevent accidents such as collisions and disconnections on the temporary yard and had not clearly indicated the overhead lines.</p></div> <div data-bbox="943 1171 1133 1289">Contractor's preventive measures</div> <div data-bbox="1155 1171 2204 1560"><p>- Re-educate workers on the use of 10t dump trucks for delivery and install signs reminding them that large vehicles are not allowed to enter certain areas. In addition, an item will be added to the safety patrol inspection list requiring checking and understanding the status of temporary yards.</p><p>- All work procedures shall include a description of procedures in the event of unscheduled work, and the prime contractor and subcontractors shall be re-educated and made thoroughly aware of the situation. In addition, the response to unscheduled work will be posted at the work site, and daily education will be provided during morning meetings.</p><p>- Prepare a plan for a preliminary survey report on publicly occupied properties and other relevant items and an accident prevention plan for contact, severing, and other incidents for temporary yards and construction vehicle transportation routes. Implement security measures to prevent accidents involving collisions and cutoffs (clear signs and warning signs). Increase the number of company safety patrols to at least twice a month, and evaluate the status of daily checks, including written reports.</p></div>

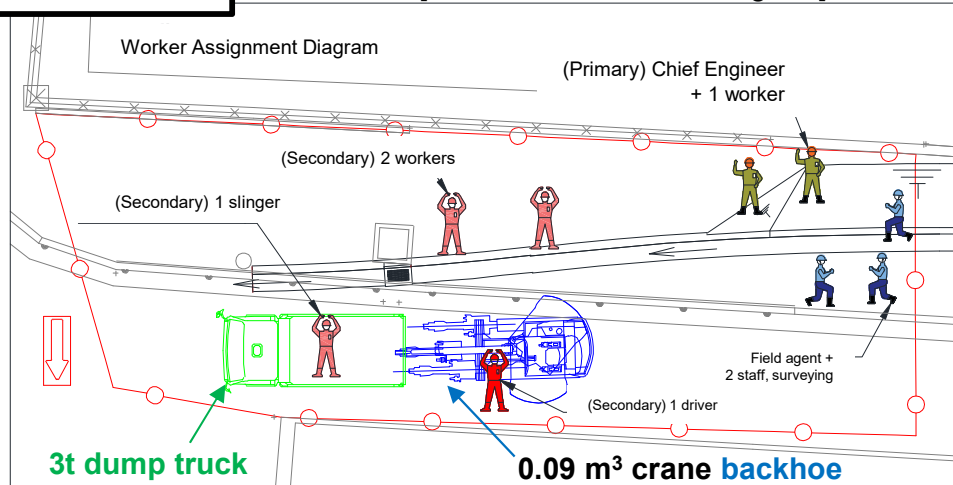
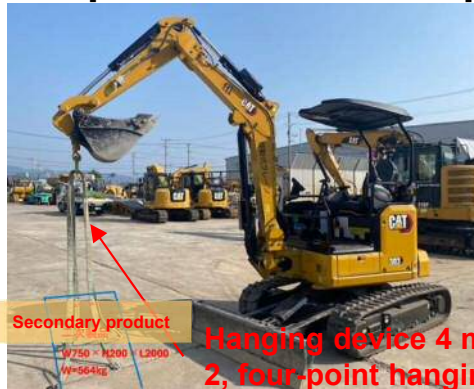
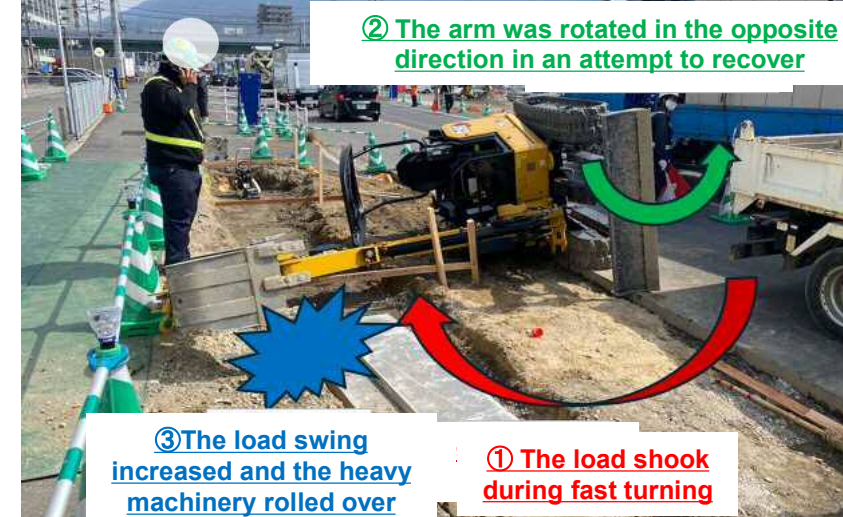
During road improvement work, a secondary concrete product (street culvert apron W750 x H200 x L2000 , W = 594 kg) was unloaded from a dump truck by a crane backhoe, causing the load to swing and the heavy equipment to overturn. **[No casualties]**

- The work continued despite the warning buzzer sounding.
- No one stopped the dangerous work.
- The rotation was so fast that the load swung, causing the arm to return to the opposite direction.
- There was no extra capacity in the performance of the machines used.
- The sling was long and the arm was raised to its maximum extent.

- If the alarm buzzer sounds, stop the work (do not proceed), review the work procedures, and inform everyone of the procedures.
- Implement re-education to improve safety awareness and provide education for new entrants based on this accident; perform on-site demonstration training.
- Keep engine output (rpm) below 80% and limit turning speeds.
- Improved performance with 0.15 m³ crane backhoe (rated load is increased by 60%).
- The length of the sling is half that used at the time of the accident (L = 1 m x 4), and measures are taken to prevent the arm from being raised more than necessary.

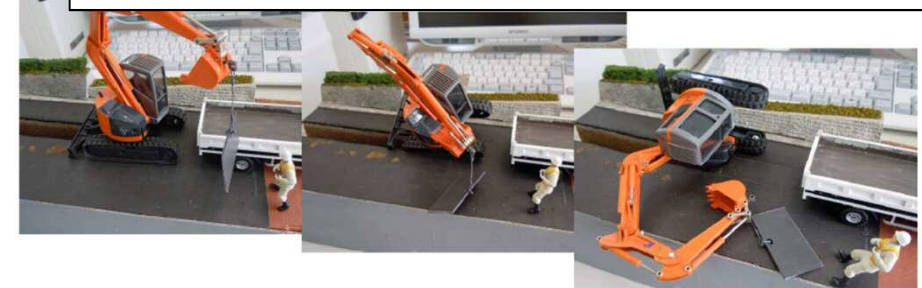
[Reference material: Ministry of Health, Labor and Welfare, Workplace Safety Website]

As for all machines, lifting operations at right angles to the caterpillar are more unstable than those in the parallel direction, and the probability of tipping over in the process is very high, especially when turning.
