Occupational hazard accidents

Public hazard accidents

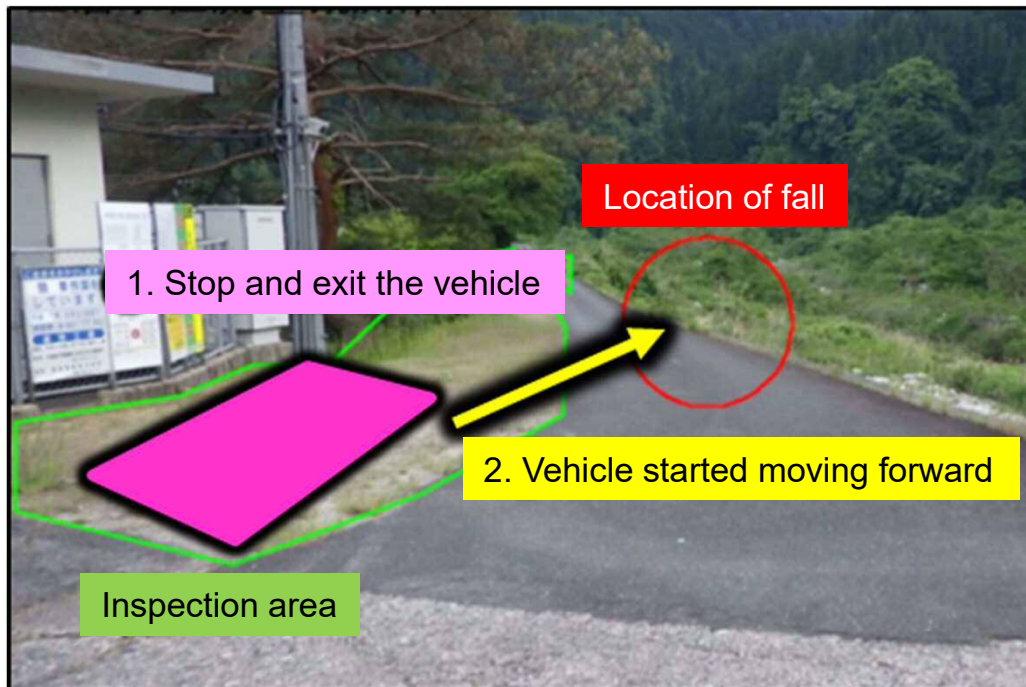
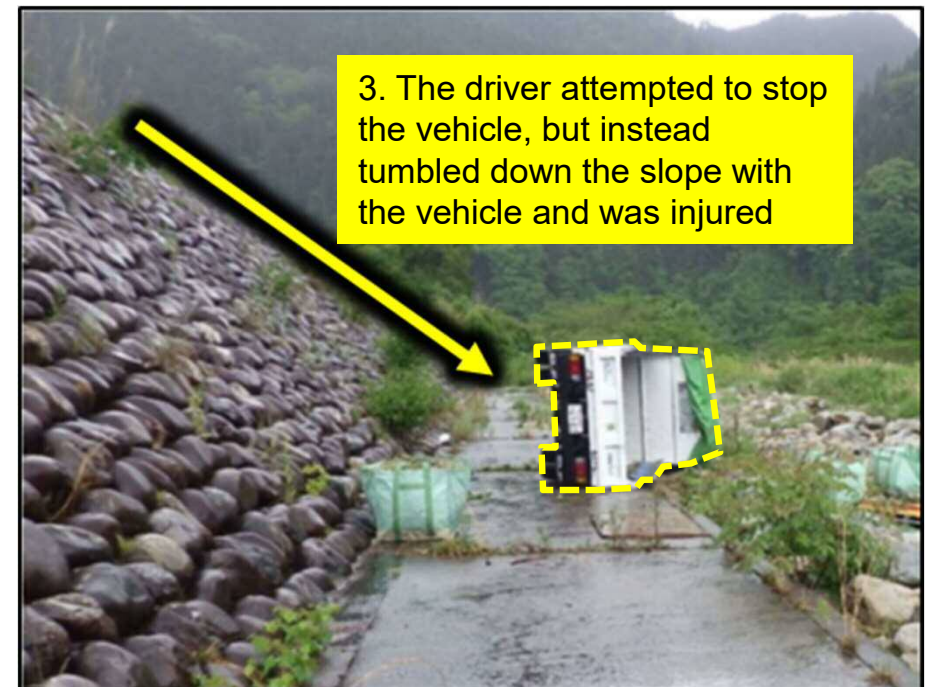
When the vehicle (2-ton dump truck) was stopped and disembarked in order to check the work site, the side brake was not pulled and the vehicle started moving, and although it tried to stop, it fell from the embankment with the vehicle and was injured. [1 person injured]

- The driver exited the vehicle without engaging the side brake.

- Ensure that all drivers are reminded to use the side brake when parking and stopping their vehicles.
- Post a sign inside the vehicle stating that the side brake must be used.

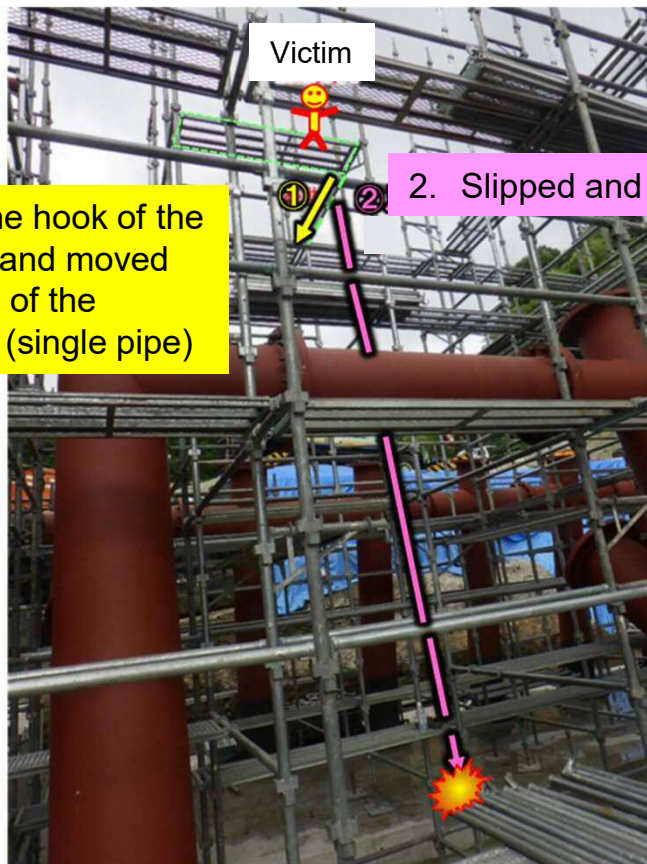
1. removed the hook of the safety belt and moved on the side of the scaffolding (single pipe)

2. Slipped and fell

- ① The subcontractor has partially canceled the installation of scaffolding boards.
- ② Without taking measures to prevent falling, the worker moved on the side of the scaffolding (single pipe) without using a safety belt.
- ③ The subcontractor did not wait for the arrival of the scaffolding assembly supervisor and performed scaffolding assembly work in his absence.

- ① If there is a problem during assembly, remove the scaffolding plate after preventing entry to the opening area, and restore the scaffolding plate after assembling the steel member.
- ② Walk on scaffolding boards and do not move unstable parts such as the side of the scaffolding (single pipe).
- ③ If the chief of scaffolding assembly is absent, make sure that the work is not performed.

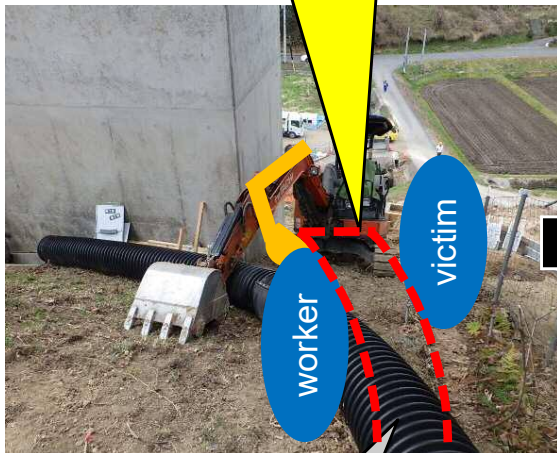
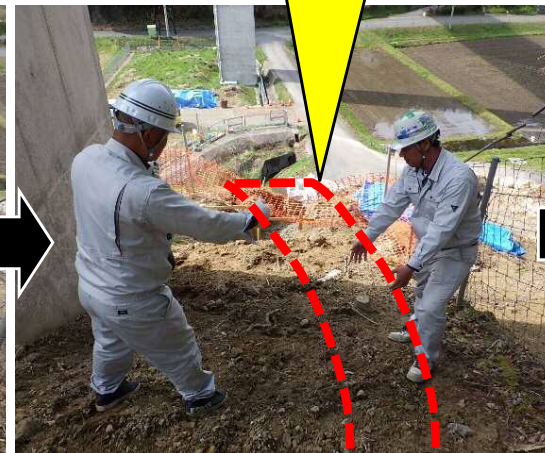
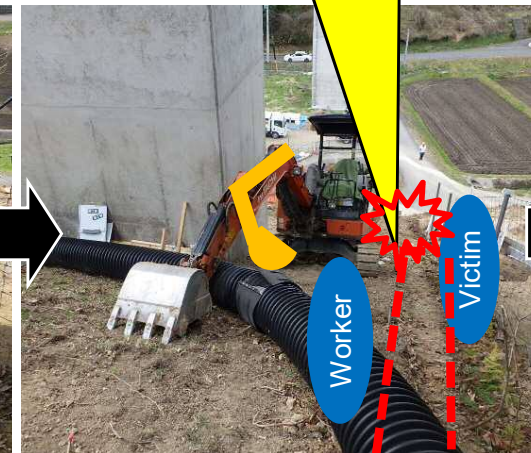
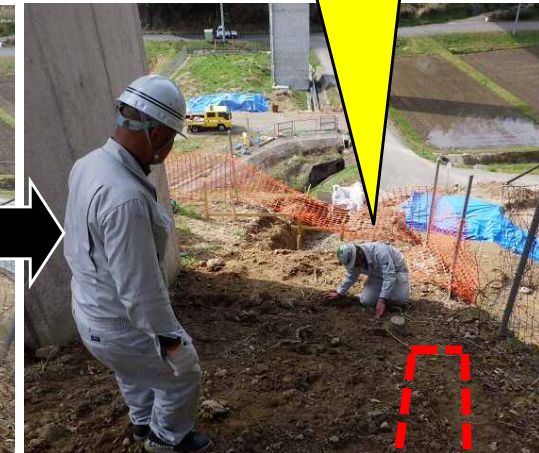
The black pipe is caught in the cabin of the backhoe.

Lifting to remove the black pipe.

The bent black pipe is released and recoils.

The recoil of the bent pipe caused a worker to lose his balance and tumble down the slope.

- The prime contractor instructed the subcontractor to excavate up to a point where the black pipe would not affect the excavation; however, the subcontractor excavated further to where the black pipe did affect the excavation.
- The work was on a slope with a high risk of falls, but safety instruction and safeguards were lacking.

- In the event of a change in the original work plan, the subcontractor shall report to the prime contractor and ask for instructions.
- If conditions change during the work, the subcontractor shall report to the prime contractor, who will determine the measures to be taken and give instructions to the subcontractor.
- The cause of the accident and countermeasures will be communicated and implemented during a safety meeting for the entire cooperative association.
- A fixed barrier and mobile safety net will be installed on the slope.
- Although it is a safe slope, a safety line will be installed on the slope and workers will use a safety belt.
- A stairway will be installed to provide safe passage.

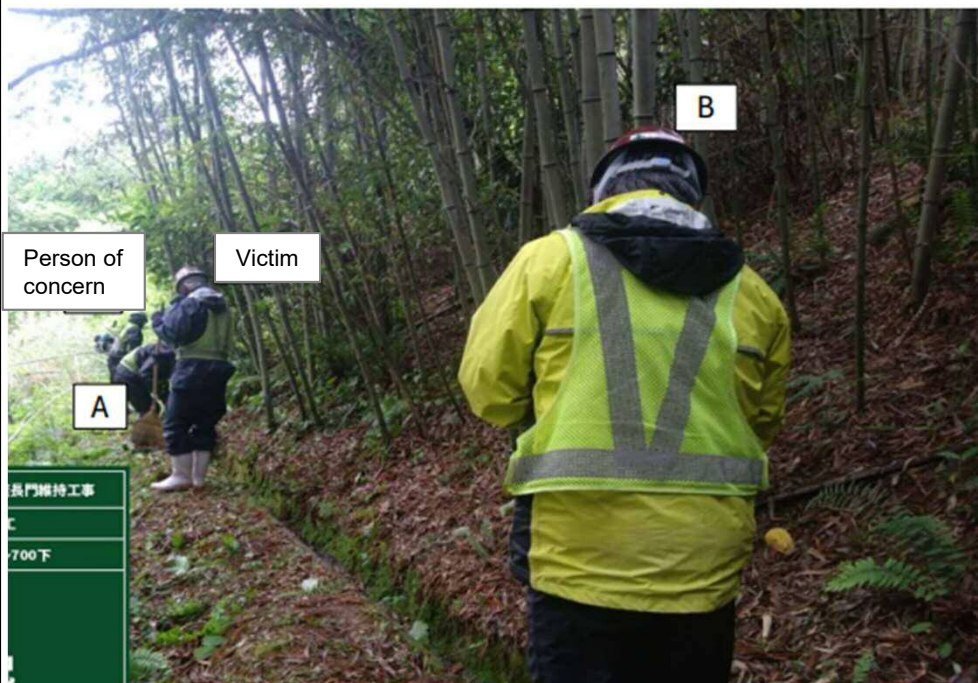
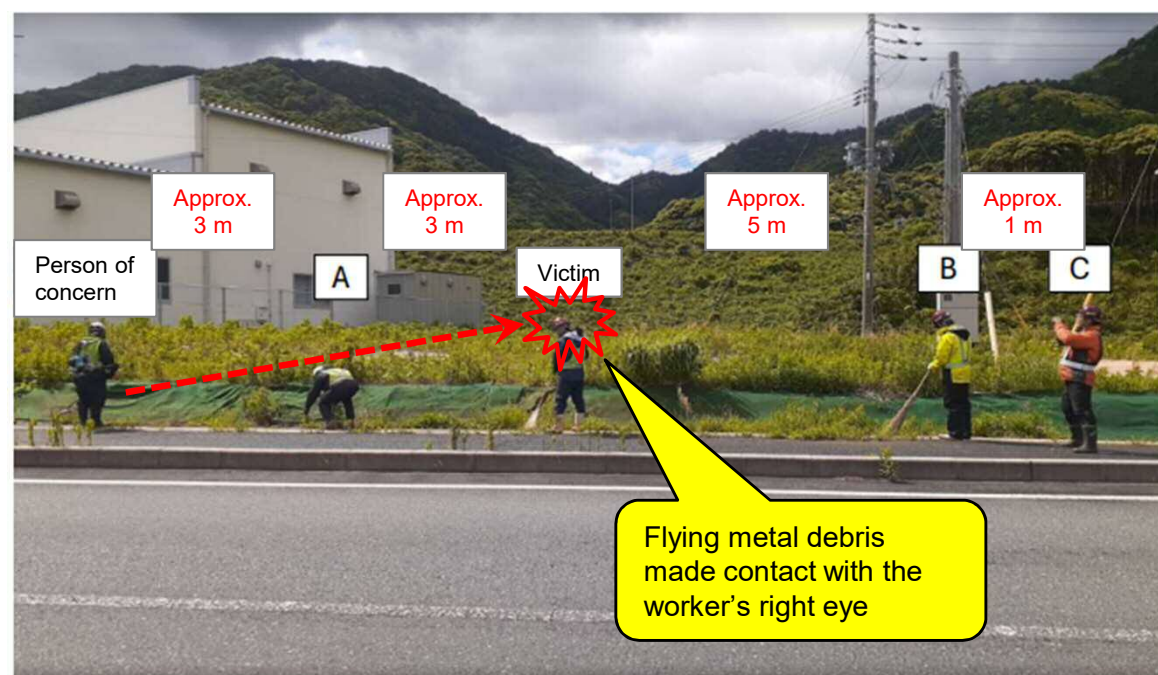
While weeding and disposing of branches along both sides of the embankment steps, a foreign object flew to a worker who was collecting weeds behind him during weeding work with a brush cutter, and he was injured when he hit his right eye.

- ① There was no awareness of the danger of flying rocks and other hazards to the weed collectors.
- ② Weed collectors were not wearing protective goggles.

- ① Recognize the danger of flying rocks and other hazards to weed collectors.
 - Revise the operational plan
 - Revise the work procedures
 - Re-education of workers
- ② All workers engaged in work using brush-cutters should wear protective goggles.

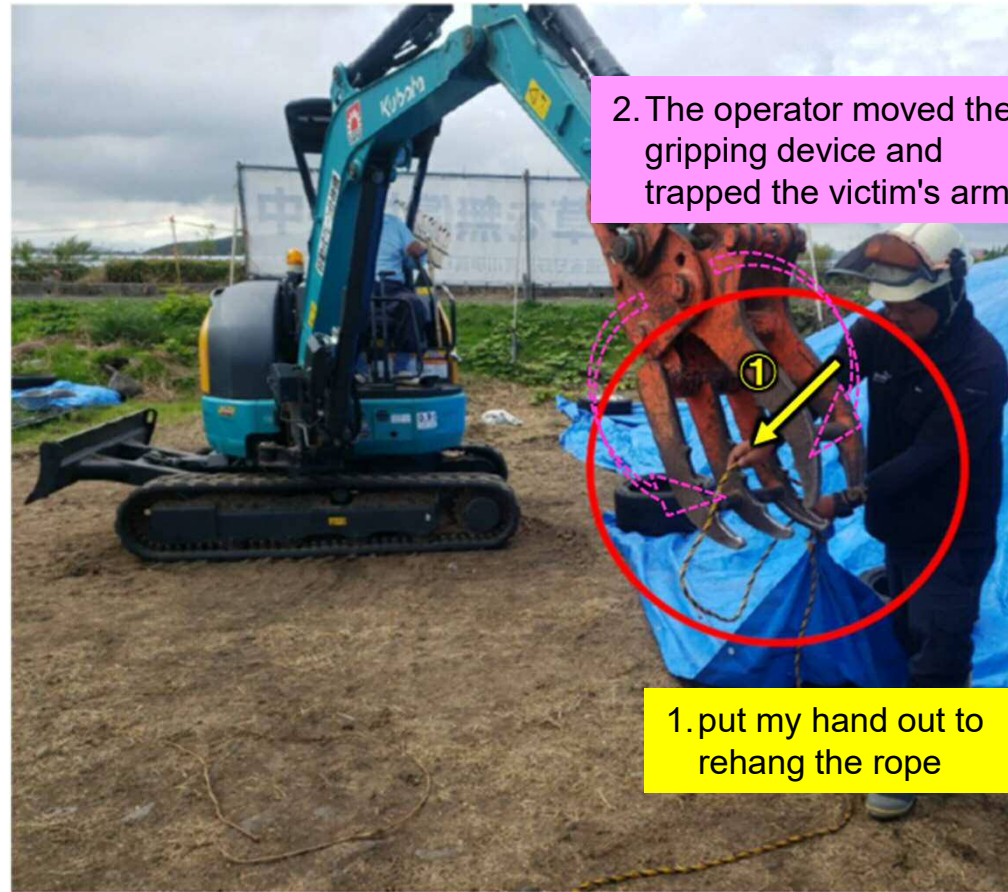
During the packing work of the cut grass, when the tiger rope was hung on the backhoe grabbing device to remove the blue sheet that covered the cut grass, the worker reached for the tiger rope and at the same time the backhoe operator moved the grabbing device to grab the tiger rope with the grabbing device, so the worker's arm was caught in the gripping device and injured. [1 person injured]

Work was performed without establishing specific work procedures or signals.

Removing blue sheets is done manually.

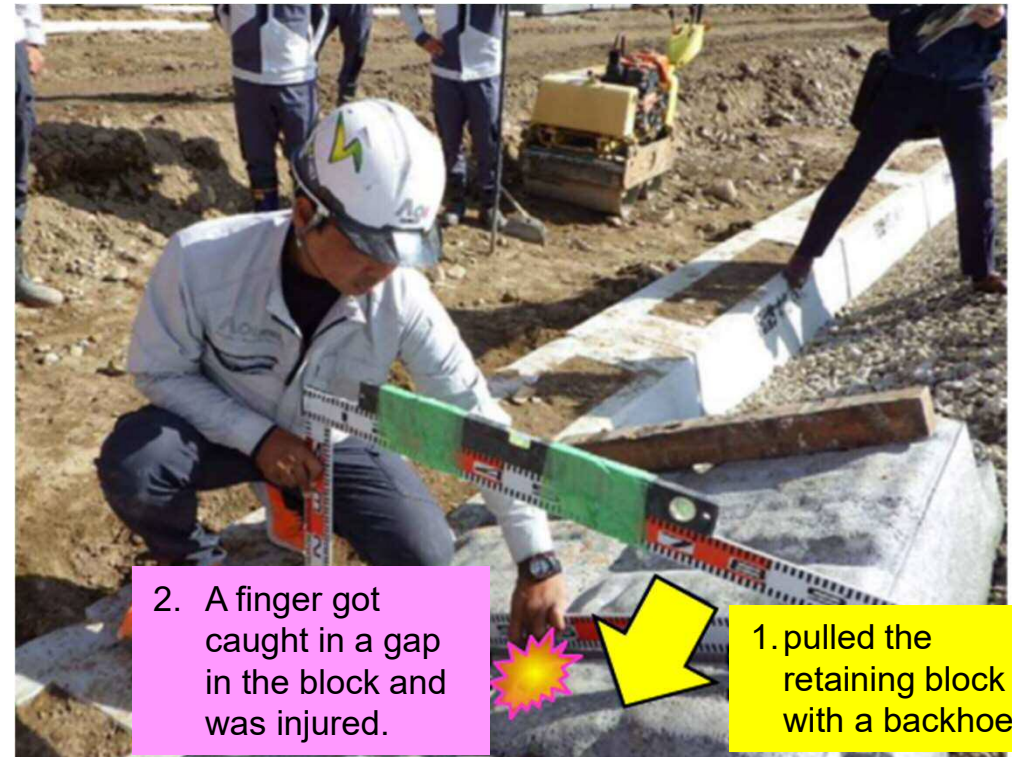
When the workforce was used to move the gap between the retaining blocks with a backhoe during the installation of the retaining blocks, the finger of the worker who was measuring the slope of the retaining block was caught in the gap between the blocks and was injured. [1 person injured]

① At the same time, heavy machinery was used to adjust the position of the seawall block, and workers checked the slope.

① Thoroughly disseminate the prohibition of simultaneous work by heavy machinery and workers.

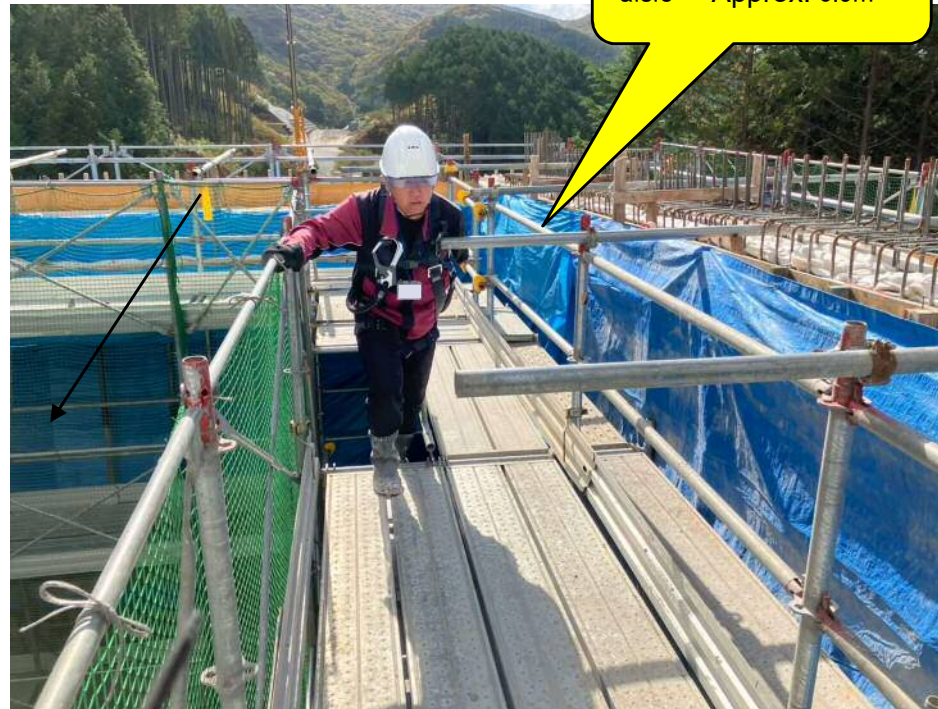
In the concrete curing work of the bridge abutment frame, when the work on the lower level of the scaffolding was completed and the work was moved to the upper stage of the scaffolding for curing work, the left breast was hit by a single pipe that was protruding into the passage.

- There was a lack of awareness of the danger of a single pipe protruding into the aisle.
- There were no indications during the patrol, and no countermeasures were taken.

- The following two points will be added to the work procedure manual of each contractor: "Eliminate steps, unevenness, and protrusions as much as possible in the work corridor" and "If there is a dangerous area, cure it with cushions, etc., and install warning signs" and reinforce them.
- Safety patrols will be strengthened by adding "status of securing passages" and "status of organization on scaffolding" to the safety patrol record.
- Protruding danger areas should be cured with caps, cushioning materials, etc., and warning signs should be clearly stated.

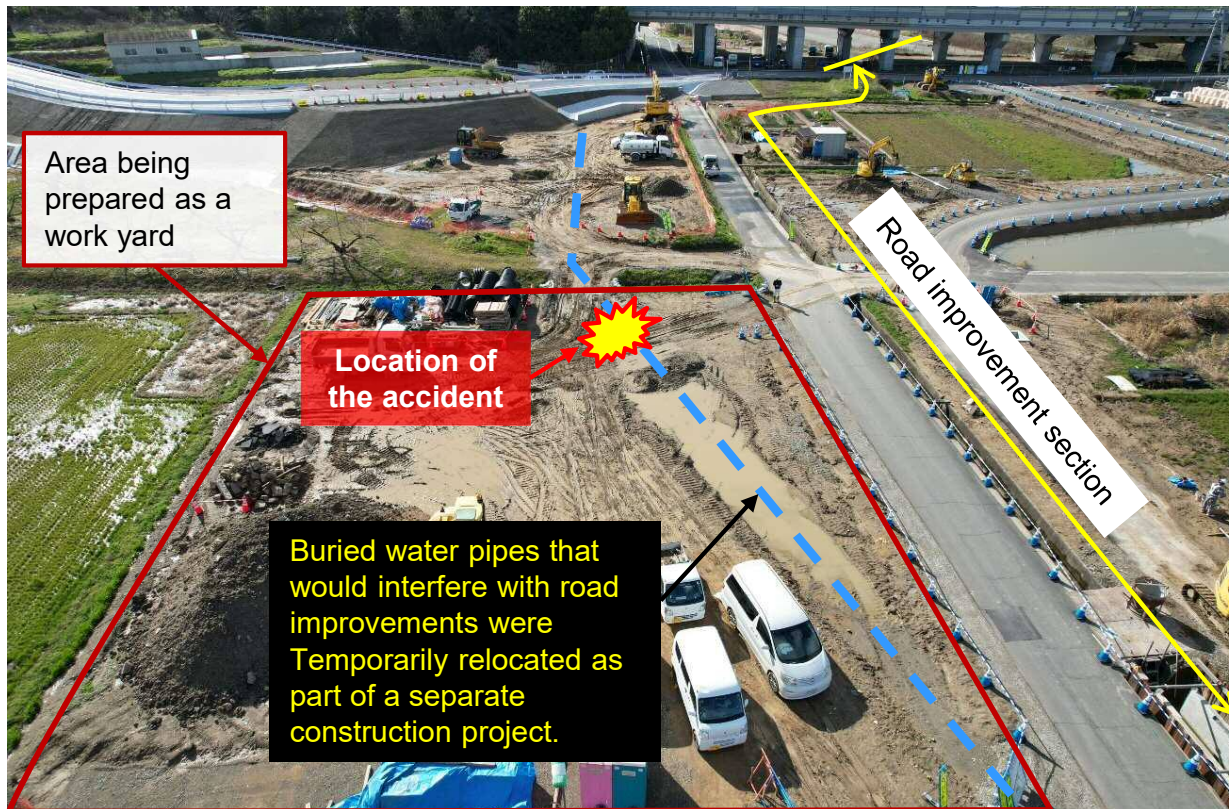
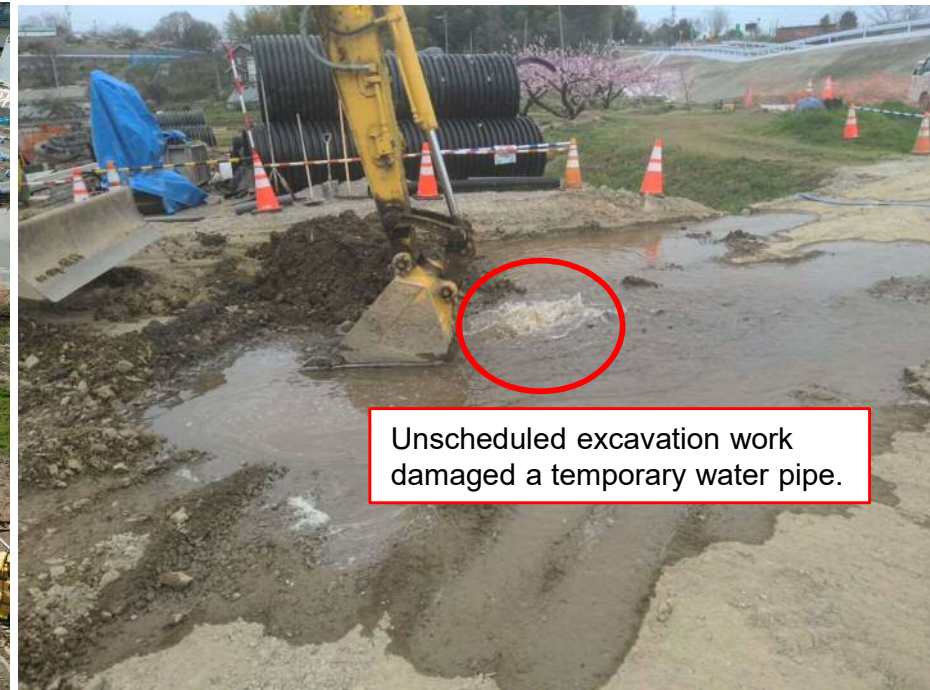
A backhoe was excavating to replace some muddy areas with good quality soil when it struck a temporary water pipe in the leased land, damaging the pipe. [Temporary water pipe damaged]

The presence of the buried temporary water pipe was known. However, the heavy equipment operator (the prime contractor's work foreman) independently decided to fix the muddy area and performed unauthorized excavation work.

- Ensure that no work is performed that is not part of the work instructions.
- If work instructions need to be changed, contact the site representative, prepare a revised work order, and resume work only after conducting hazard prediction activities and meetings.
- The type and depth of buried objects should be clearly indicated at the site of the buried object to ensure its presence is known to all workers.

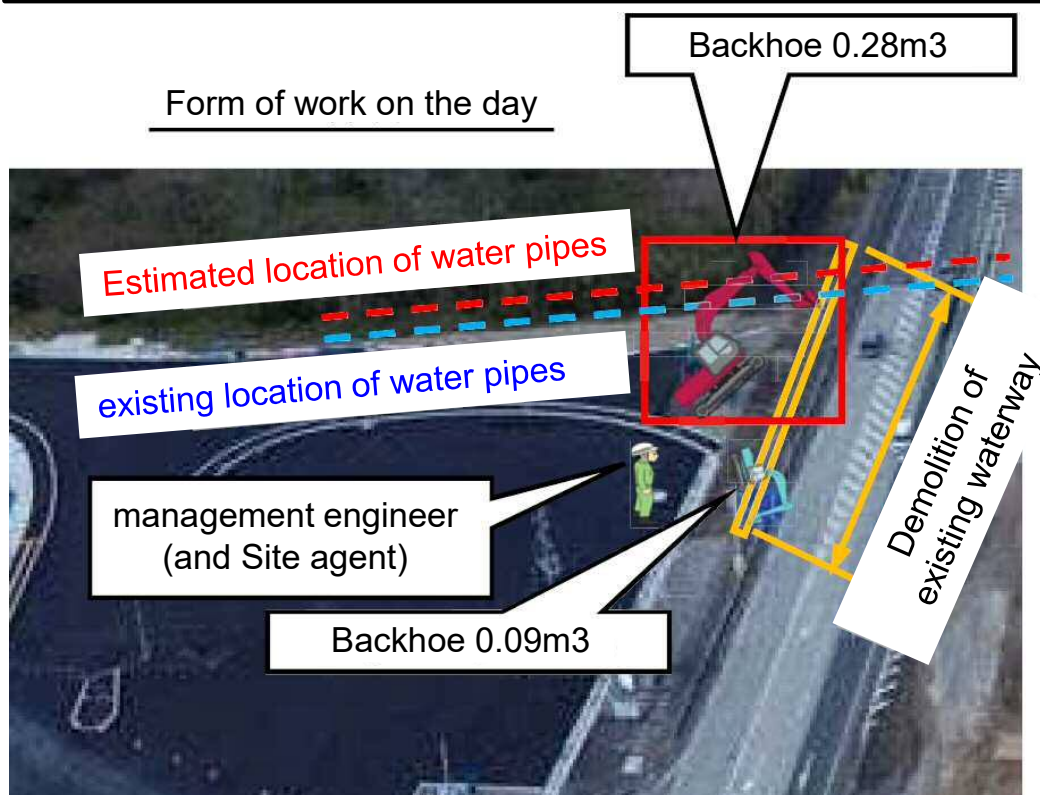
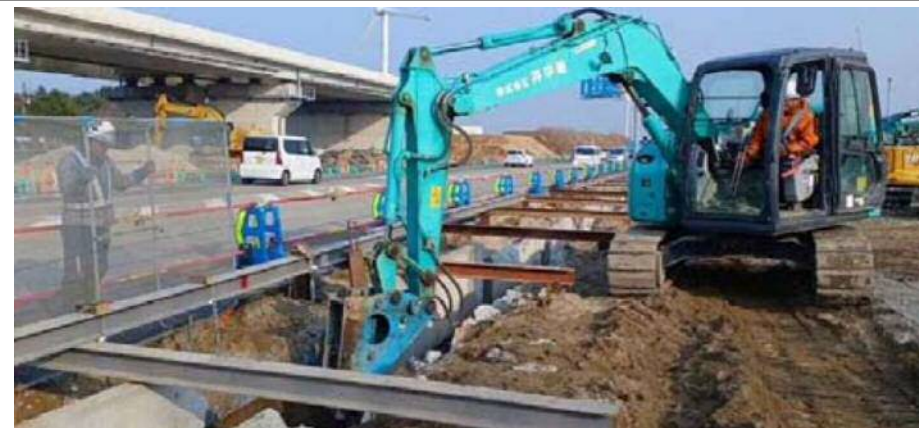
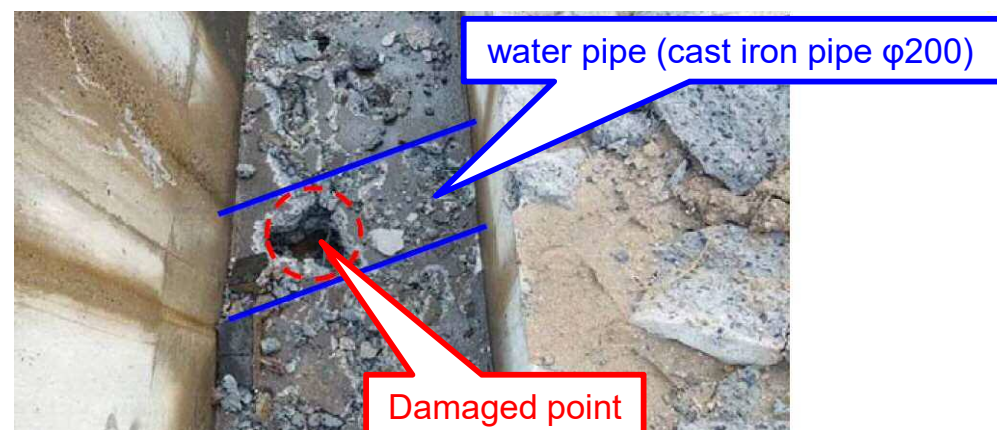
Accident overview During the demolition of an existing concrete channel using a hydraulic breaker, a water pipe (cast iron pipe $\phi 200$) buried directly under the bottom plate of the channel was damaged. [No impact on the surrounding area due to water outages]

- Initially, preliminary surveys of buried objects were conducted in accordance with the contract. For additional work, the plan was to begin construction from the front of the burial site and conduct preliminary excavation surveys as work progressed, but damage occurred because the burial site was not where it was estimated to be.
- Regardless of whether it was additional work or not, it was necessary to conduct a trial excavation survey before the start of demolition to clarify the location of the buried pipe.

- In all excavation and demolition work, we will thoroughly conduct preliminary surveys and trial excavations of buried objects before the start of construction, not when approaching the nearest work area.

- All excavation sites will be investigated using underground pipe exploration ground radar, and the areas where a reaction has been obtained will be tested in the presence of the burial manager and visually confirmed.

- Cautionary signboards indicating the type and depth of underground objects will be installed at the locations confirmed by exploratory excavation, etc., and a piping route map will be posted on site so that the relevant parties can always grasp the information at the time of work, and the piping route will be marked with spray and visualized.

- Distribute a map of buried objects to all workers and ensure that they are fully aware of the type, location, depth, and piping route of buried pipes at the site of buried pipes every day.

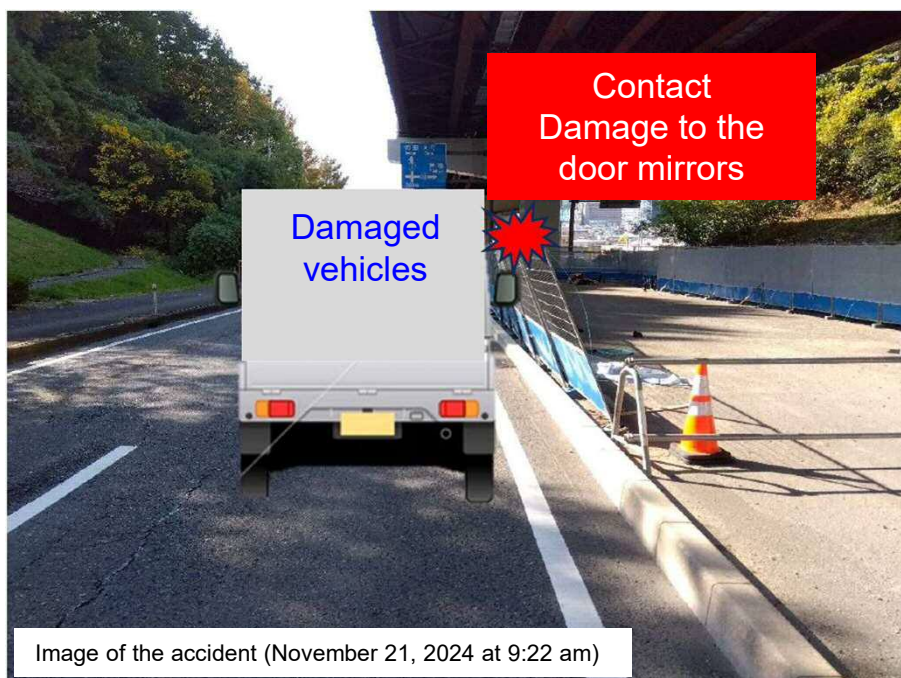
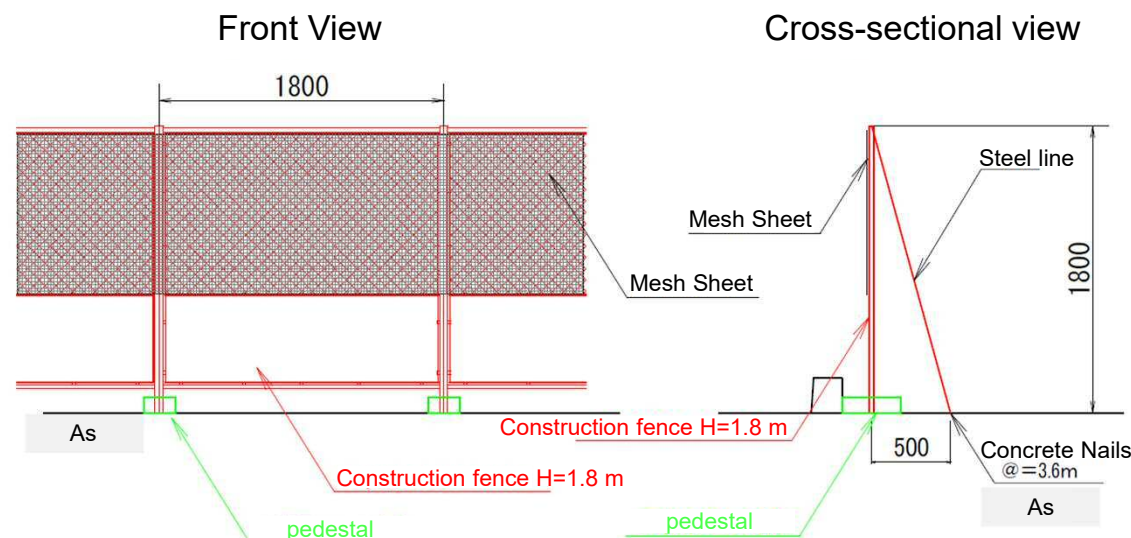
A construction fence installed to use the space under the overpass as a temporary storage area for construction materials collapsed onto the road when a large vehicle passed by, damaging the door mirrors of 2 vehicles travelling behind it. [2 general vehicles were damaged]

- As a countermeasure against theft, a mesh sheet was attached to the construction fence and a blindfold was used.
- This structure is susceptible to wind when large vehicles pass by, but the support method was insufficient.
- As a result, the base of the construction fence shifted, and the concrete nails driven into the asphalt pavement to secure the backup wire came loose due to the wind vibrations.

- The use of the yard under the viaduct will be discontinued, and another private site will be secured as a temporary storage site.
- In the future, when installing a similar construction fence on a road, we will confirm the installation method in-house and take measures according to the site conditions.
- The structure is based on the following with reference to the results of other constructions.
<When the installation ground is pavement (AS, etc.)>
 - ① The pedestal of the construction fence shall be H steel (400×400).
 - ② Use special tools (H steel supports, etc.) to fix the construction fence and H steel.
 - ③ Drive a single tube into 3@1.8m = 5.4m in one place and take a hold with a chain.
 - * Reinforcement to prevent falls on the roadway side
- Reflect the details of the measures in the construction plan and work procedure.
