Occupational hazard accidents

Construction accidents due to inadequate safety management measures by prime contractors, excluding the Government Buildings Department and the Port and Airport Department

Public hazard accidents

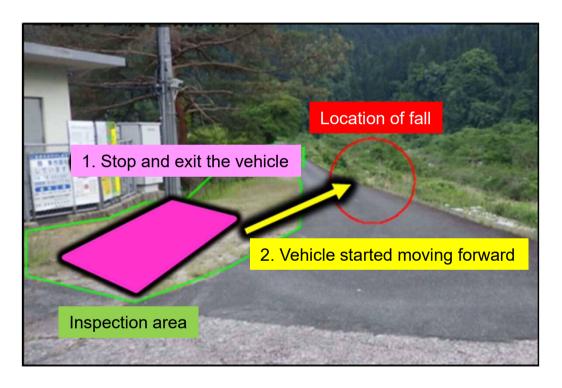
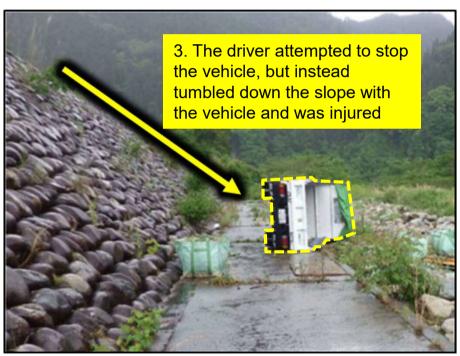
When the vehicle (2-ton dump truck) was stopped and disembarked in order to check the work site, the side brake was not pulled and the vehicle started moving, and although it tried to stop, it fell from the embankment with the vehicle and was injured. [1 person injured]

The driver exited the vehicle without engaging the side brake.

- Ensure that all drivers are reminded to use the side brake when parking and stopping their vehicles.
- Post a sign inside the vehicle stating that the side brake must be used.

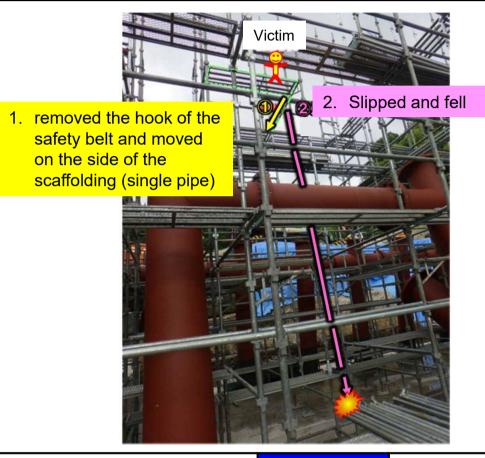
While assembling scaffolding for the installation of steel members of an erosion control dam, a worker removed the hook of the safety belt and moved on the side of the scaffolding (single pipe), slipped his foot, fell and was injured. [1 person injured]

- ①The subcontractor has partially canceled the installation of scaffolding boards.
- ②Without taking measures to prevent falling, the worker moved on the side of the scaffolding (single pipe) without using a safety belt.
- 3 The subcontractor did not wait for the arrival of the scaffolding assembly supervisor and performed scaffolding assembly work in his absence.

- ① If there is a problem during assembly, remove the scaffolding plate after preventing entry to the opening area, and restore the scaffolding plate after assembling the steel member.
- ②Walk on scaffolding boards and do not move unstable parts such as the side of the scaffolding (single pipe).
- ③If the chief of scaffolding assembly is absent, make sure that the work is not performed.

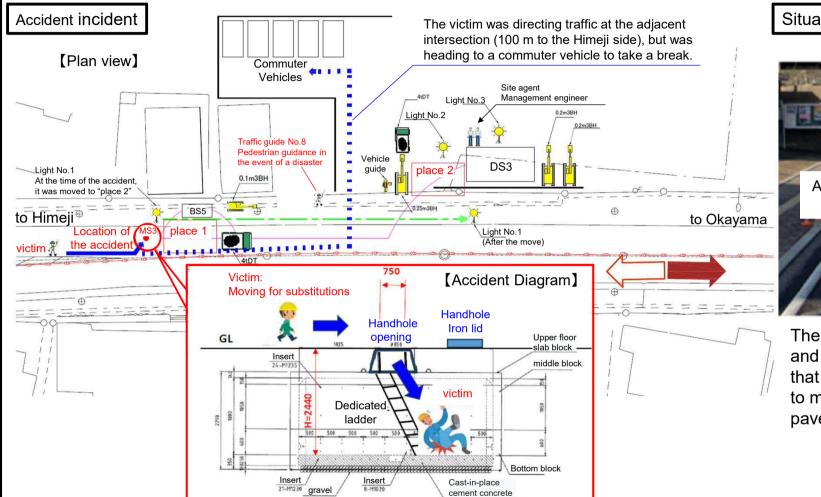
During the construction of the pipeline of the C.C.BOX, the iron lid of the handhole was opened and the main contractor was conducting a passage test, and the victim who was moving for a shift fell from the handhole opening and suffered bruises (fall injury) all over his body. [injured]

The 4tDT was parked on the road, and the victim fell without noticing that the MS3 was open while trying to move from the road to the pavement.

- ① Work was carried out on the opening without taking measures to prevent it from falling, such as fencing or covering.
- ② Some security guards were not informed of the handhole opening.
- 3 The site agent left the scene without closing the lid, and the supervising engineer was not able to instruct the person to close the lid.
- 4 It was dark because the lights were moved. (couldn't see the opening)

- (1) Barricade and then open the handhole lid.
- 2 During the release of the iron lid, a temporary lid to prevent falling (attached document) will be installed.
- 3 An additional flush bar is installed on top of the temporary lid. (Visualization of openings)
- ④ At the morning meeting, inform all security guards of the details of the work and the opening points in person.
- (5) When working in the handhole, a watchman is always placed at the top. (Selected from the members of the day)
- ⑥ Install lighting at the openings and do not move the lights until the work is finished.

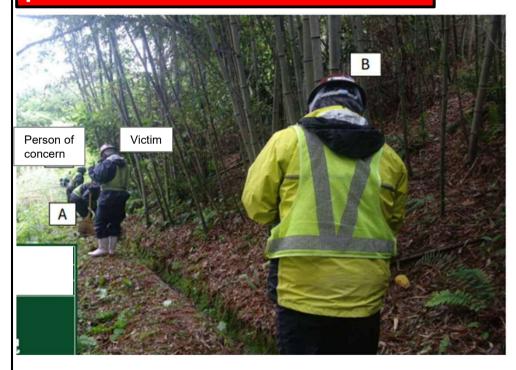
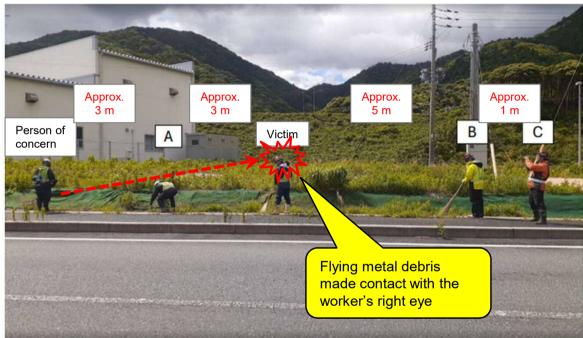
While weeding and disposing of branches along both sides of the embankment steps, a foreign object flew to a worker who was collecting weeds behind him during weeding work with a brush cutter, and he was injured when he hit his right eye.

- ① There was no awareness of the danger of flying rocks and other hazards to the weed collectors.
- ② Weed collectors were not wearing protective goggles.

- ① Recognize the danger of flying rocks and other hazards to weed collectors.
- Revise the operational plan
- Revise the work procedures
- Re-education of workers
- ② All workers engaged in work using brush-cutters should wear protective goggles.

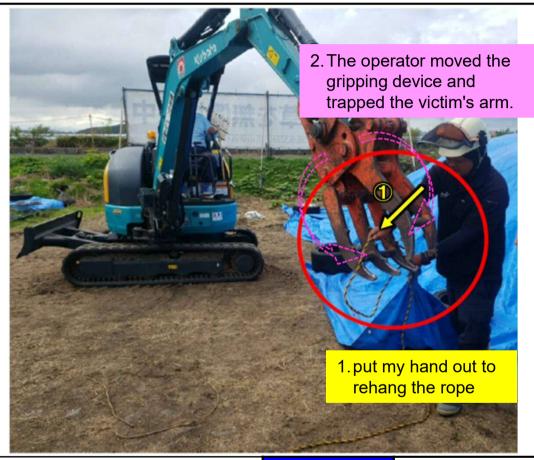
During the packing work of the cut grass, when the tiger rope was hung on the backhoe grabbing device to remove the blue sheet that covered the cut grass, the worker reached for the tiger rope and at the same time the backhoe operator moved the grabbing device to grab the tiger rope with the grabbing device, so the worker's arm was caught in the gripping device and injured. [1 person injured]

Work was performed without establishing specific work procedures or signals.

Removing blue sheets is done manually.

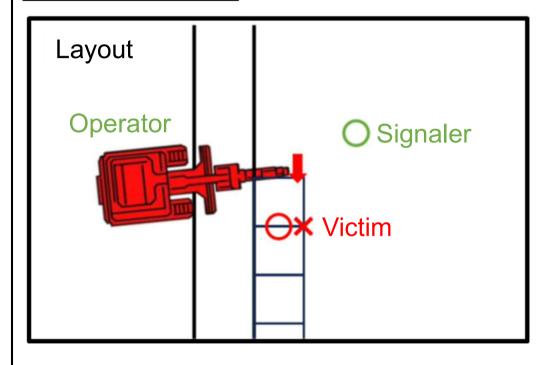
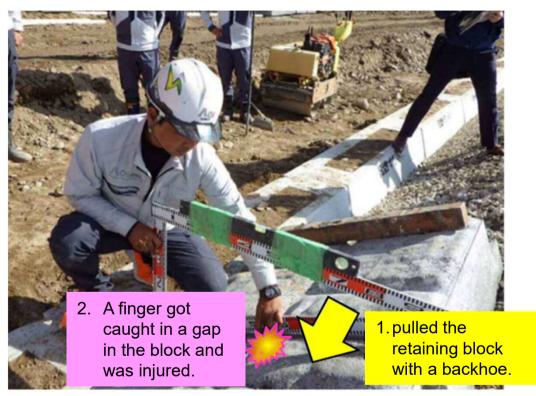
When the workforce was used to move the gap between the retaining blocks with a backhoe during the installation of the retaining blocks, the finger of the worker who was measuring the slope of the retaining block was caught in the gap between the blocks and was injured. [1 person injured]

①At the same time, heavy machinery was used to adjust the position of the seawall block, and workers checked the slope.

1) Thoroughly disseminate the prohibition of simultaneous work by heavy machinery and workers.

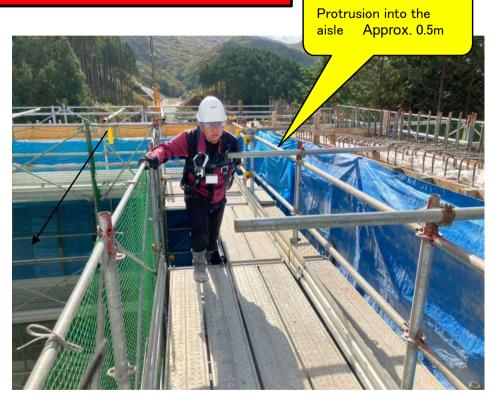
In the concrete curing work of the bridge abutment frame, when the work on the lower level of the scaffolding was completed and the work was moved to the upper stage of the scaffolding for curing work, the left breast was hit by a single pipe that was protruding into the passage.

- There was a lack of awareness of the danger of a single pipe protruding into the aisle.
- There were no indications during the patrol, and no countermeasures were taken.

- The following two points will be added to the work procedure manual of each contractor: "Eliminate steps, unevenness, and protrusions as much as possible in the work corridor" and "If there is a dangerous area, cure it with cushions, etc., and install warning signs" and reinform them.
- Safety patrols will be strengthened by adding "status of securing passages" and "status of organization on scaffolding" to the safety patrol record.
- Protruding danger areas should be cured with caps, cushioning materials, etc., and warning signs should be clearly stated.

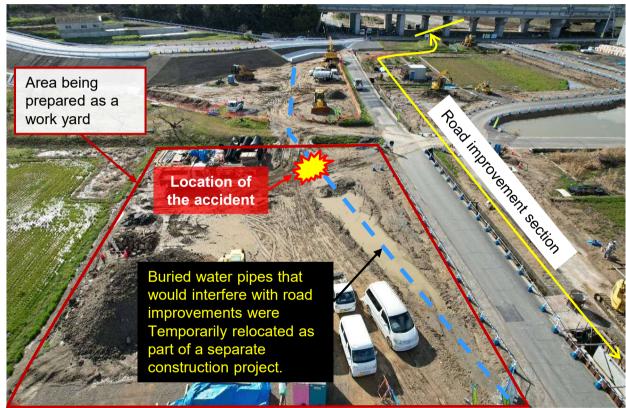
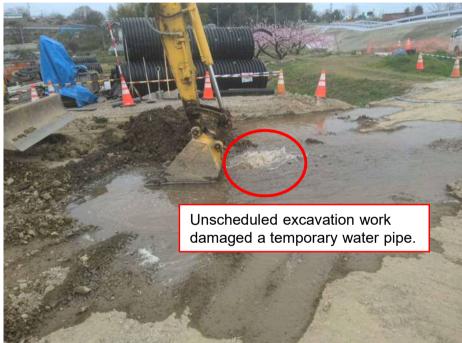
A backhoe was excavating to replace some muddy areas with good quality soil when it struck a temporary water pipe in the leased land, damaging the pipe. [Temporary water pipe damaged]

The presence of the buried temporary water pipe was known. However, the heavy equipment operator (the prime contractor's work foreman) independently decided to fix the muddy area and performed unauthorized excavation work.

- Ensure that no work is performed that is not part of the work instructions.
- If work instructions need to be changed, contact the site representative, prepare a revised work order, and resume work only after conducting hazard prediction activities and meetings.
- The type and depth of buried objects should be clearly indicated at the site of the buried object to ensure its presence is known to all workers.

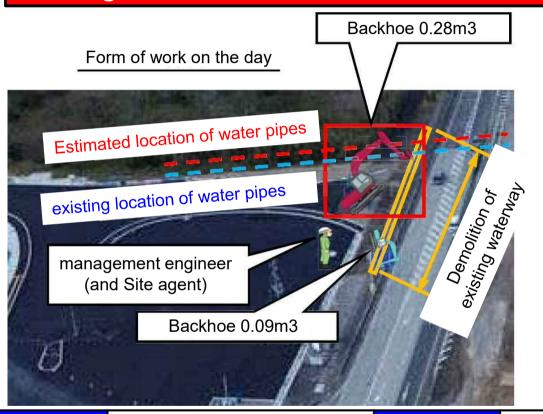
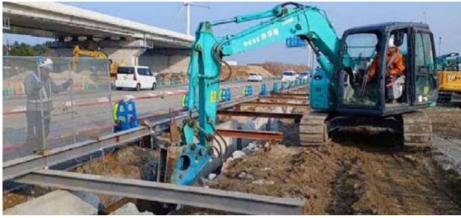
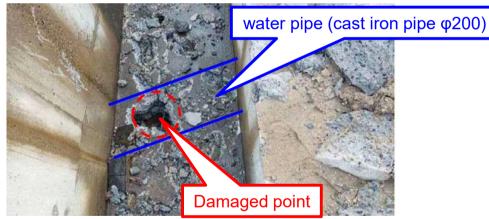
During the demolition of an existing concrete channel using a hydraulic breaker, a water pipe (cast iron pipe φ 200) buried directly under the bottom plate of the channel was damaged. [No impact on the surrounding area due to water outages]

- Initially, preliminary surveys of buried objects were conducted in accordance with the contract. For additional work, the plan was to begin construction from the front of the burial site and conduct preliminary excavation surveys as work progressed, but damage occurred because the burial site was not where it was estimated to be.
- Regardless of whether it was additional work or not, it was necessary to conduct a trial excavation survey before the start of demolition to clarify the location of the buried pipe.

- In all excavation and demolition work, we will thoroughly conduct preliminary surveys and trial excavations of buried objects before the start of construction, not when approaching the nearest work area.

- All excavation sites will be investigated using underground pipe exploration ground radar, and the areas where
 a reaction has been obtained will be tested in the presence of the burial manager and visually confirmed.

- Cautionary signboards indicating the type and depth of underground objects will be installed at the locations
 confirmed by exploratory excavation, etc., and a piping route map will be posted on site so that the relevant
 parties can always grasp the information at the time of work, and the piping route will be marked with spray
 and visualized.

- Distribute a map of buried objects to all workers and ensure that they are fully aware of the type, location, depth, and piping route of buried pipes at the site of buried pipes every day.

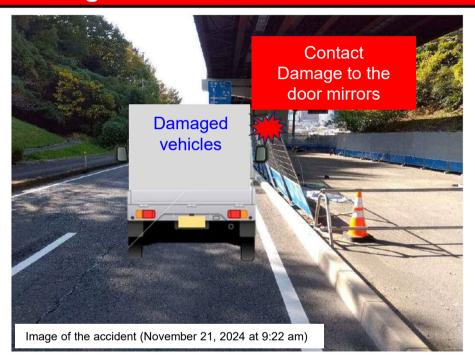
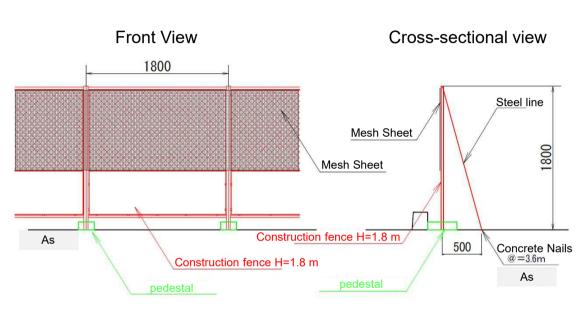
A construction fence installed to use the space under the overpass as a temporary storage area for construction materials collapsed onto the road when a large vehicle passed by, damaging the door mirrors of 2 vehicles travelling behind it., [2 general vehicles were damaged]

- As a countermeasure against theft, a mesh sheet was attached to the construction fence and a blindfold was used.
- This structure is susceptible to wind when large vehicles pass by, but the support method was insufficient.
- As a result, the base of the construction fence shifted, and the concrete nails driven into the asphalt pavement to secure the backup wire came loose due to the wind vibrations.

- The use of the yard under the viaduct will be discontinued, and another private site will be secured as a temporary storage site.
- In the future, when installing a similar construction fence on a road, we will confirm
 the installation method in-house and take measures according to the site conditions.
- The structure is based on the following with reference to the results of other constructions.
- <When the installation ground is pavement (AS, etc.)>
- ① The pedestal of the construction fence shall be H steel (400×400).
- ② Use special tools (H steel supports, etc.) to fix the construction fence and H steel.
- ③ Drive a single tube into 3@1.8m = 5.4m in one place and take a hold with a chain.

* Reinforcement to prevent falls on the roadway side
- Reflect the details of the measures in the construction plan and work procedure.
