# Summary of Accidents in FY2024 (1st half)

Construction accidents due to inadequate safety management measures by prime contractors, excluding the Government Buildings Department and the Port and Airport Department

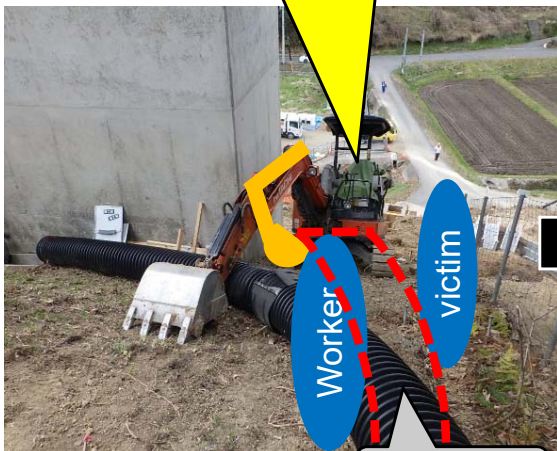
While moving an existing black pipe (400 mm diameter), which was an obstacle to a backhoe on a slope, the pipe became caught on the cabin of the backhoe; when the black pipe was lifted and removed from the backhoe, the recoil caused a worker to lose his balance and tumble down the slope, sustaining injuries. [1 person injured]

The black pipe is caught in the cabin of the backhoe.

- The prime contractor instructed the subcontractor to excavate up to a point where the black pipe would not affect the excavation; however, the subcontractor excavated further to where the black pipe did affect the excavation.
- The work was on a slope with a high risk of falls, but safety instruction and safeguards were lacking.

- In the event of a change in the original work plan, the subcontractor shall report to the prime contractor and ask for instructions.
- If conditions change during the work, the subcontractor shall report to the prime contractor, who will determine the measures to be taken and give instructions to the subcontractor.
- The cause of the accident and countermeasures will be communicated and implemented during a safety meeting for the entire cooperative association.
- A fixed barrier and mobile safety net will be installed on the slope.
- Although it is a safe slope, a safety line will be installed on the slope and workers will use a safety belt.
- A stairway will be installed to provide safe passage.

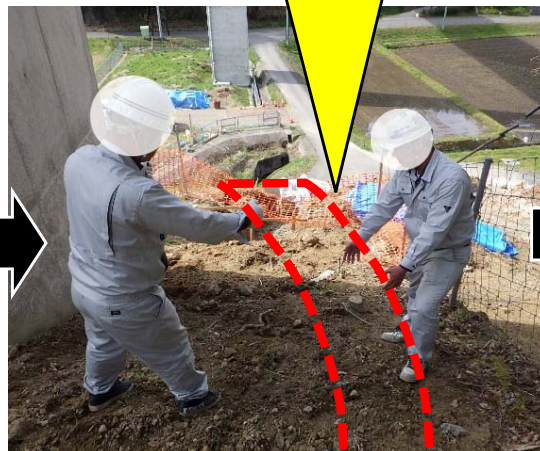
Lifting to remove the black pipe.

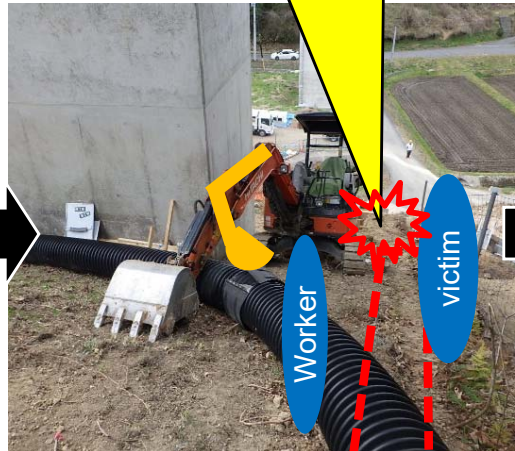
The bent black pipe is released and recoils.

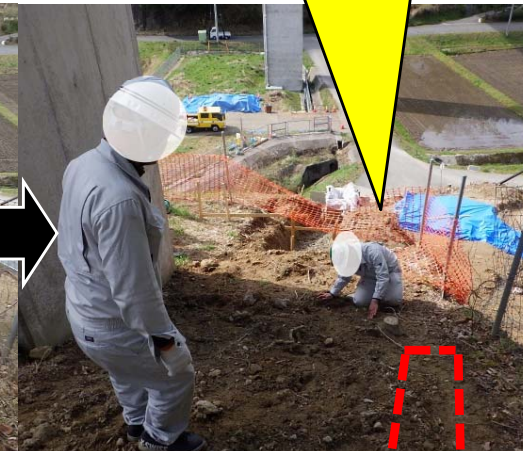
The recoil of the bent pipe caused a worker to lose his balance and tumble down the slope.

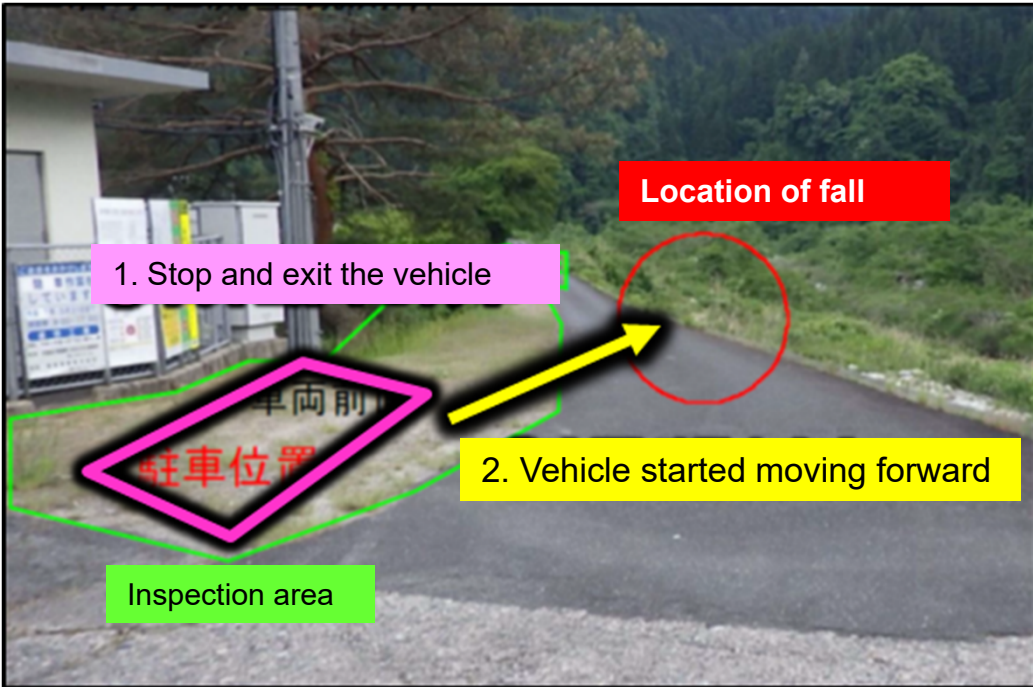
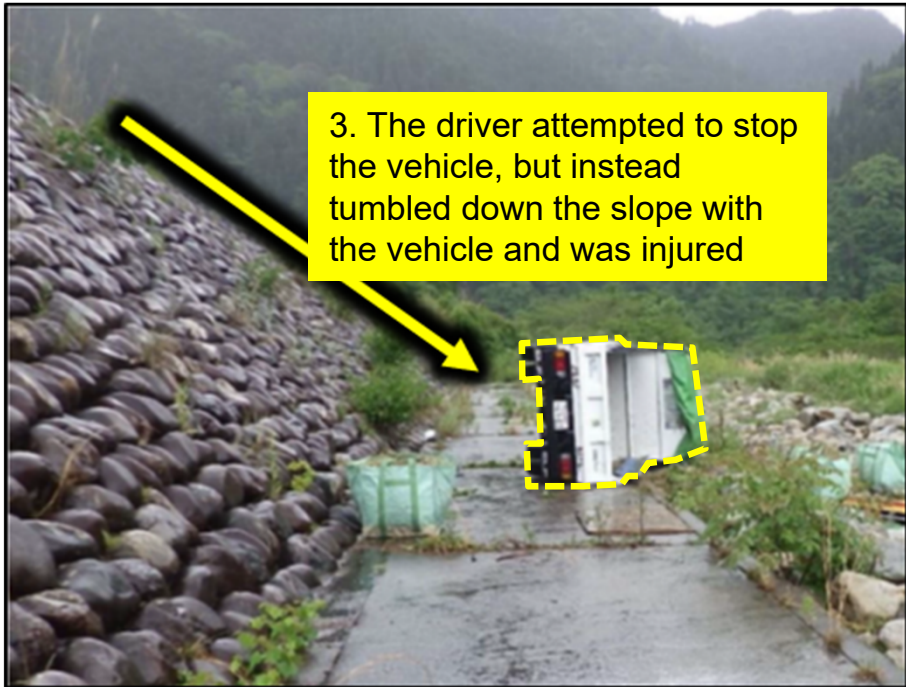
Accident overview	When the driver stopped and exited the vehicle (two-ton dump truck) to check the work area, the side brake was not engaged and the vehicle started moving. [1 person injured]		
Accident incident

<p>The photo shows a two-ton dump truck overturned on a steep, rocky slope. A yellow box labeled "3. The driver attempted to stop the vehicle, but instead tumbled down the slope with the vehicle and was injured" points to the truck.</p>	
Cause of accident	<div><div>- The driver exited the vehicle without engaging the side brake.</div><div>Contractor's preventive measures</div><div><div>- Ensure that all drivers are reminded to use the side brake when parking and stopping their vehicles.</div><div>- Post a sign inside the vehicle stating that the side brake must be used.</div></div></div>

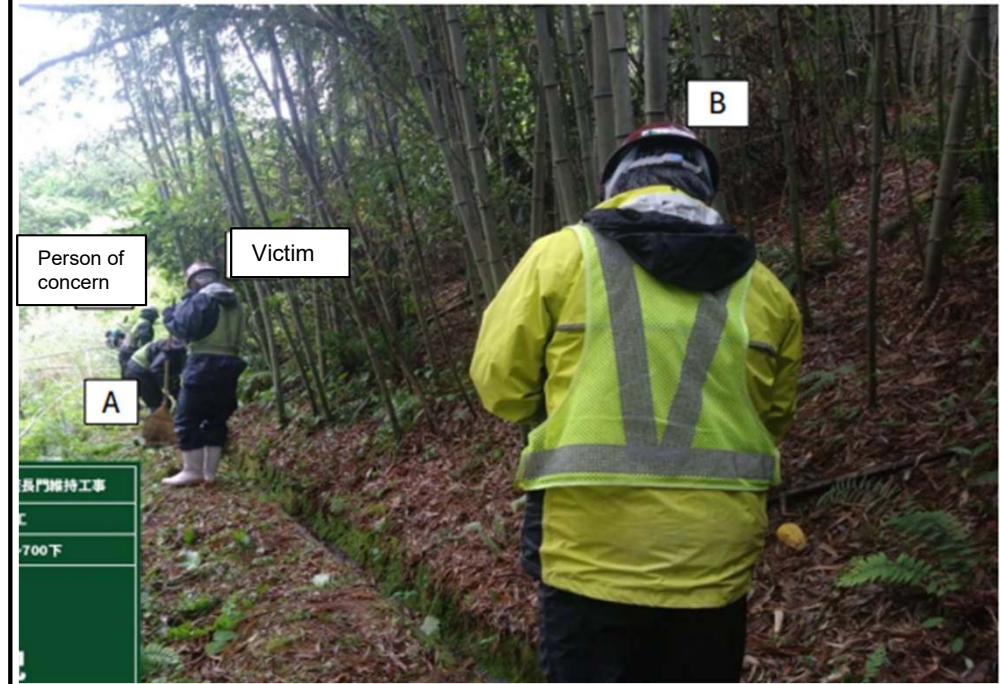
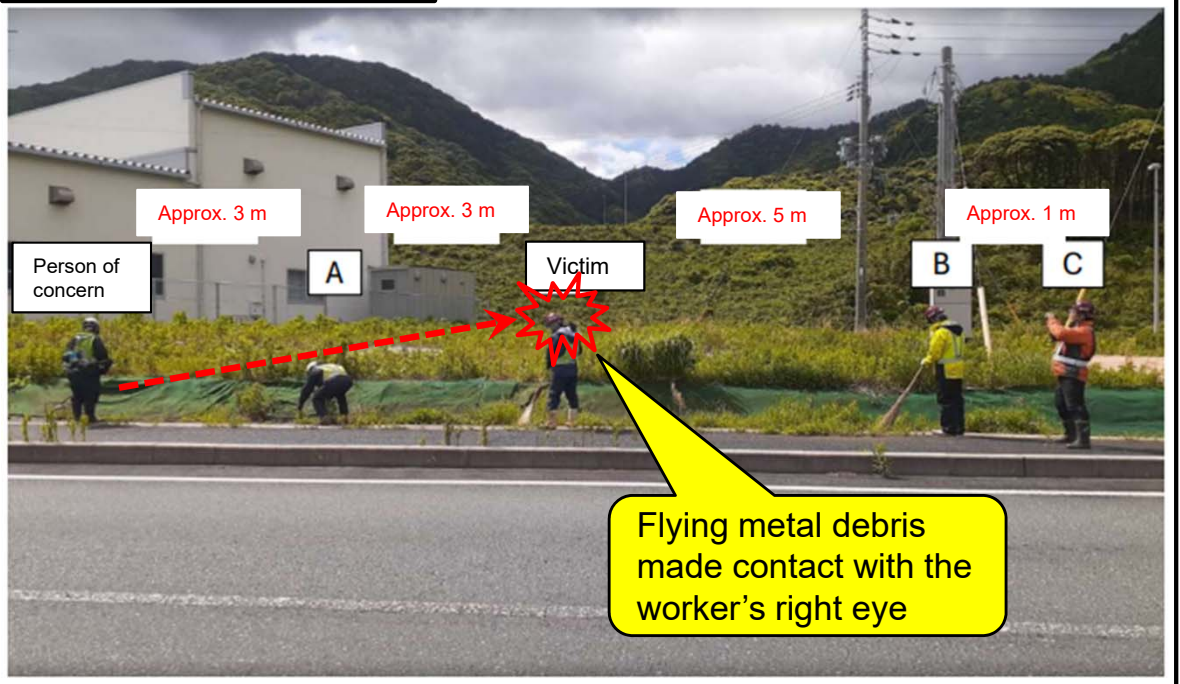
<b>Accident overview</b>	While weeding and removing branches from both sides of a small embankment on a channel, a foreign object struck the right eye of a worker collecting weeds behind a brush-cutter, injuring the worker.
--------------------------	--

<b>Cause of accident</b>	① There was no awareness of the danger of flying rocks and other hazards to the weed collectors.	<b>Contractor's preventive measures</b>	① Recognize the danger of flying rocks and other hazards to weed collectors.
	② Weed collectors were not wearing protective goggles.		- Revise the operational plan - Revise the work procedures - Re-education of workers ② All workers engaged in work using brush-cutters should wear protective goggles.

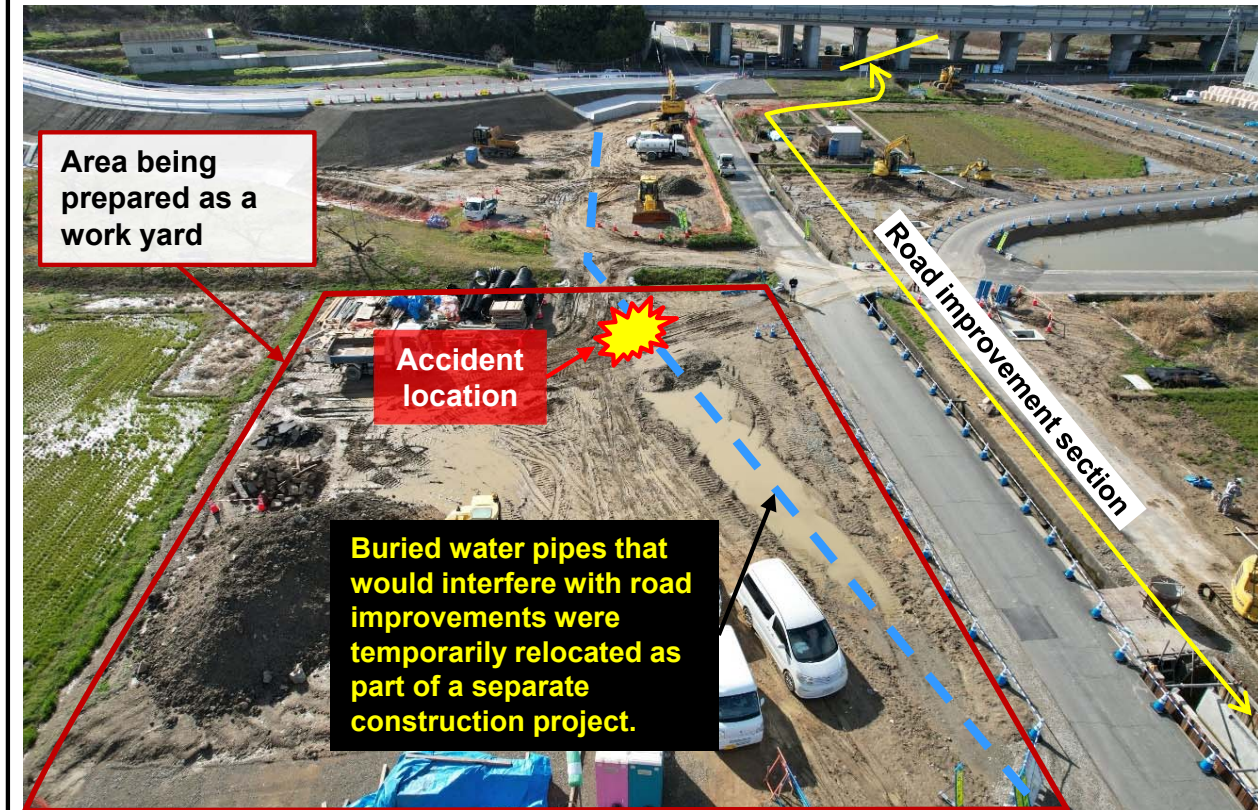
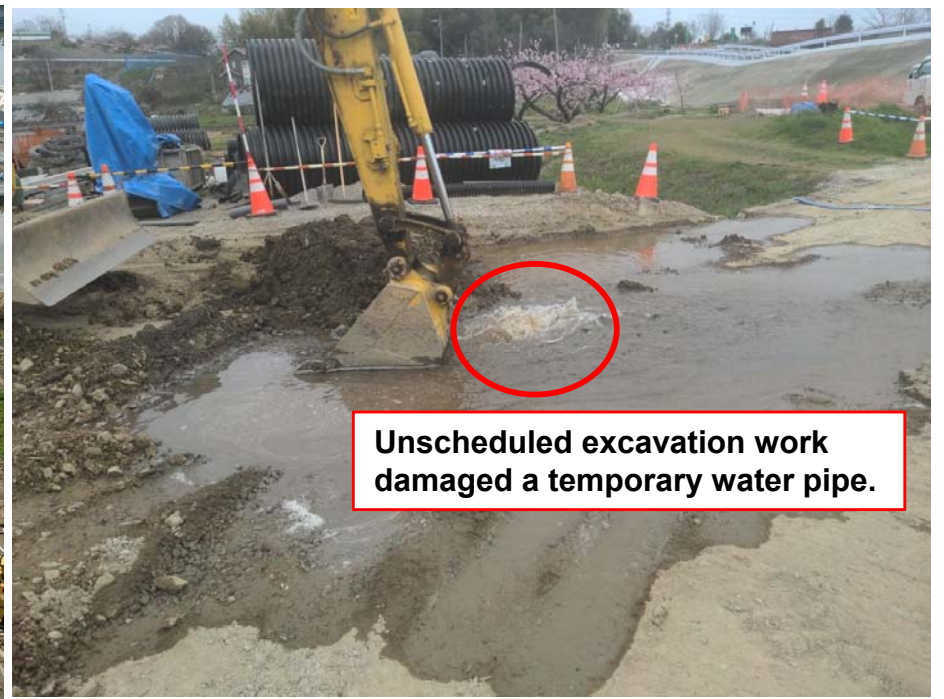
Accident incident

**Accident overview** A backhoe was excavating to replace some muddy areas with good quality soil when it struck a temporary water pipe in the leased land, damaging the pipe. **[Temporary water pipe damage]**

<b>Cause of accident</b>	The presence of the buried temporary water pipe was known. However, the heavy equipment operator (the prime contractor's work foreman) independently decided to fix the muddy area and performed unauthorized excavation work.	<b>Contractor's preventive measures</b>	<ul style="list-style-type: none"><li>- Ensure that no work is performed that is not part of the work instructions.</li><li>- If work instructions need to be changed, contact the site representative, prepare a revised work order, and resume work only after conducting hazard prediction activities and meetings.</li><li>- The type and depth of buried objects should be clearly indicated at the site of the buried object to ensure its presence is known to all workers.</li></ul>
--------------------------	--	---	--
