Occupational hazard accidents

Public hazard accidents

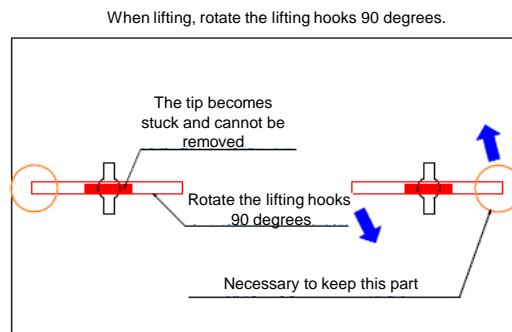
▼ Causes of the Accident

- The handling procedures for the lifting hooks were not sufficiently communicated.
- The victim held a slinging qualification but lacked experience in civil engineering work and did not fully understand the use of the lifting hooks.
- Protective gear (safety boots) was not worn.
- The victim's medical diagnosis results were not adequately verified.

- Use actual lifting hooks for verification, and the prime contractor's staff shall ensure all relevant personnel are informed.
- If during new entrant training it is confirmed that an individual has limited experience, hold a meeting involving site staff and the subcontractor's chief engineer to determine the work tasks they will perform.

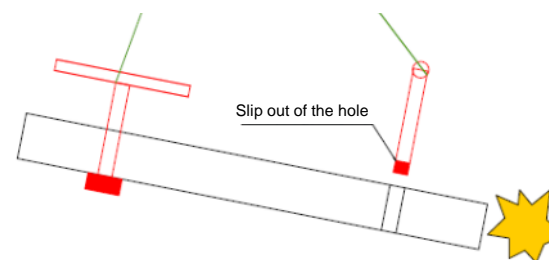
"When tension is applied to the belt sling for lifting, a force causes the lifting hooks to rotate in the direction of the arrow, causing it to return to the inserted state. Therefore, you must hold the area marked with the circle to prevent it from rotating.

Because it wasn't held securely, the hanging hook rotated and one side came loose.

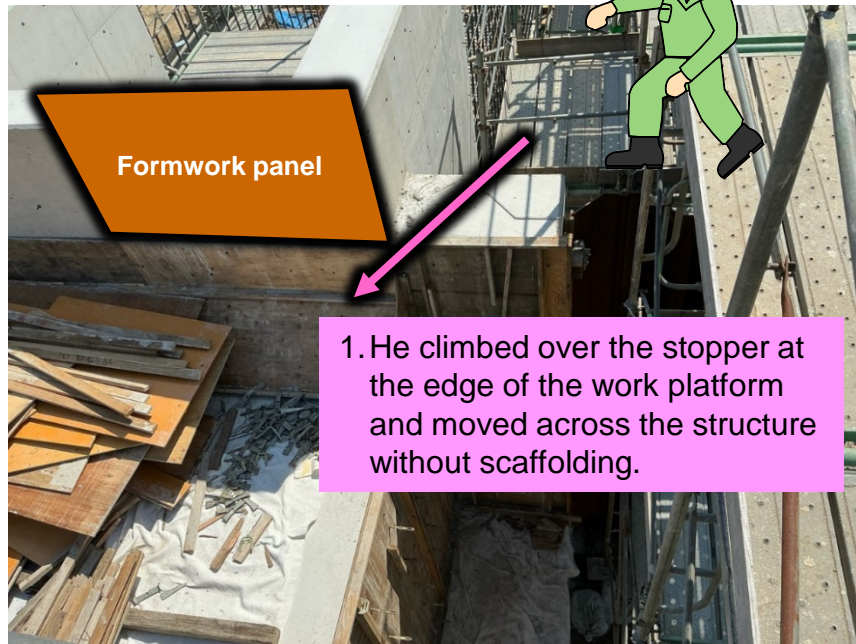
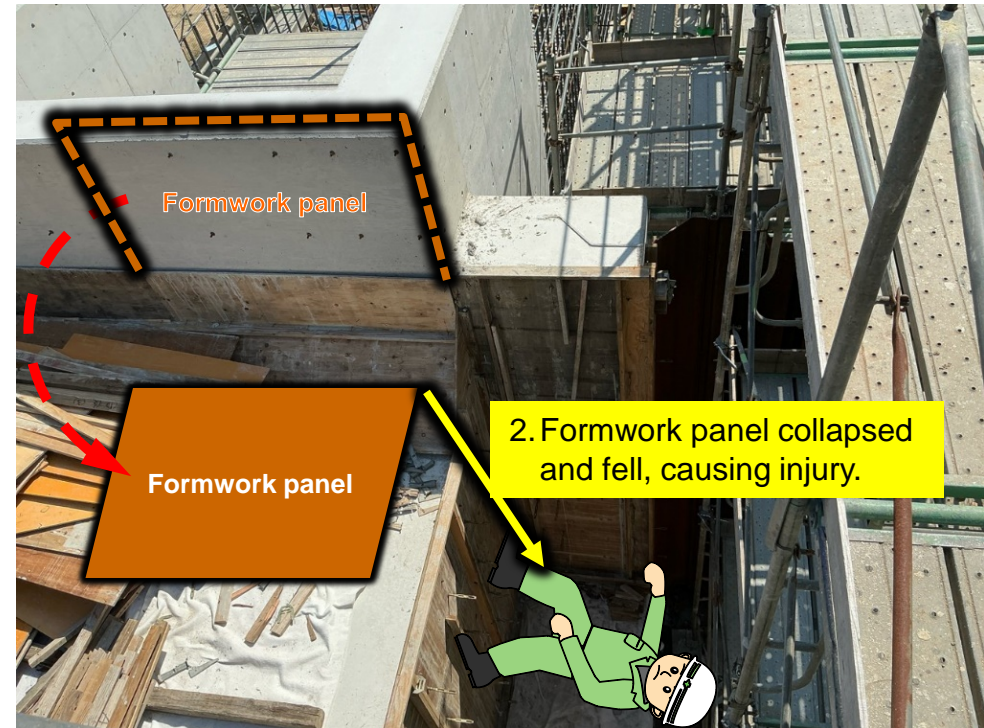
Accident incident

While dismantling the formwork for a sluice gate, the victim attempted to assist another worker who was not scheduled for that task. He climbed over the stopper at the edge of the work platform and moved outside the designated work passageway. The formwork panel he touched collapsed, causing him to fall from a height of 3.4 meters and sustain injuries.

① Because the work was performed without reporting or confirming it with the prime contractor.

① When making changes to scheduled work or adding additional work, ensure that the prime contractor is notified. The prime contractor shall create work instruction procedures for the changed or added work, and then have all workers involved reconfirm the work procedures and conduct hazard prediction activities.

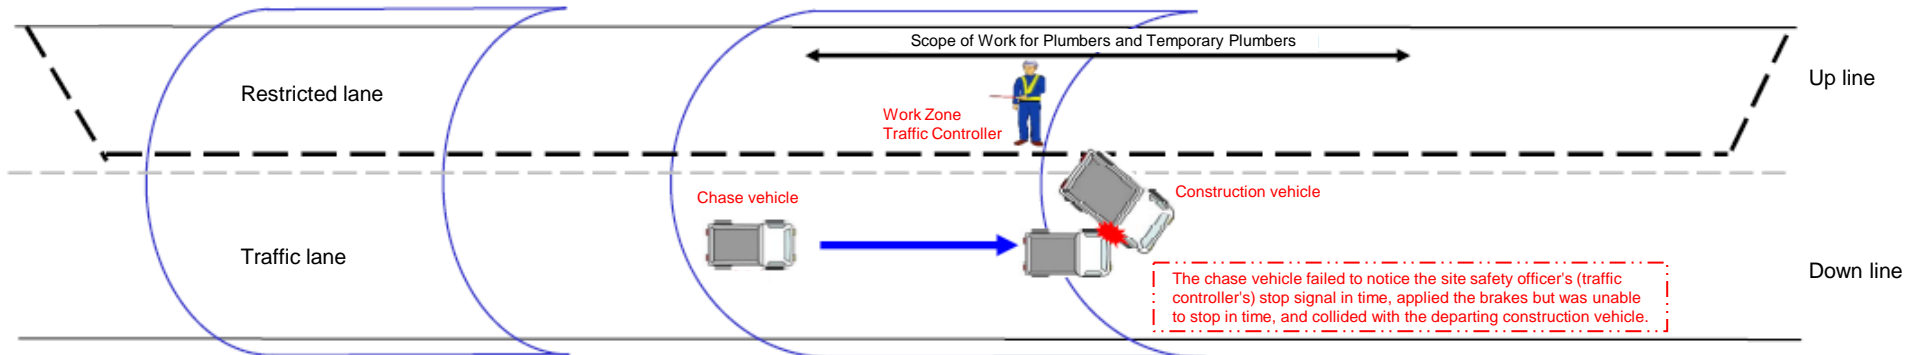
Situation at the time of accident

Accident overview During tunnel warning system construction, while a 4-ton dump truck exited the alternating traffic lane following a signal from a traffic controller, the chase vehicle (a light truck) rear-ended the 4-ton dump truck.

- ① Specific communication methods and signals for construction vehicles entering and exiting the restricted lane by the work zone traffic controller and the chase vehicle driver had not been established.
- ② Communication points during entry and exit for work within the restricted zone during KY activities were ambiguous, relying solely on verbal communication, and had not been effectively communicated to workers and controllers.

- Establish specific communication methods and signals for construction vehicles entering and exiting the restricted zone, and ensure all relevant personnel are fully informed.
- Clarify the communication structure and signals for the control team. (Strictly prohibit entry/exit of construction vehicles until contact is established with the follow-up vehicle)
 - Always confirm the follow-up vehicle has stopped before allowing vehicles to exit.
 - Ensure workers carry documentation outlining site rules.
 - Communicate entry/exit procedures from the restricted zone and vehicle positioning (entry/exit points).

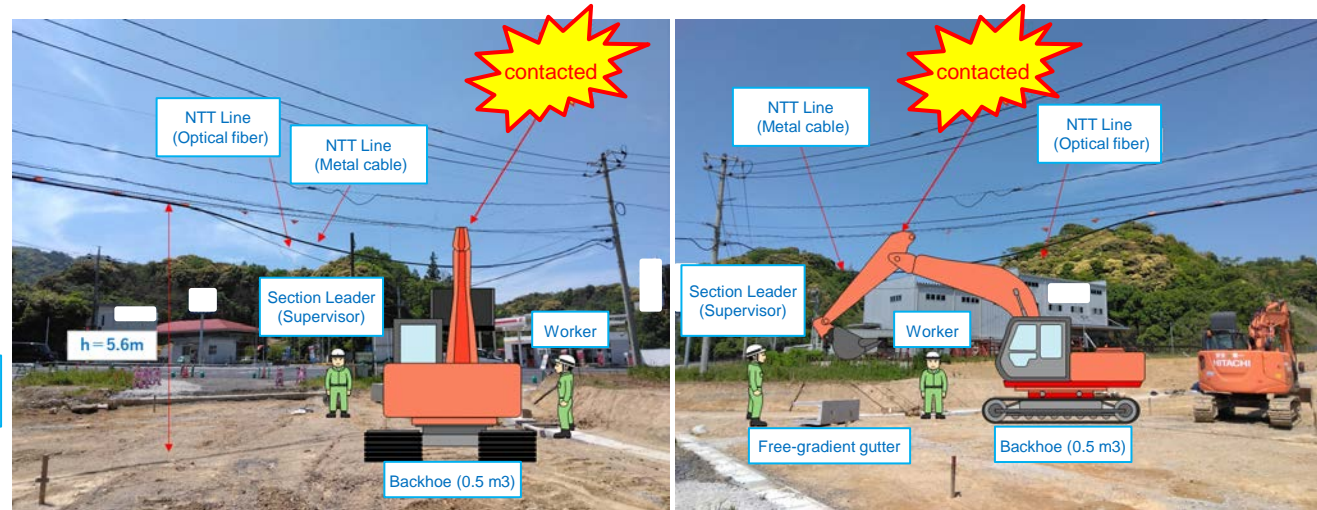
< The backhoe arm came into contact with overhead lines >

- ① Despite being aware of overhead wires at the work site, no height restriction measures using gates were implemented before or after the lines.
- ② Despite the need to minimize heavy machinery operations beneath overhead lines, unnecessary work was performed.
- ③ The supervisor designated in the construction plan failed to verify the overhead lines.

- ① Install fencing with height restrictions (H=5m, W=8m) via gates and warning signs, caution flags, etc., at intervals of 3m before and after overhead lines.
- ② To minimize work under overhead lines where contact is possible, gutter cutting operations shall be performed at temporary storage areas away from overhead lines.
- ③ Assign dedicated supervisors to prevent contact or cutting accidents involving overhead lines, which are obstacles.

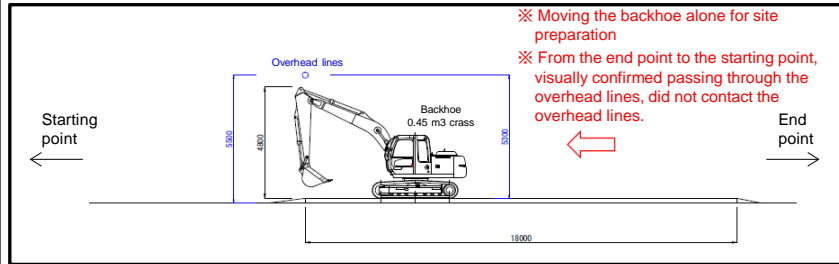
- ※ Moving the backhoe alone for site preparation
- ※ From the end point to the starting point, visually confirmed passing through the overhead lines, did not contact the overhead lines.

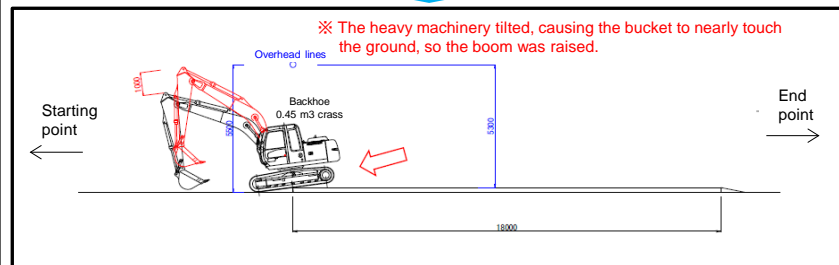
- ※ The heavy machinery tilted, causing the bucket to nearly touch the ground, so the boom was raised.

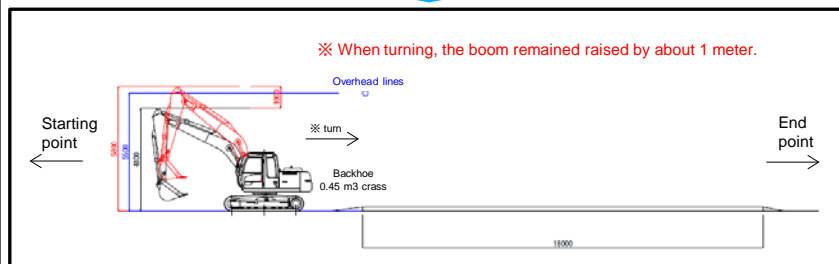
- ※ When turning, the boom remained raised by about 1 meter.

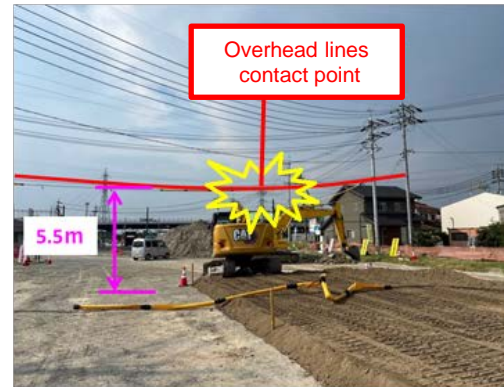
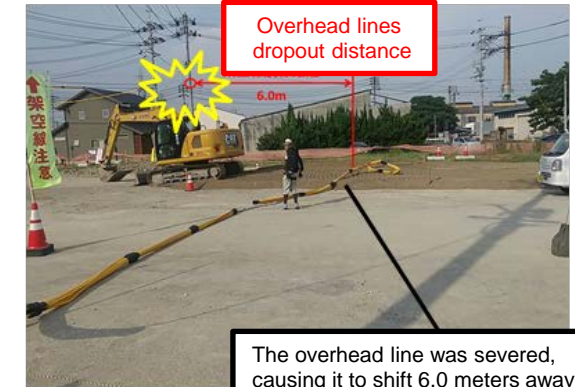
The overhead line was severed, causing it to shift 6.0 meters away from its original position.

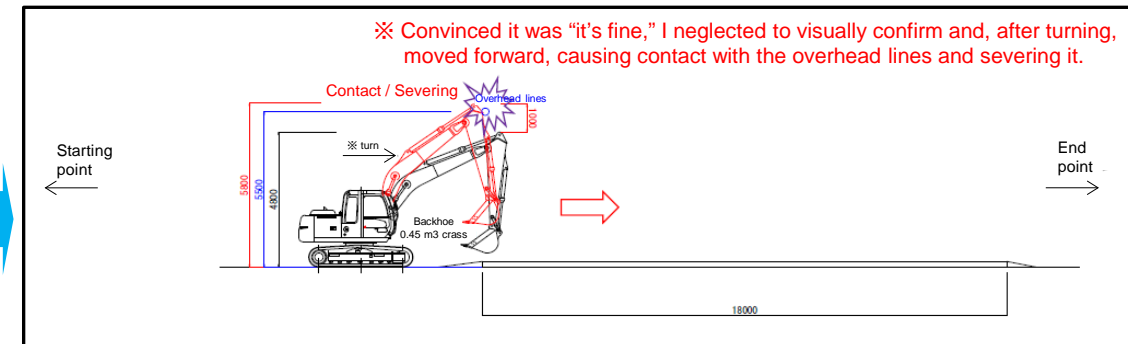
- ※ Convinced it was "it's fine," I neglected to visually confirm and, after turning, moved forward, causing contact with the overhead lines and severing it.

- The parties involved performed unscheduled work on their own initiative.
- The operator assumed "it was fine" and neglected visual confirmation.
- The test embankment yard was located too close to overhead lines.
- Instruction and thoroughness for subcontractor workers were insufficient during work meetings and KY activities.
- The work procedure manual covered the entire subgrade embankment process, leaving procedures for each specific area unclear.
- The prime contractor's staff were occupied with other tasks, neglecting overall supervision of the site.
- The key for the 0.45m³ backhoe was taken to the site for heavy equipment inspection but remained in the possession of the responsible party, resulting in inadequate management.

- Reinstruct and reinforce to subcontractors from the prime contractor to avoid performing unplanned work.
- Backhoe operators must visually confirm overhead lines before moving or rotating heavy machinery.

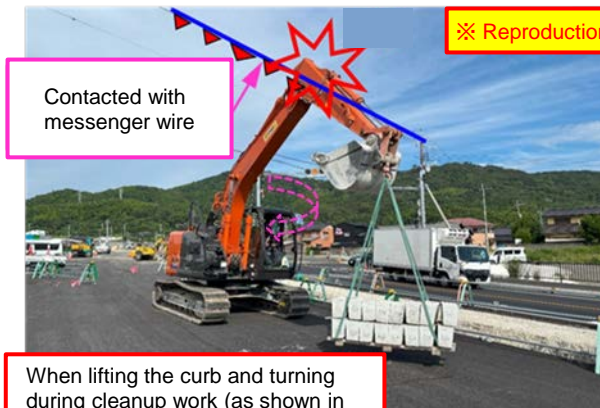
【 Accident scene photo 】

When lifting the curb and turning during cleanup work (as shown in the photo), it came into contact with the messenger wire.

- Insufficient protective measures were taken for overhead wires, and the work instructions on the day of the accident did not specify the machinery to be used.
- The supervisor was working alone while away from the heavy machinery.
- Although the presence of overhead wires was recognized, awareness of them had declined.

Install protective lines at appropriate positions relative to overhead wires, and add overhead wire countermeasures to the KY activity sheet and work procedure manual. Furthermore, for overhead wires crossing the site, designate a 5-meter zone from each end point (total 10 meters) as the "Overhead Wire Countermeasure Area." Lay rubber mats on the road surface to alert workers, and install signs at all four corners to clearly mark the area, ensuring thorough awareness among workers. Furthermore, backhoe operators must be strictly instructed to always confirm the presence of the heavy equipment guide controllers before operating. Heavy equipment guide controllers must also be strictly instructed to remain near the equipment and provide accurate guidance. These measures shall be clearly documented in the KY Activity Sheet and work procedures, shared and adhered to across the entire site to prevent recurrence.

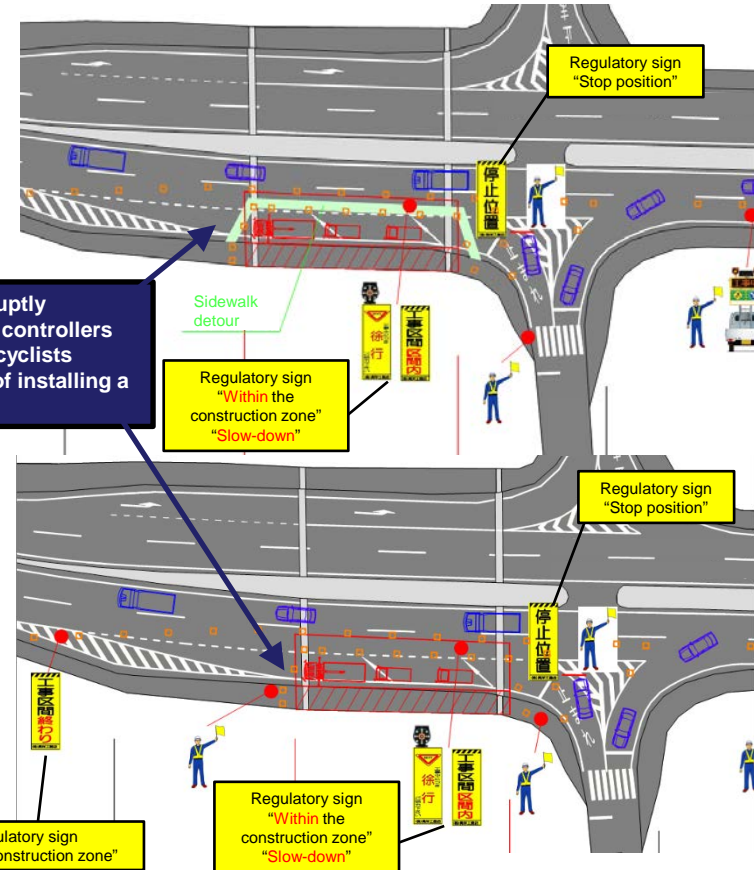
The regulation was abruptly changed to have traffic controllers guide pedestrians and cyclists within the site instead of installing a detour route.

- ① Without reporting to supervising staff, the site representative unilaterally changed the plan to implement traffic control methods differing from the original construction plan and proceeded with the work.
- ② No pedestrian walkway was installed.
- ③ No entry prevention measures using cone bars were in place.
- ④ No Regulatory signs visible from a distance were provided.
- ⑤ No Regulatory signs for sidewalk users were provided.

- ① Strengthen the system for checking alignment between construction plans and site conditions, as well as change procedures.
- ② Ensure safe pedestrian walkways by separating work areas and passageways using color cones and cone bars.
- ③ Enclose sidewalks completely with color cones and cone bars to prevent gaps, implementing strict no-entry measures for the general public.
- ④ Install additional lighting to ensure visibility for traffic controllers from a distance.
- ⑤ Install illuminated warning signs and rotating lights to alert pedestrians and cyclists.

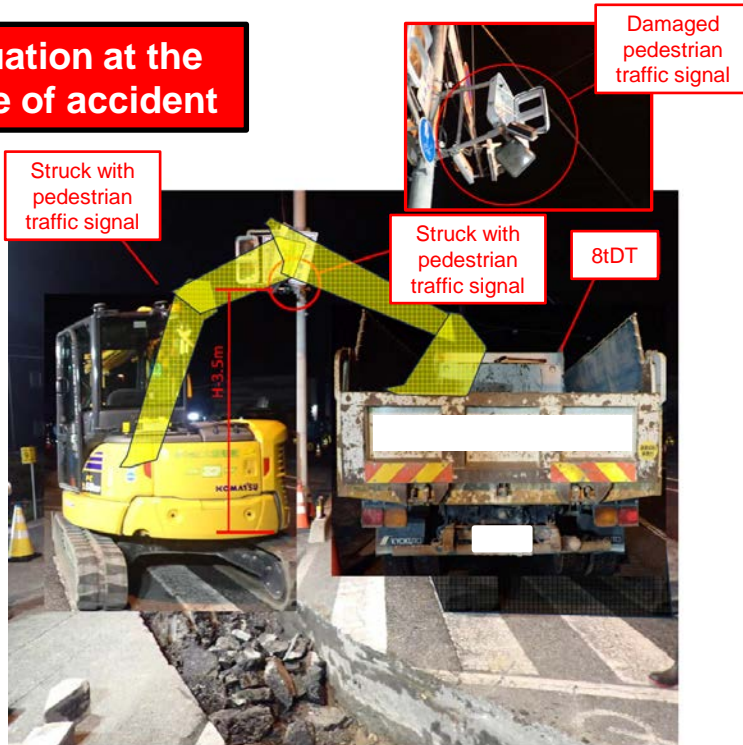
Situation at the time of accident

While loading As shells onto a dump truck, a backhoe's boom struck and damaged a pedestrian signal luminaire fixture during a swing maneuver.

- ① Specific construction instructions (equipment placement, monitoring procedures, etc.) were inadequate.
- ② The signaler looked away from the backhoe without giving the stop signal and was monitoring other work.
- ③ The pedestrian signal light was in the signaler's blind spot from their standing position.
- ④ The backhoe operator rotated the backhoe without receiving instructions from the signaler.

- ① When operating heavy machinery where contact with obstacles is possible, do not rotate the machinery toward obstructions or occupied structures. Create a layout diagram (work procedure manual) specifying protective measures using safety equipment. During construction, the prime contractor's internal inspector (head office staff) shall verify the layout diagram against the actual site.

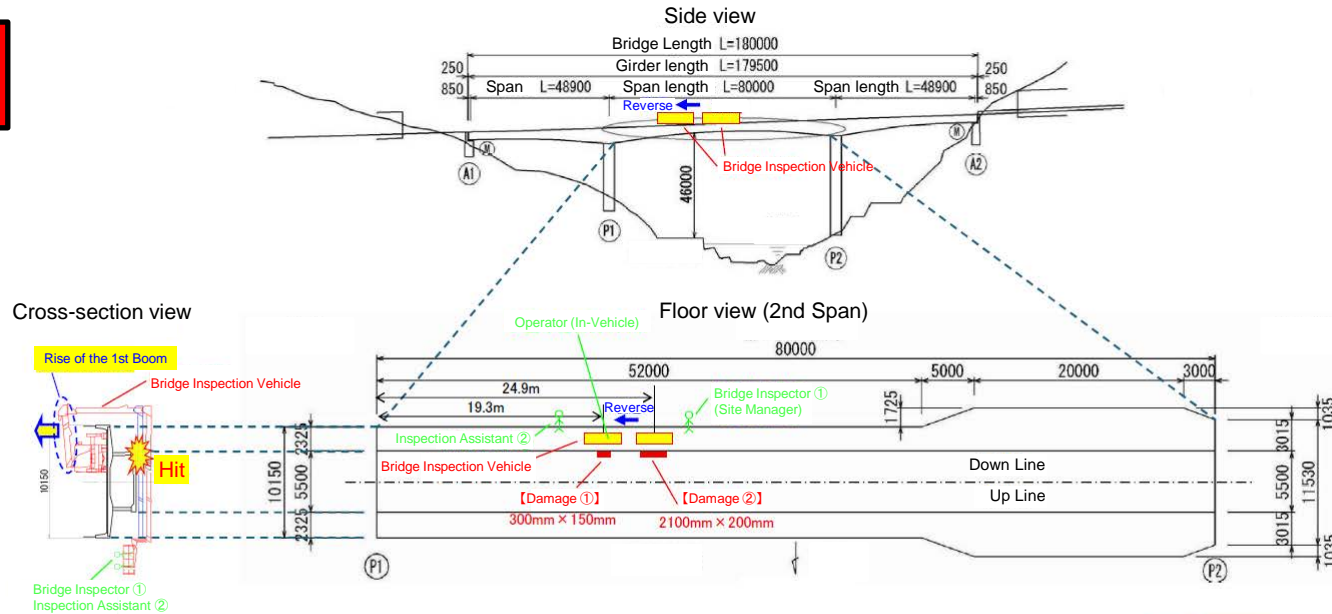
Situation at the time of accident

During bridge inspection operations, when the boom of the bridge inspection vehicle was activated, the cover at the tip of the third boom made contact with the main girder of the bridge. This resulted in damage to the cover at the boom tip and left contact marks on the main girder.

- ① The 1st boom was raised.(Although we were aware that the 1st boom should not be raised or lowered as a rule, the work was performed within a limited timeframe under concentrated restrictions, and work efficiency was prioritized.)
- ② Verification of the clearance between the main girder and the boom was insufficient.

- ① During inspection work beneath girders, install a misoperation prevention cover or similar device on the control lever to prevent operation of the first boom. Carefully review the work process and establish a schedule with ample time.
- ② A) Before inspection, use the "Work Procedure and Condition Confirmation Sheet" to confirm and share all precautions with all on-site personnel, eliminating any lack of understanding.
B) Install collision prevention sensors on the inspection vehicle to prevent contact with the bridge structure and road fixtures.
