# Keep in mind

~How we responded to "the heavy rain disaster in July 2018"~

国土交通省  
中国地方整備局

Ministry of Land, Infrastructure, Transport and Tourism  
Chugoku Regional Development Bureau

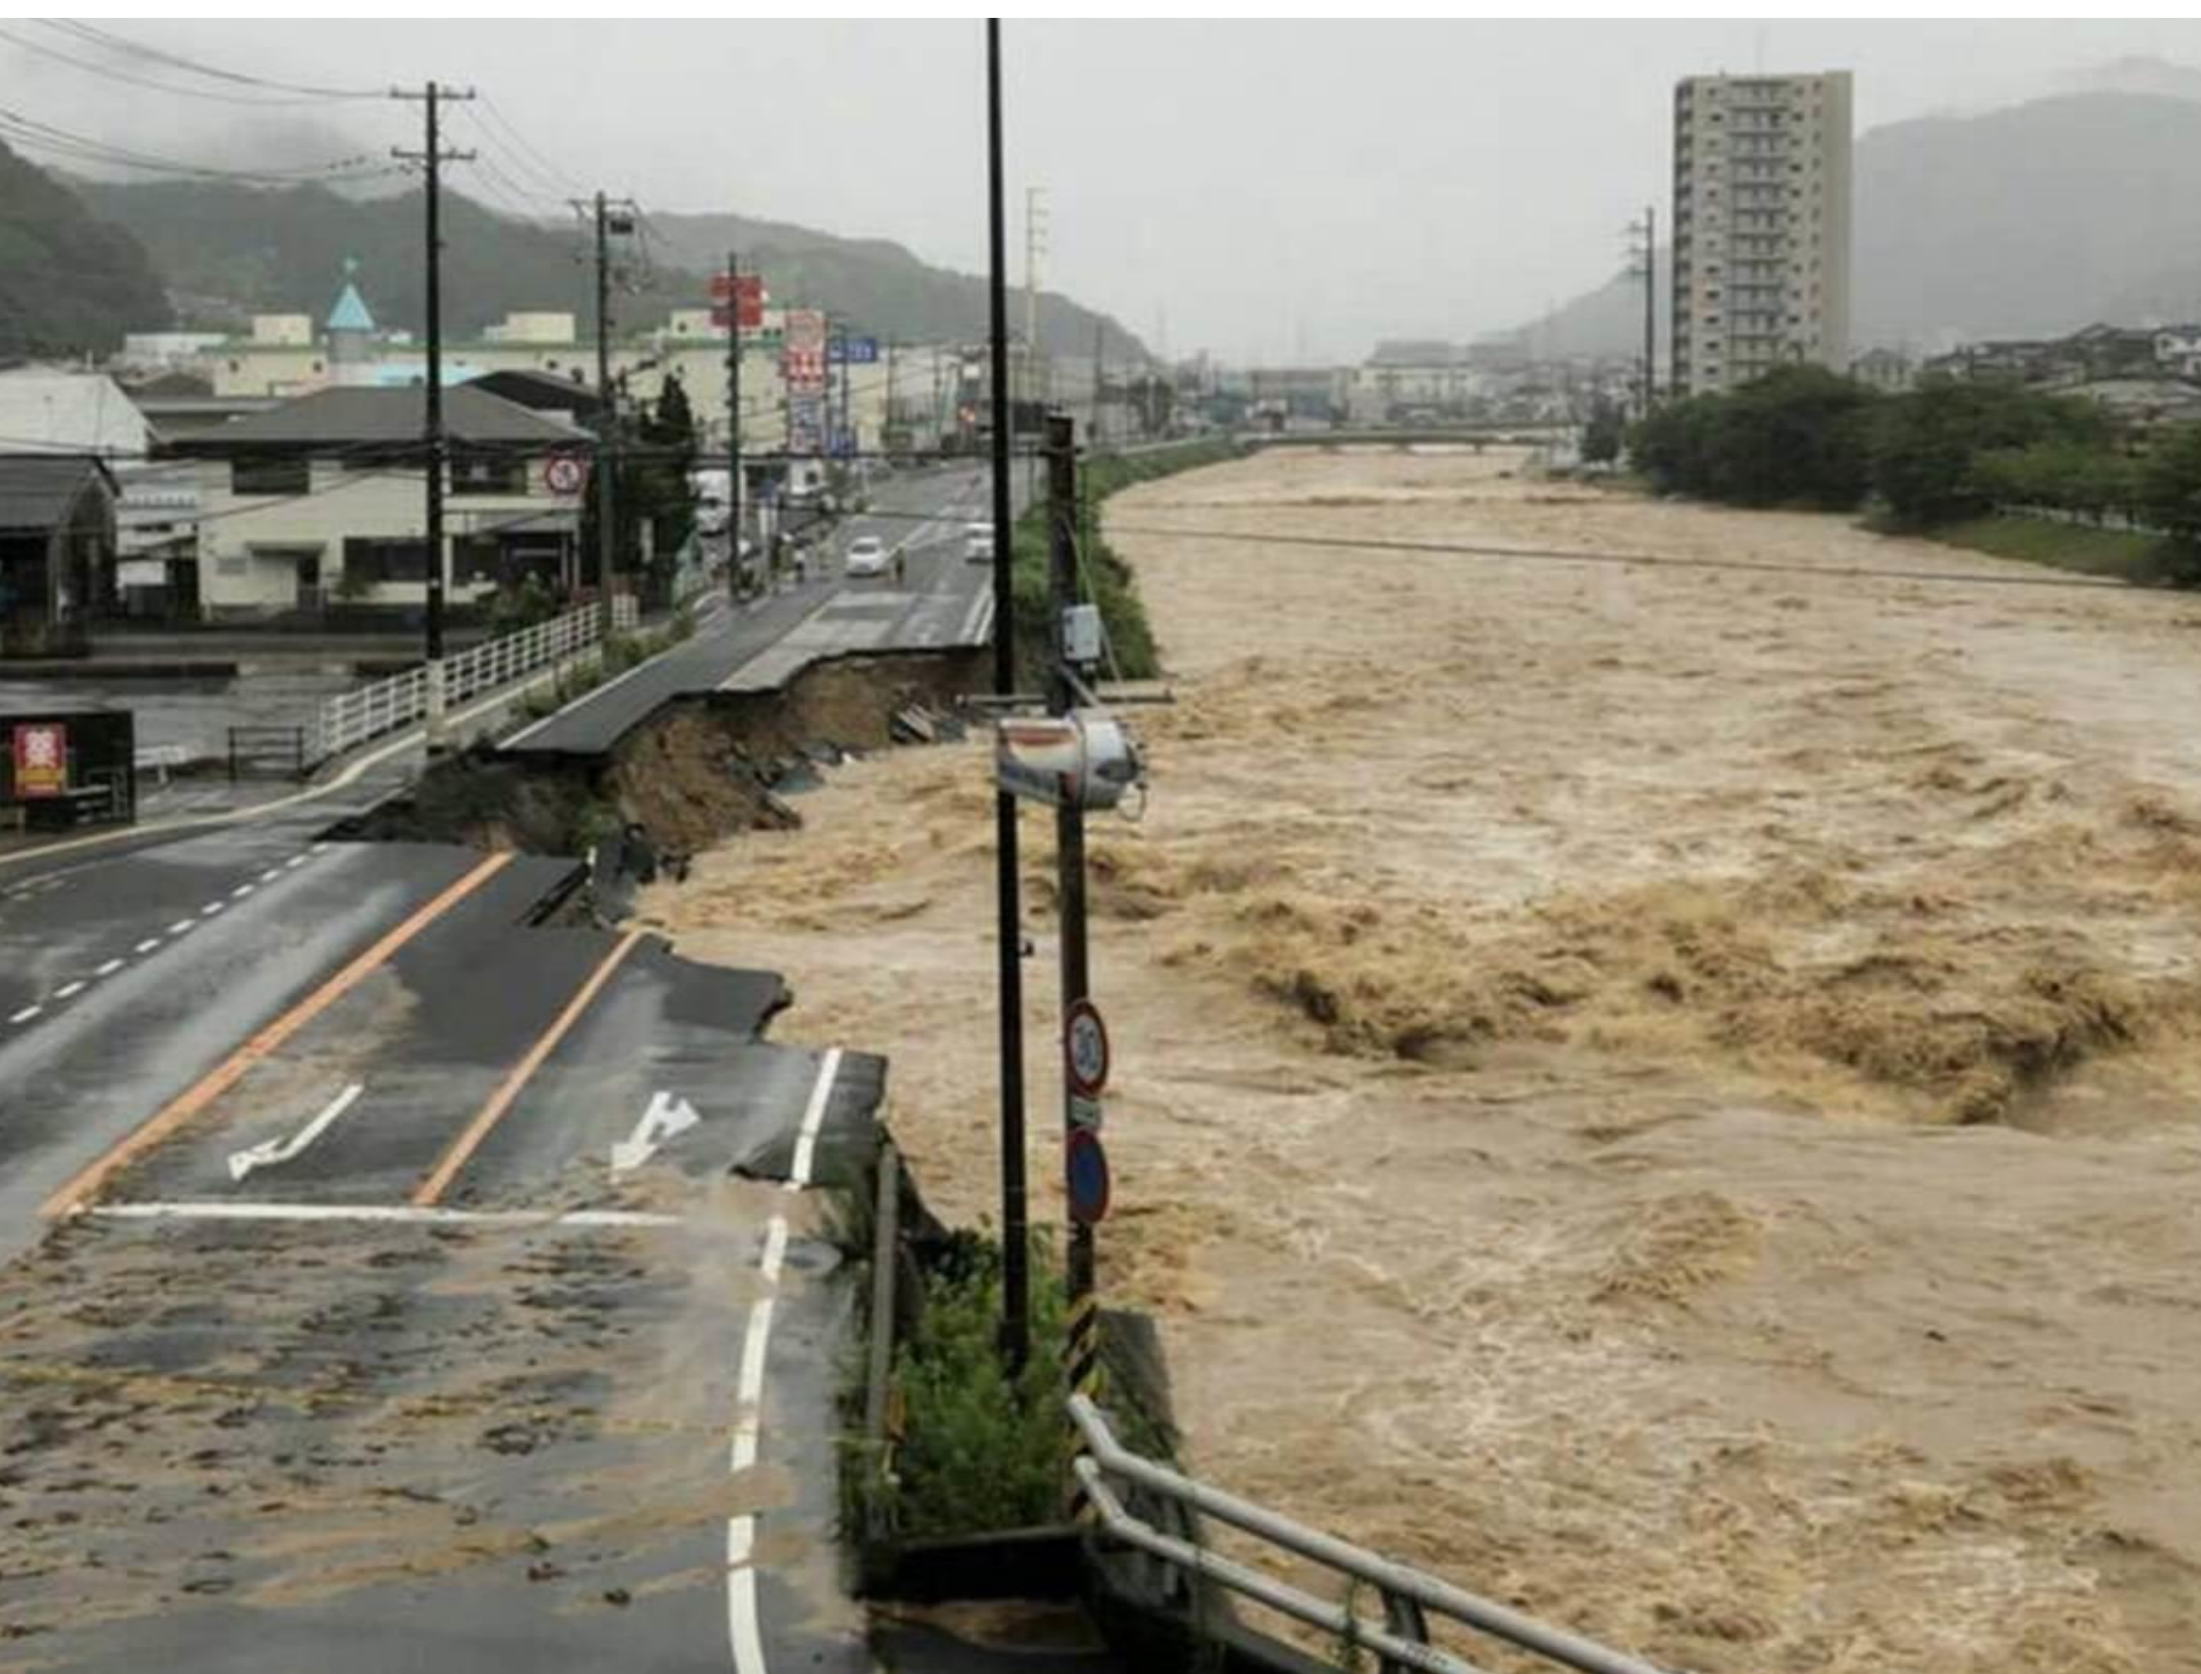
**Traffic closed due to the loss of riverbank protection**  
 [Aki Ward, Hiroshima City, Hiroshima] (National Highway 2)

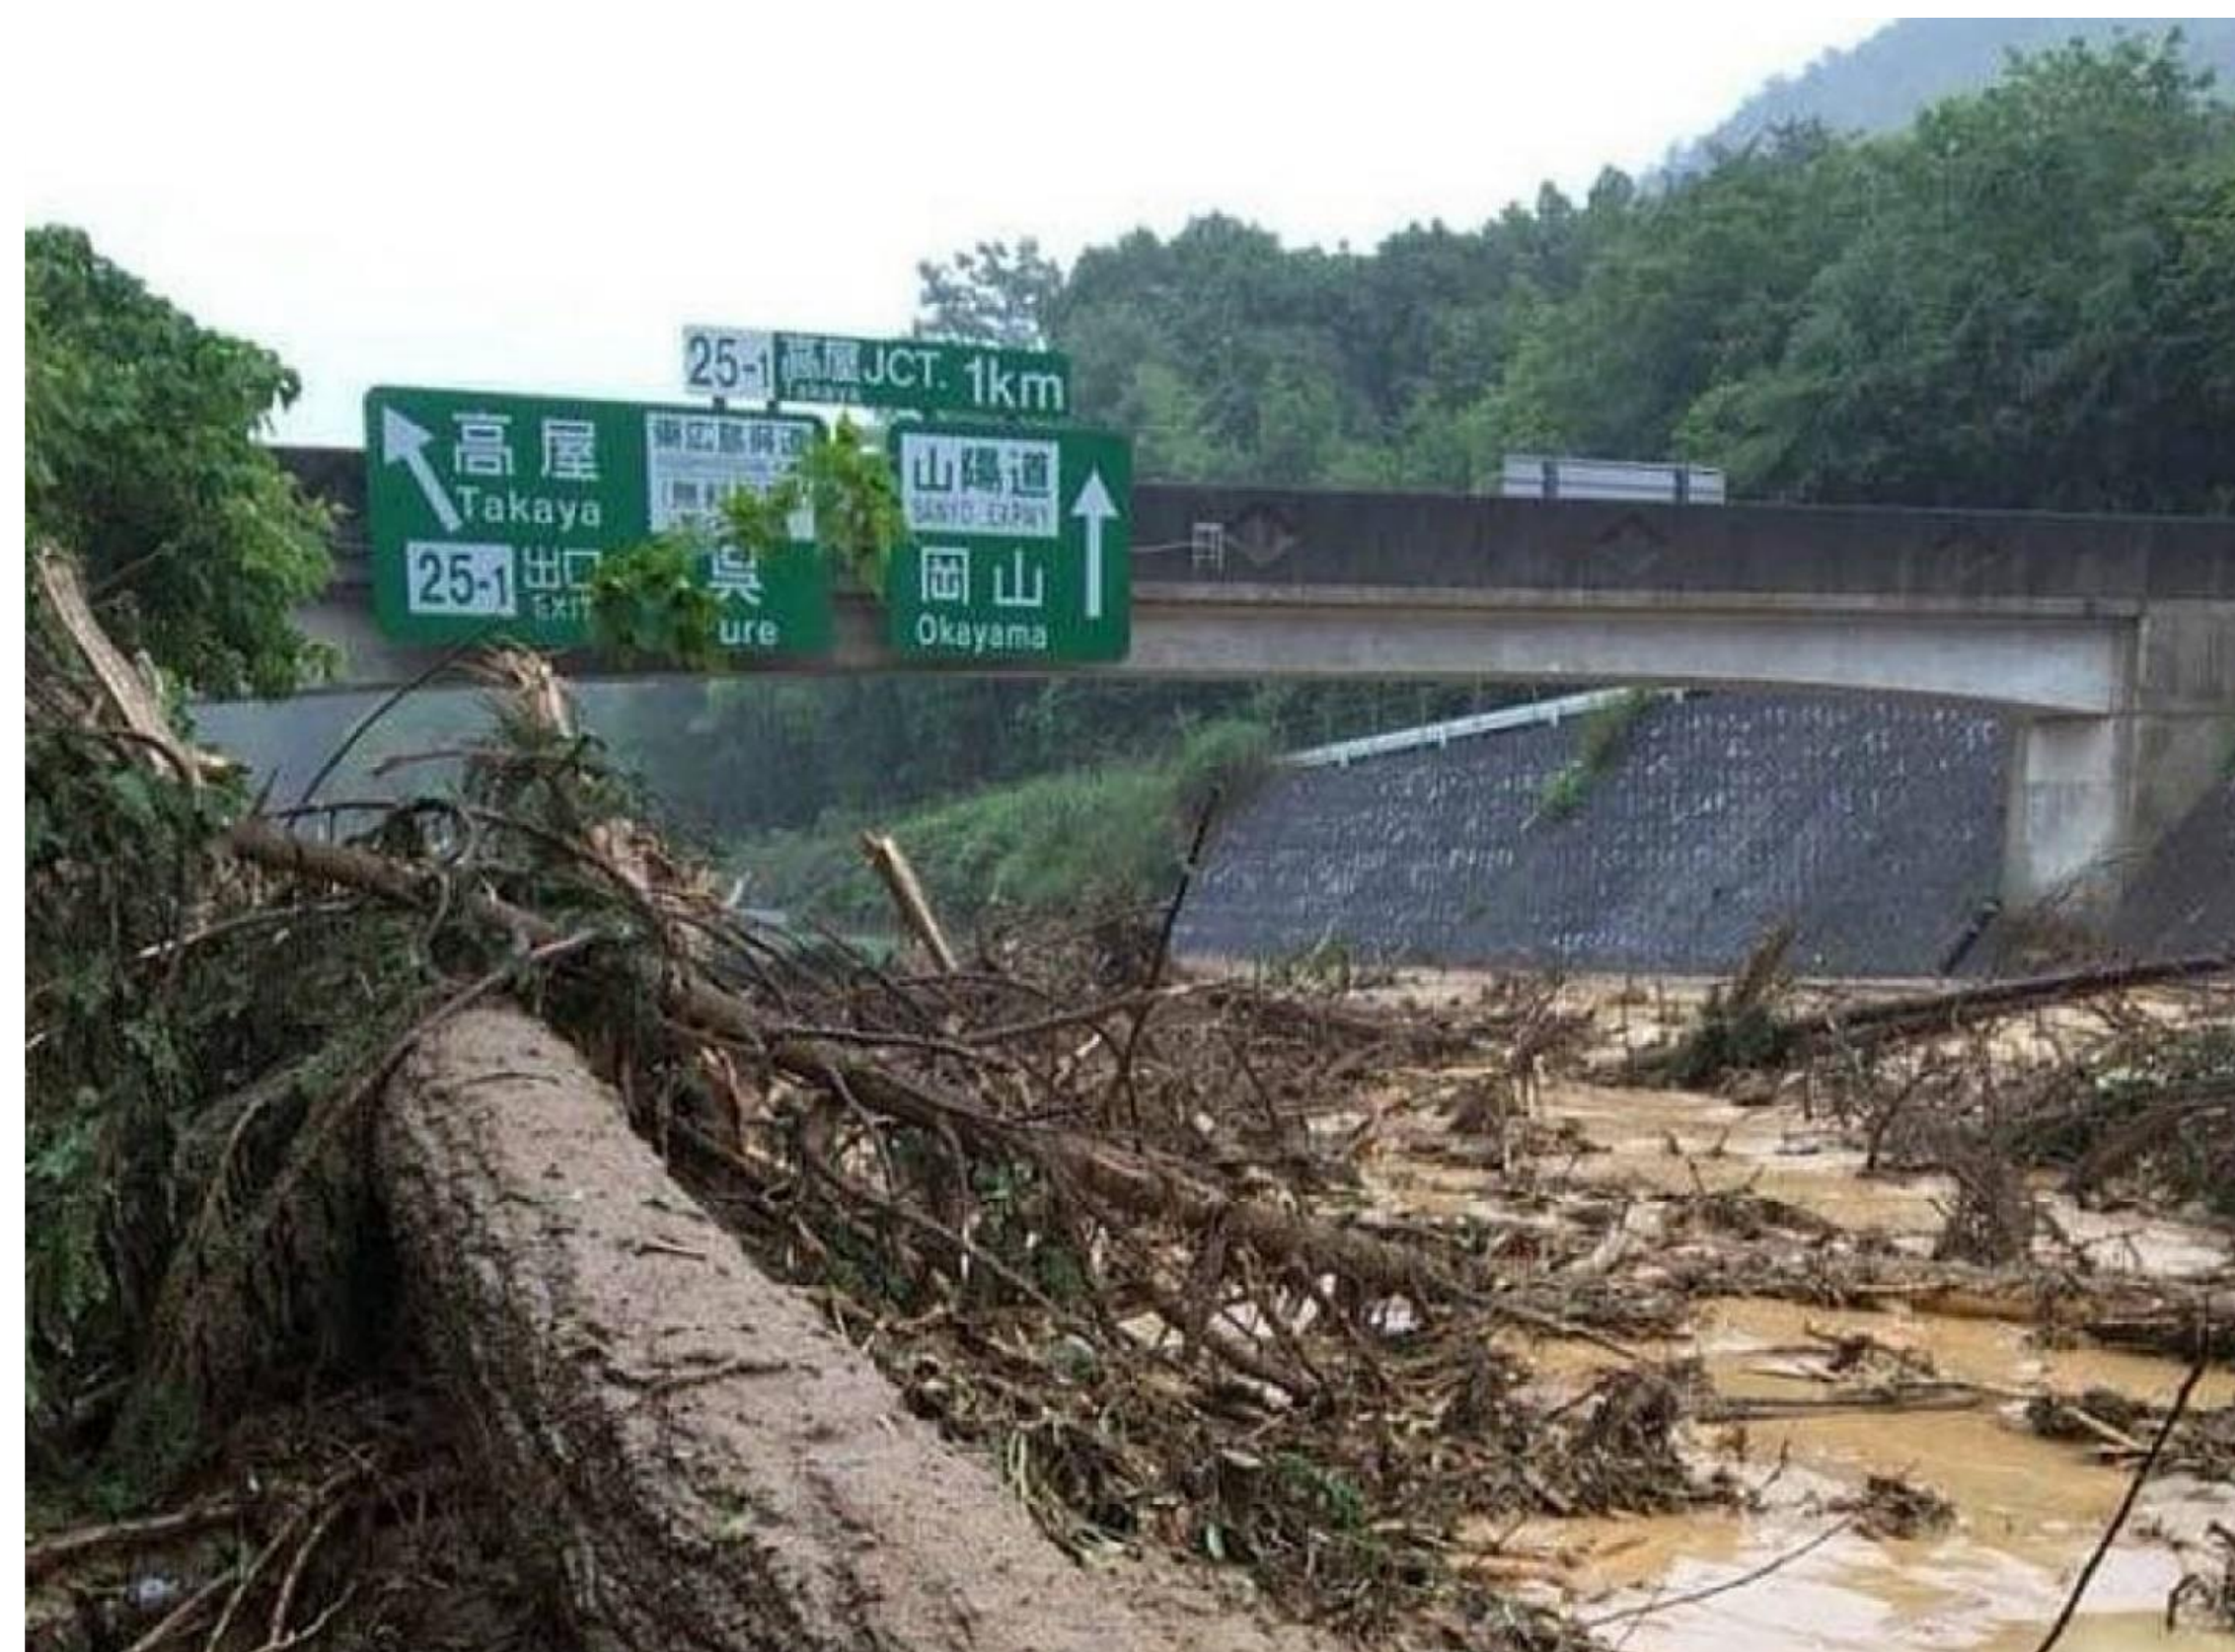
**Mass washout and driftwood inflow out of the road**  
 [Higashihiroshima City, Hiroshima] (Sanyo Expressway (Around Takaya IC, JCT))

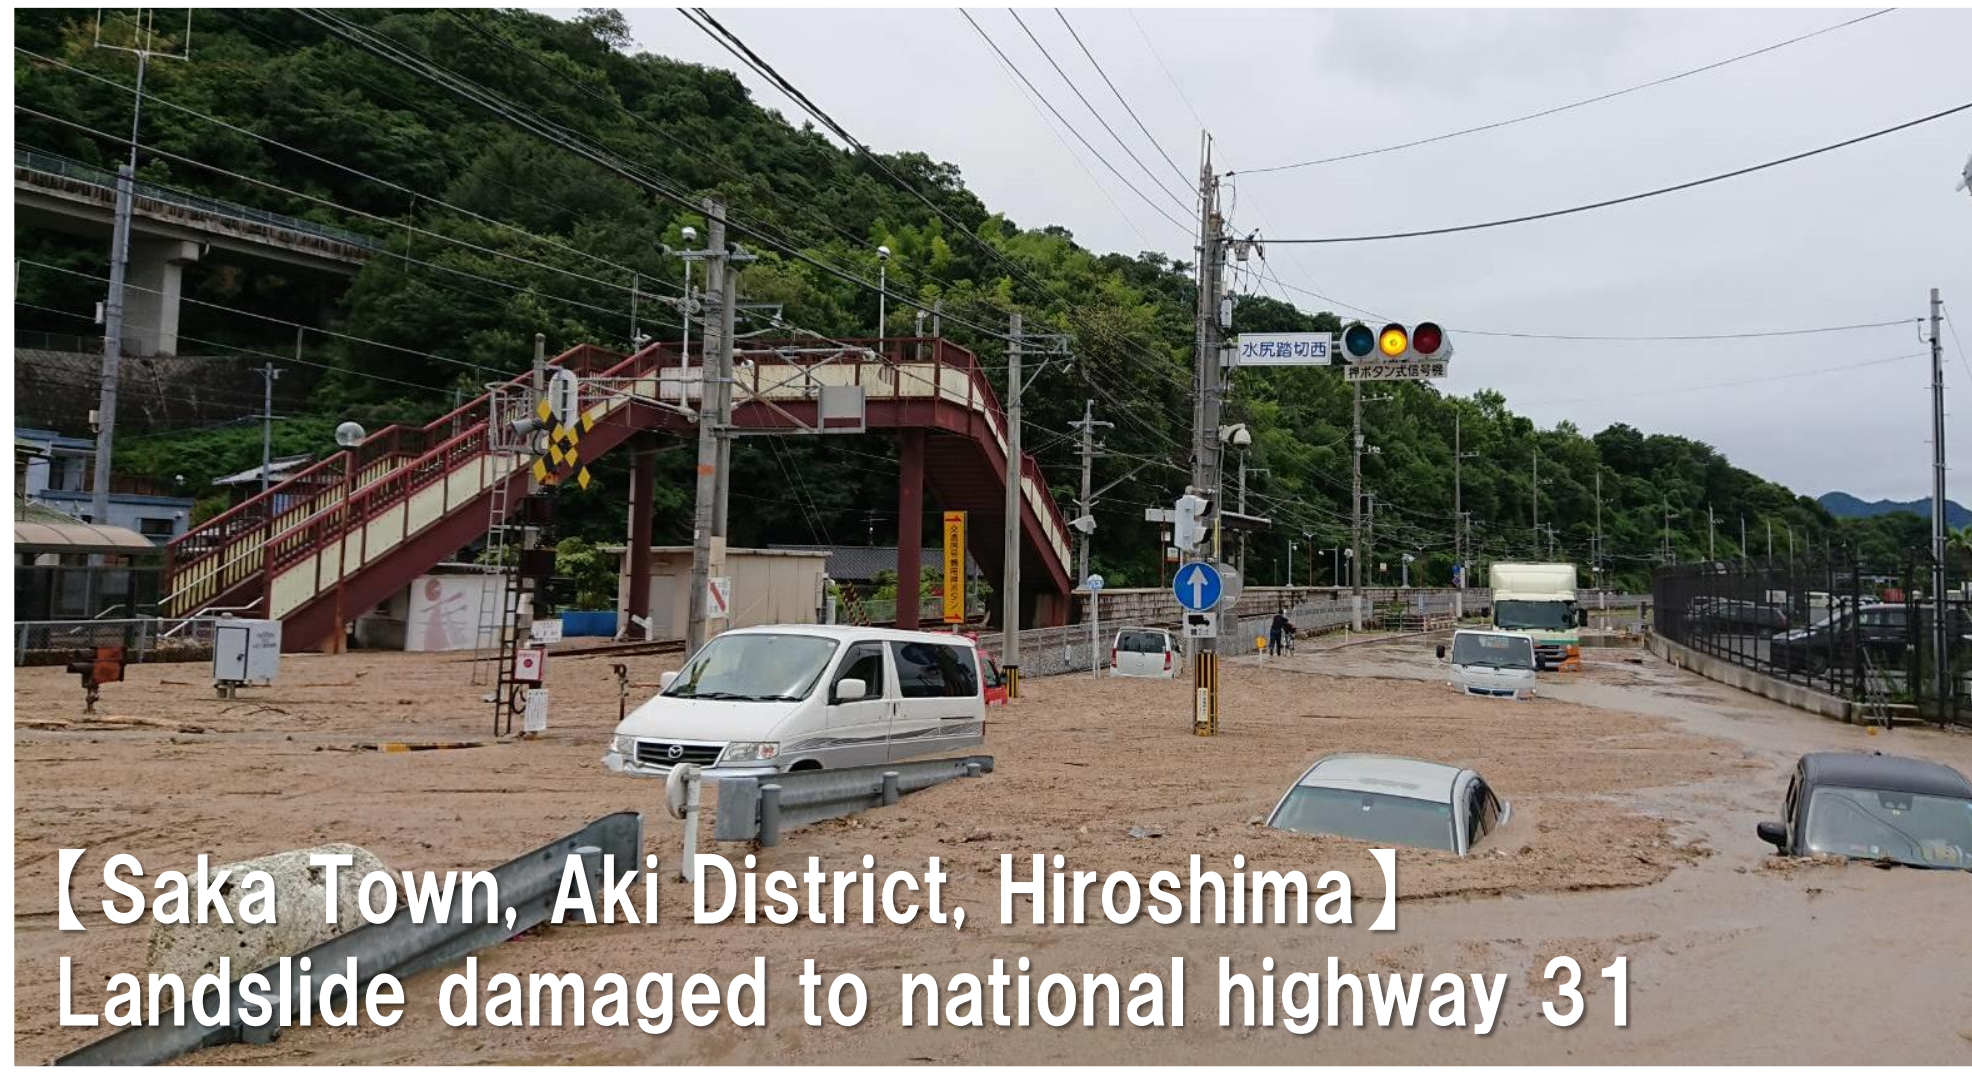
Hillside failure at Mizushiri (Saka Town, Aki District, Hiroshima) knocked down “Hiroshima-Kure road,” “Kure Line (JR West),” and “National highway 31” at the same time that transportation infrastructures links between Hiroshima and Kure were lost.

【Saka Town, Aki District, Hiroshima】  
Landslide damaged to national highway 31

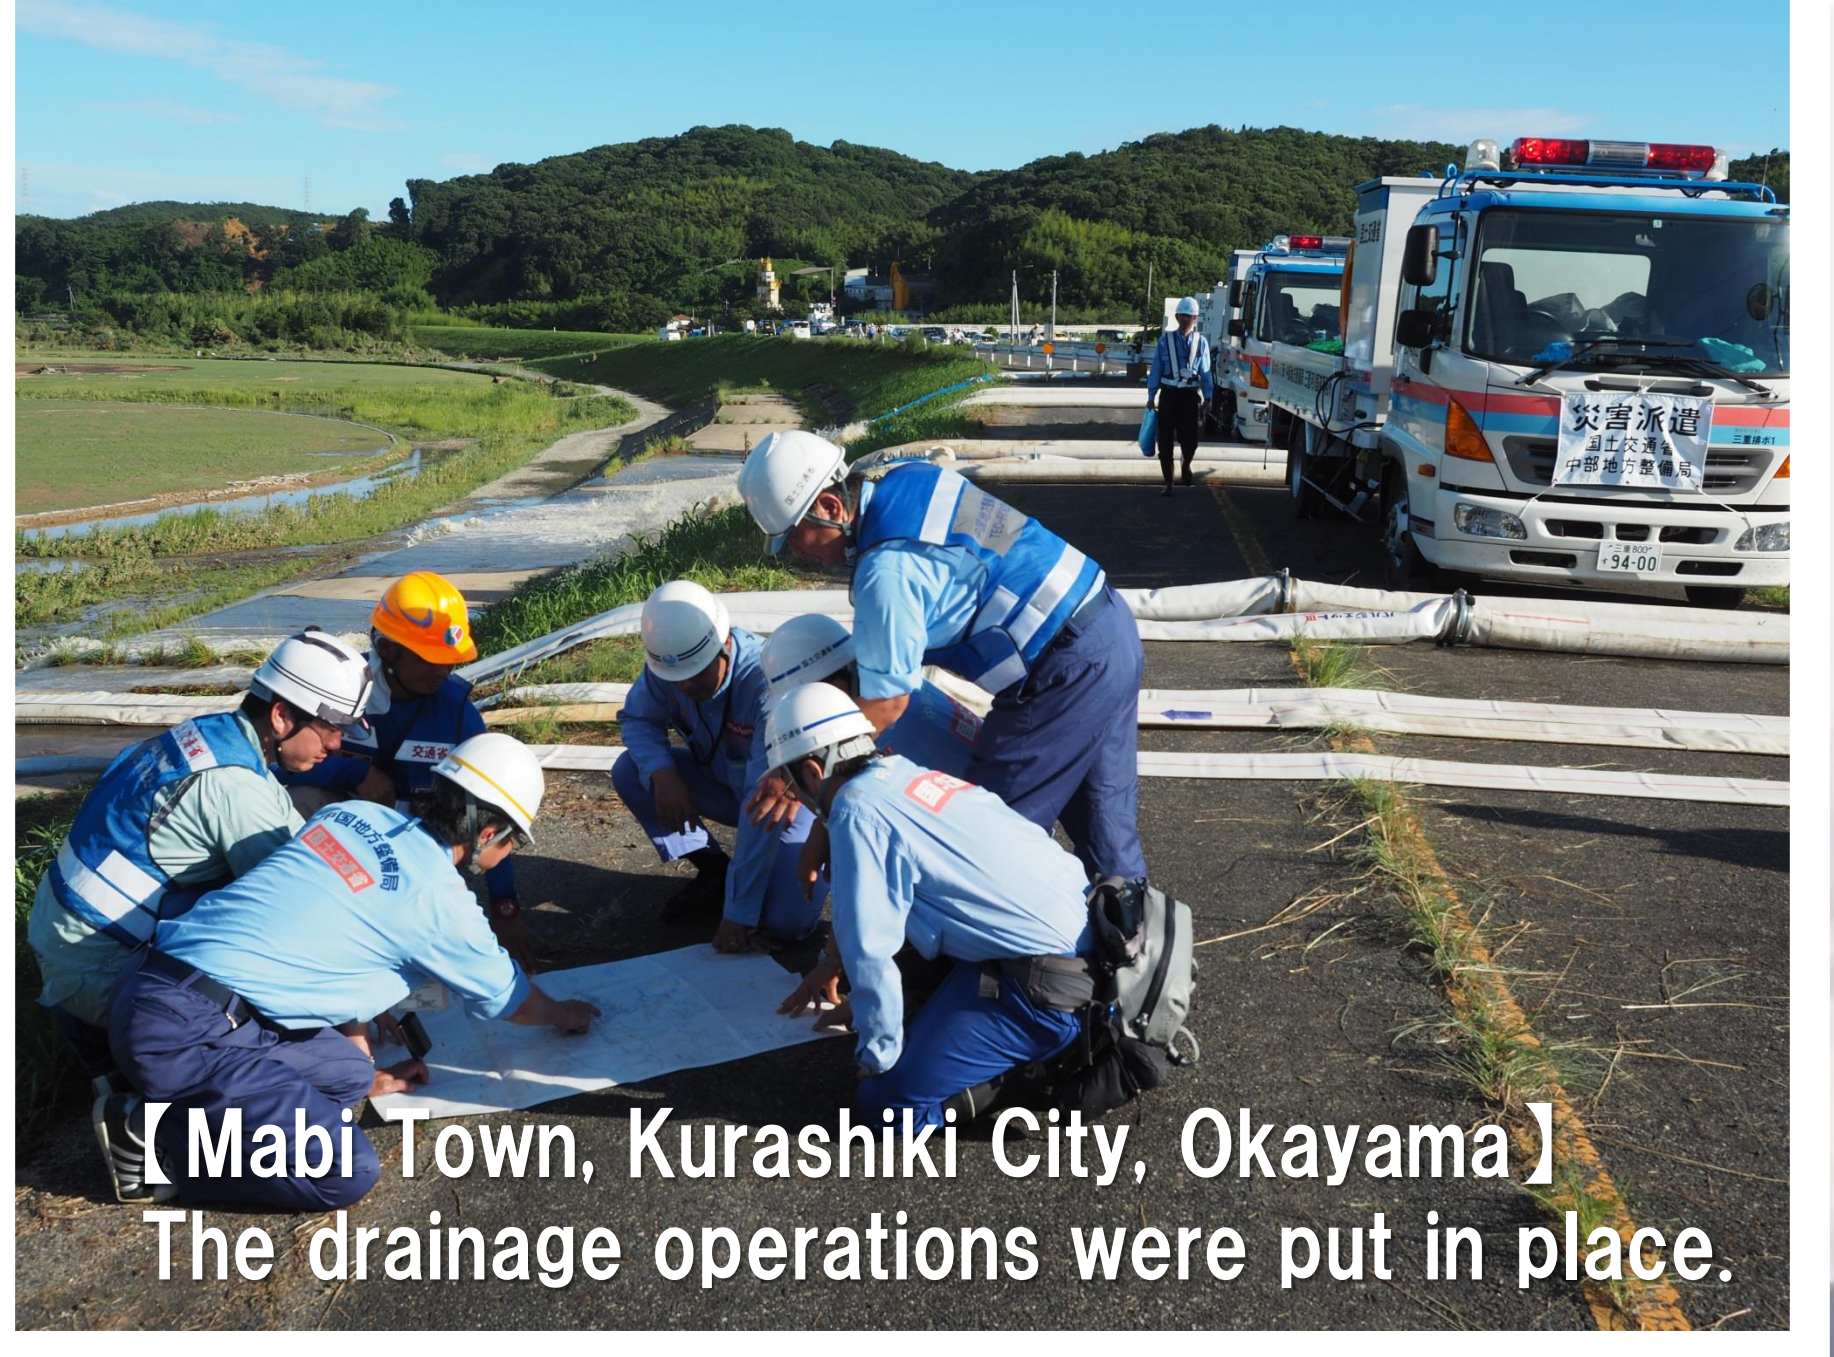
【Mabi Town, Kurashiki City, Okayama】  
The drainage operations were put in place.

Right on the day flood disaster occurred in July 7, we **massed drainage pump vehicles** to Mabi Town, Kurashiki City, Okayama from all around the nation. We managed to start the drainage operation, keeping up day-in and day-out, by 23 fleets since July 8, and accomplished its operation on July 11.

The amount of drained flood water was not less than 700,000m<sup>3</sup>.

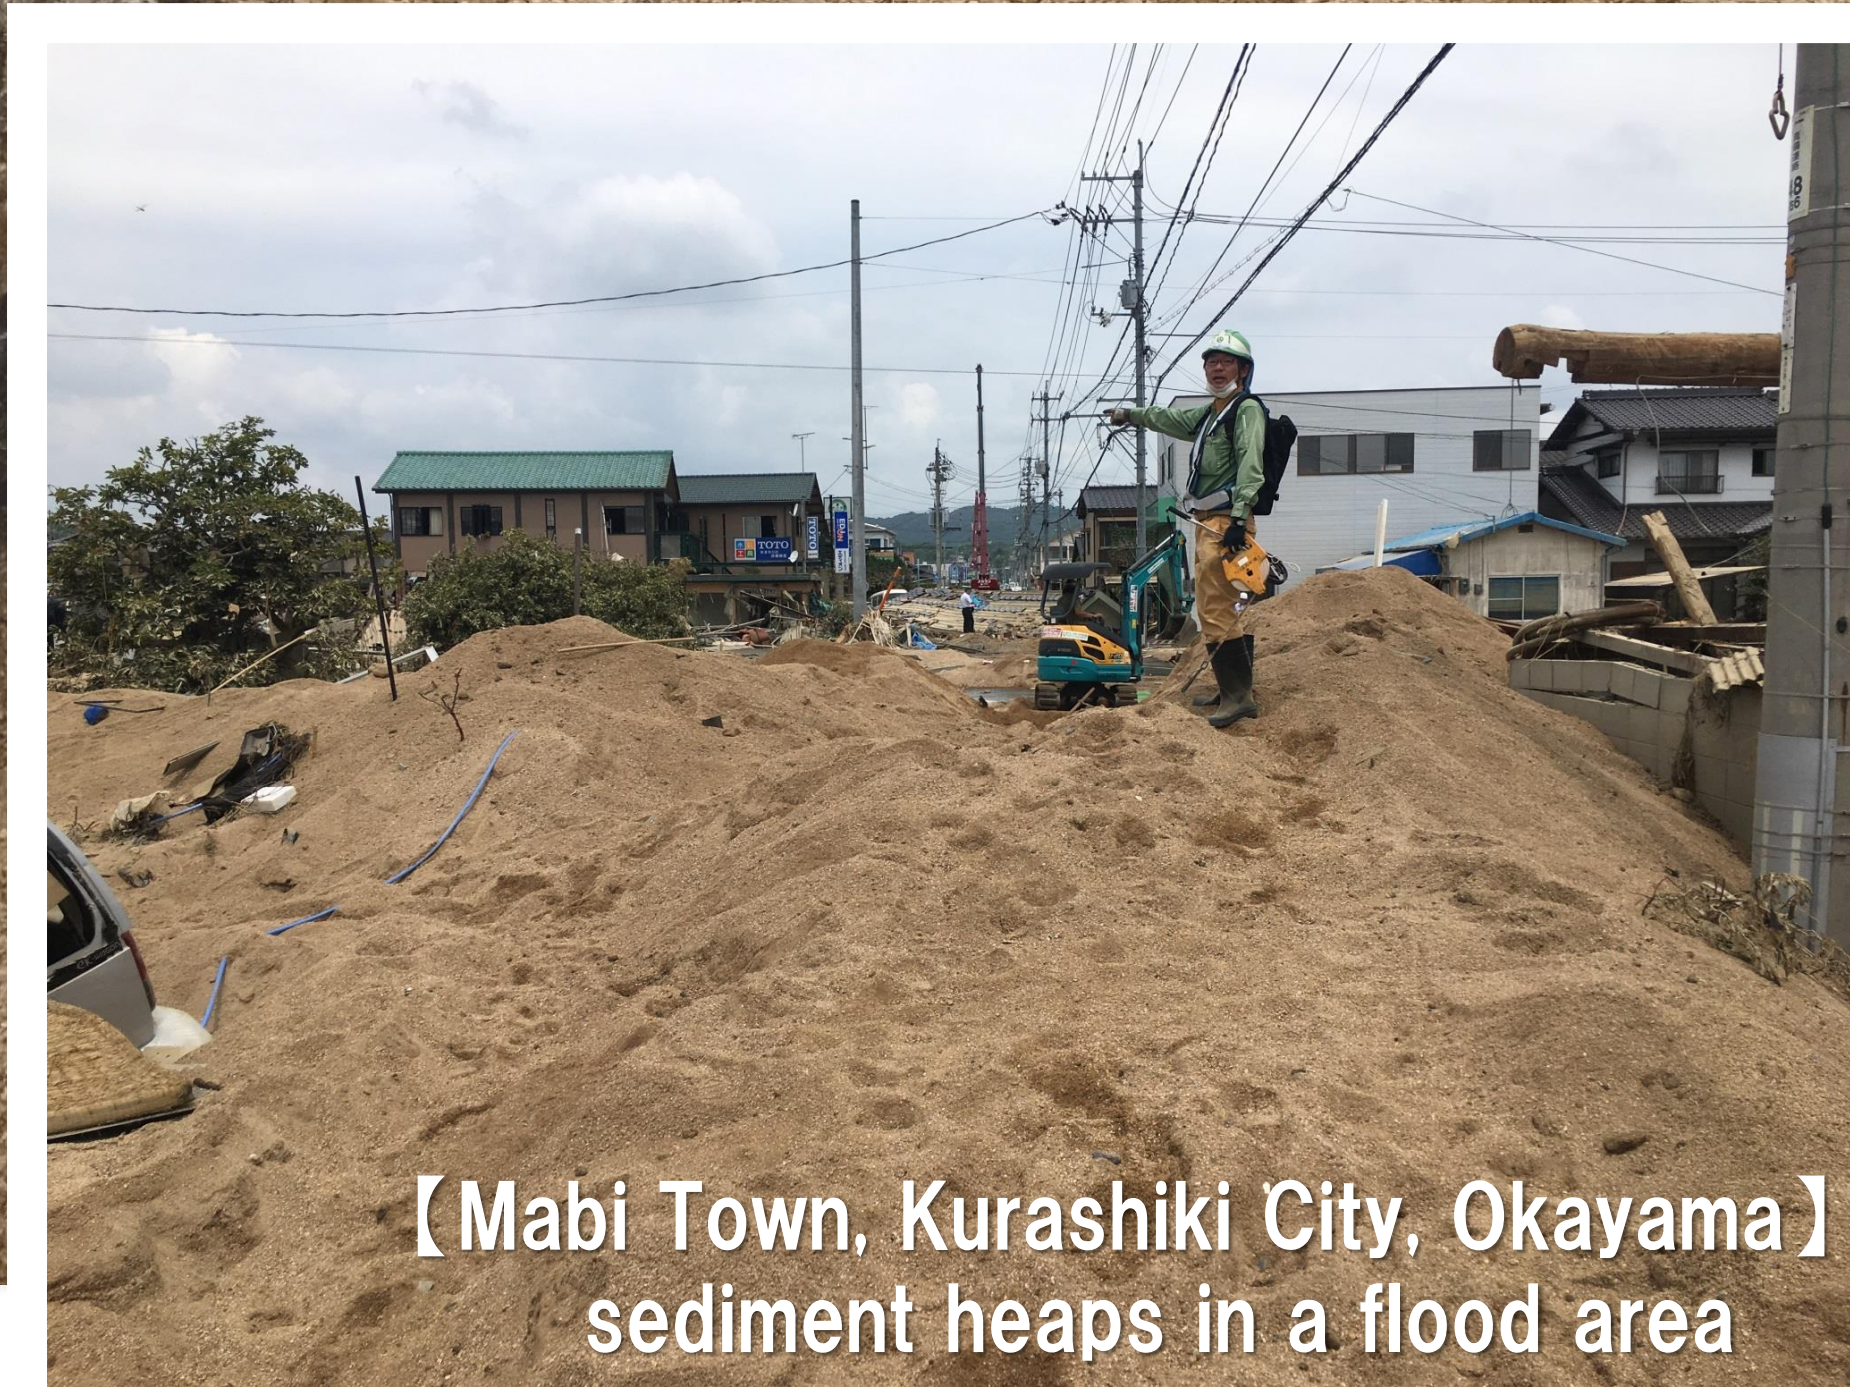
【Mabi Town, Kurashiki City, Okayama】  
sediment heaps in a flood area

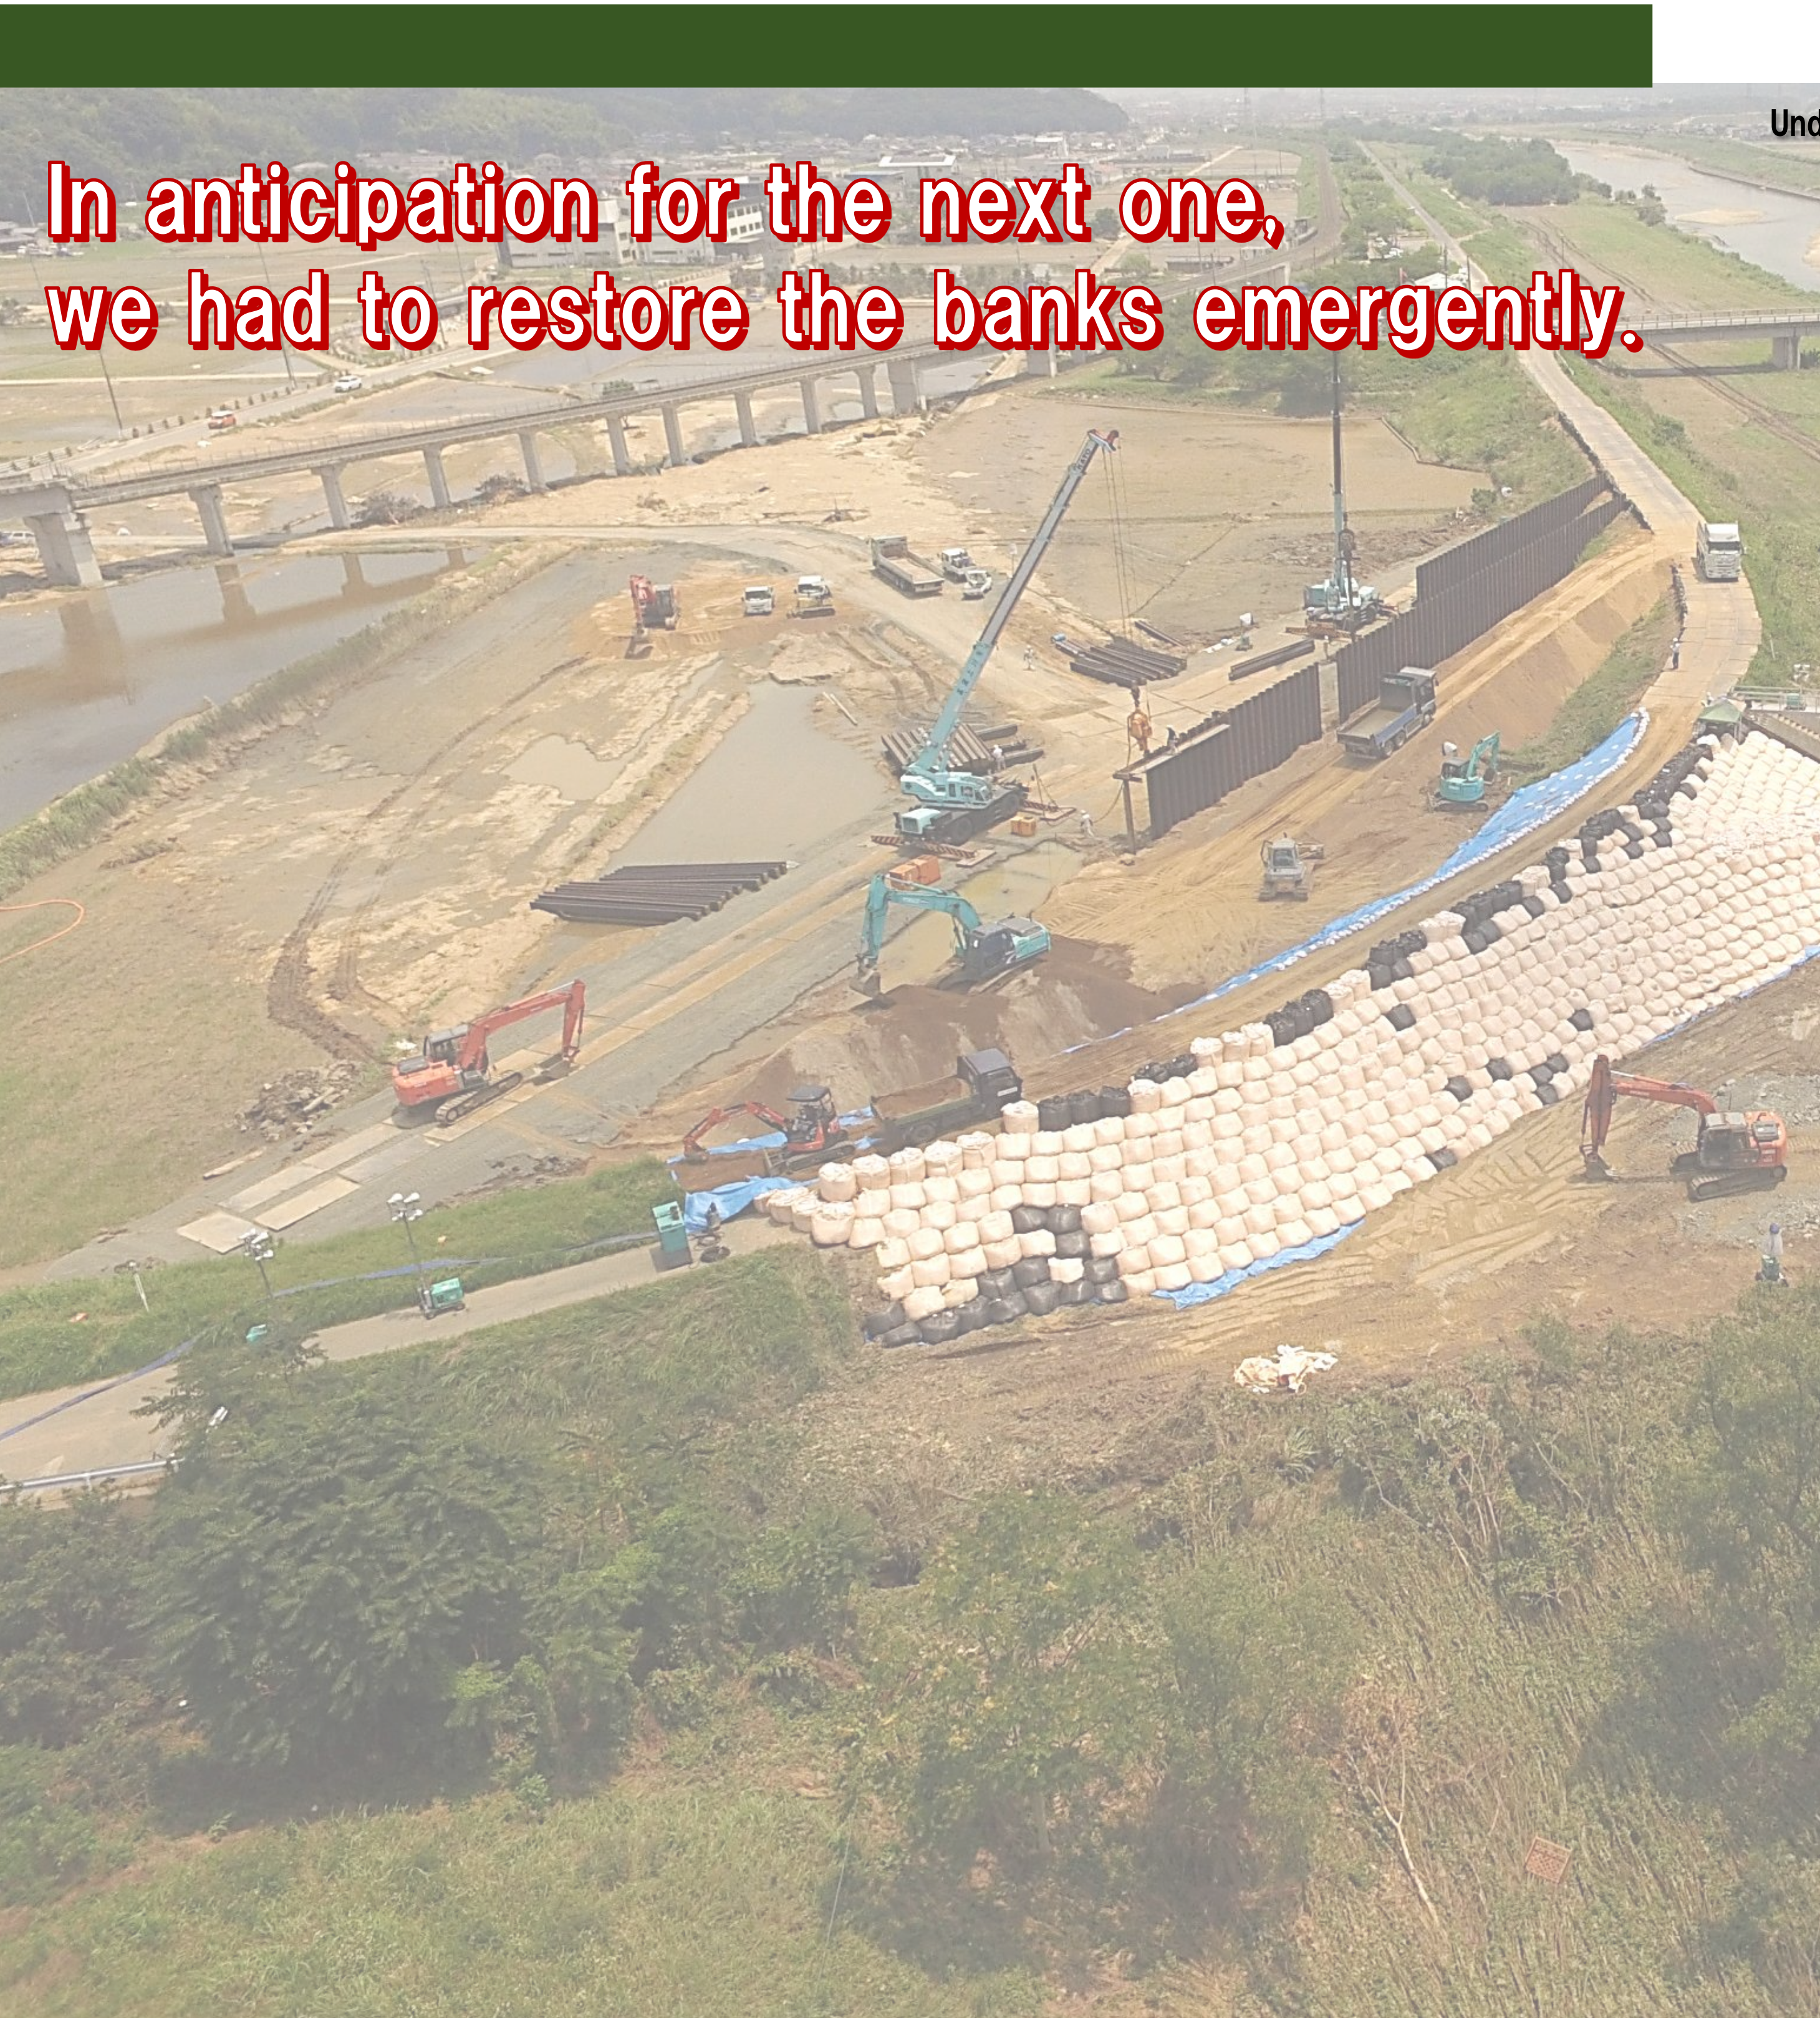
Under repairs, Oda River levee (Mabi Town, Kurashiki City, Okayama)  
Photo: 15 July 2018

In anticipation for the next one,  
we had to restore the banks emergently.

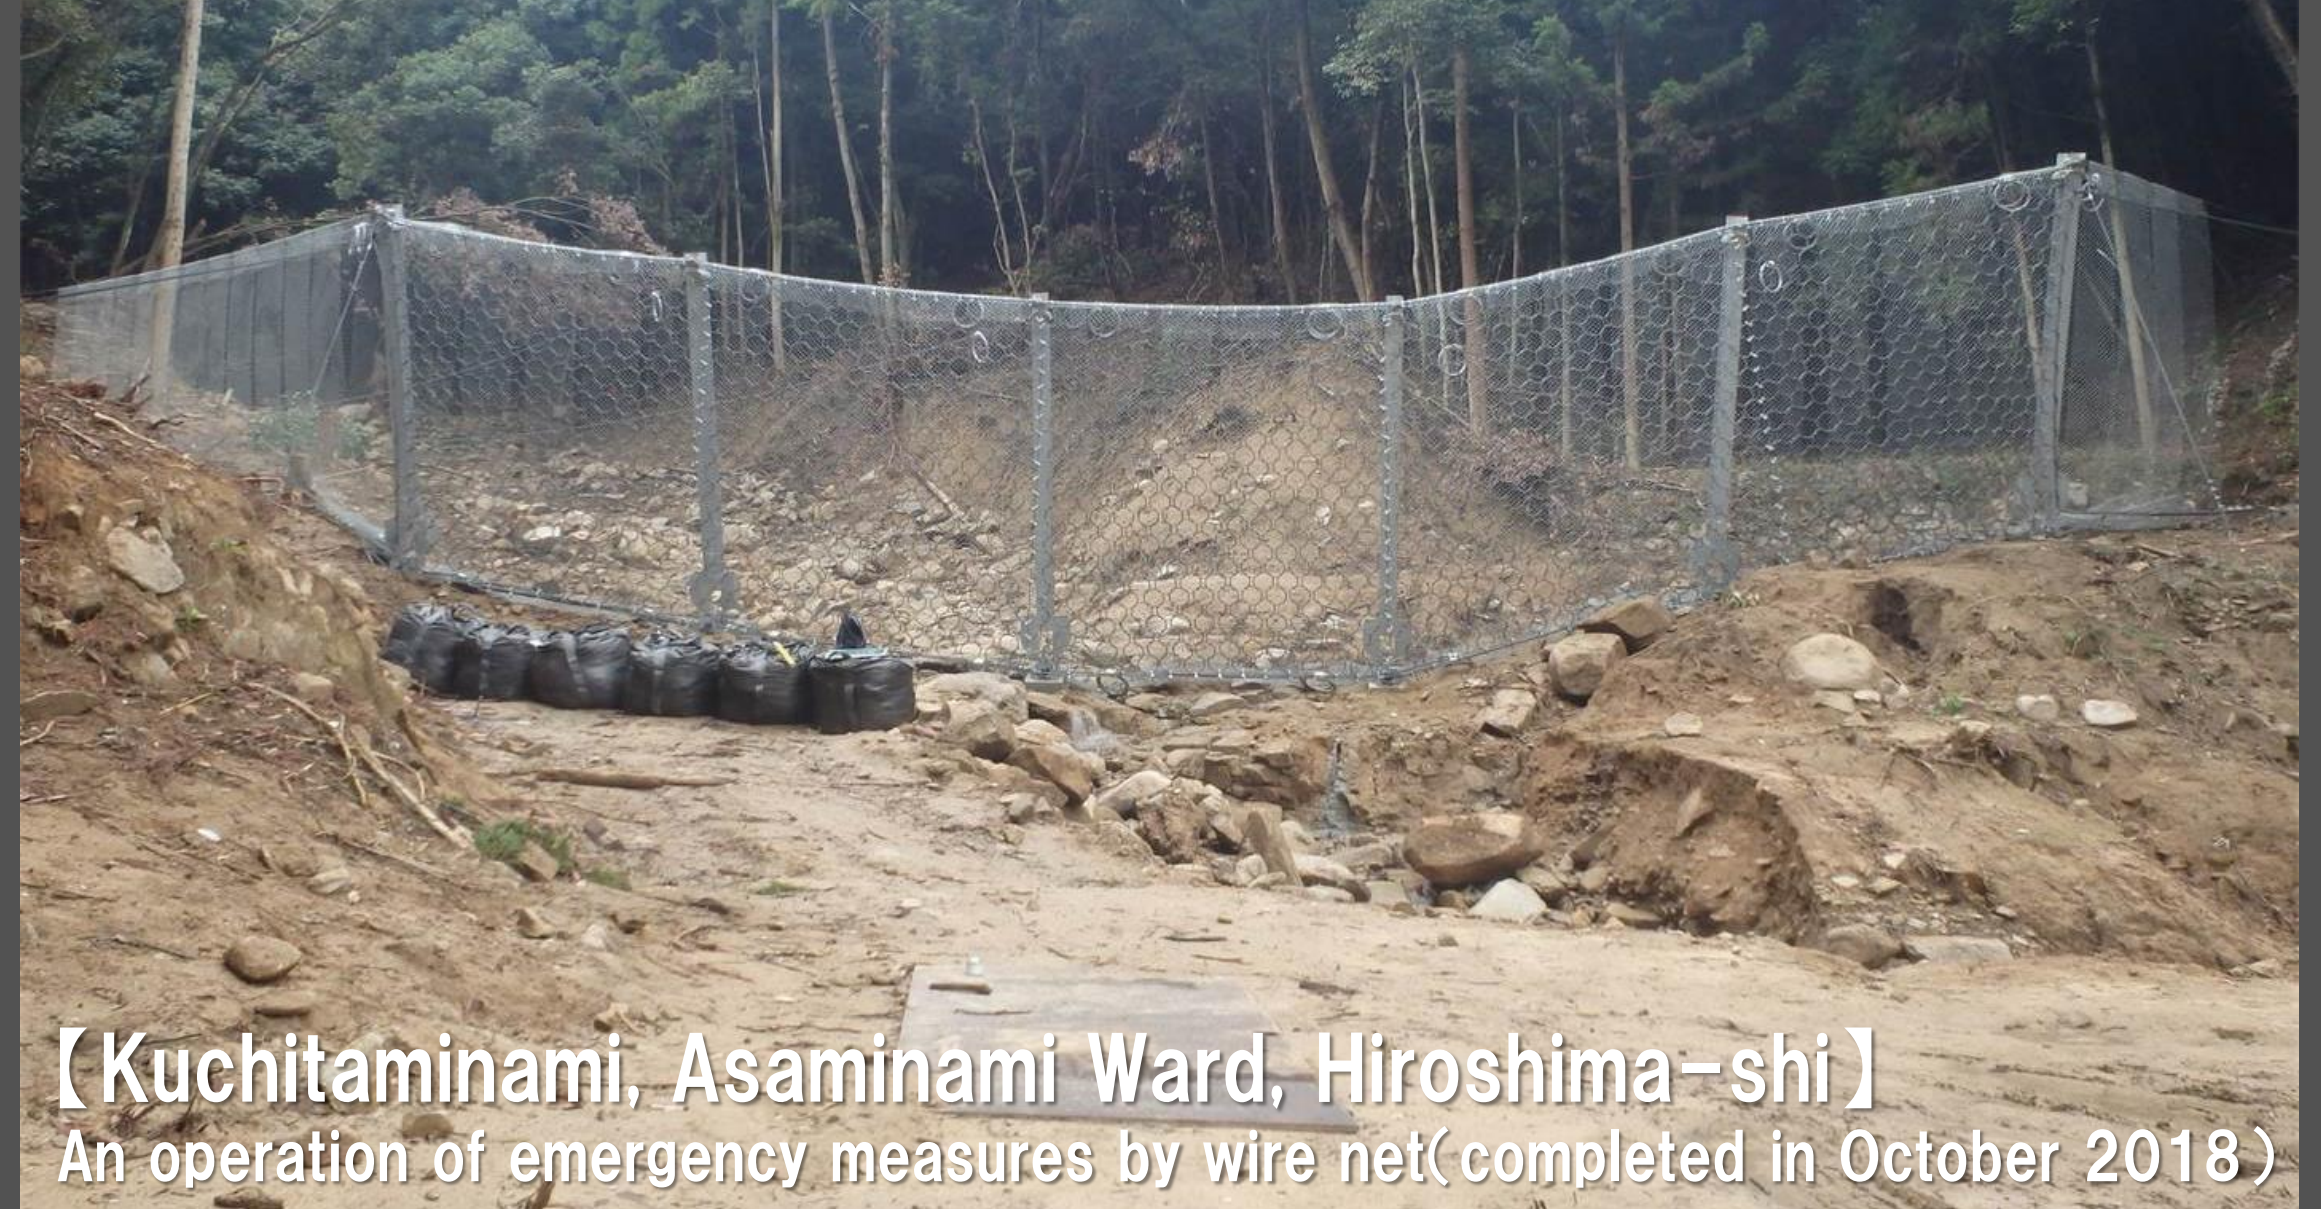
【Kuchitaminami, Asaminami Ward, Hiroshima-shi】  
An operation of emergency measures by wire net (completed in October 2018)

○Emergency restoration by strong wire net
