Chugoku Regional Development Bureau Planning Department

# Occupational hazard

## **Case 1: Construction worker accident (occupational hazard) [Falls]**

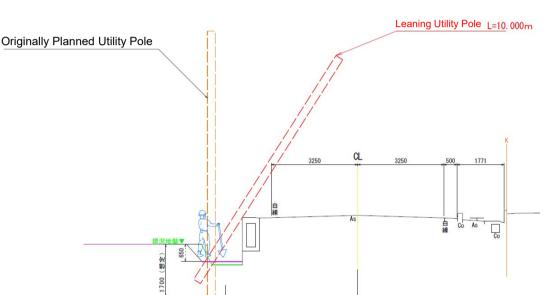
Cause of ·Since heavy machinery and cranes that could affect the Contractor's •Be sure to consult with the facility manager when an overhead accident overhead line were not used, no discussions were held line is within the construction area, even if it does not directly measures to affect the construction. with the pole manager. prevent · Check the utility poles and overhead lines within the •The embedded depth of the pole was not confirmed with recurrence construction area using the road register and on-site survey, and the pole manager, and construction was conducted based check for overlaps as necessary to avoid missing necessary on the general embedding procedure communicated by the measures. pole construction company and from past experience. •Temporarily halt work if the site manager of the main contractor •The ground soil was relatively loose and could be determines that the soil is prone to collapse during excavation, manually excavated; however, work continued because it then reconsider whether to continue construction. was determined that the machine would not tip over if the
