Occupational hazard accidents

Public hazard accidents

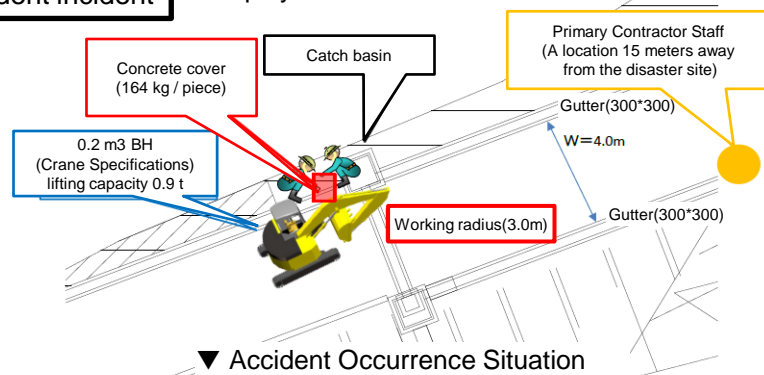
▼ Deployment in the Event of an Accident

At the spoil disposal site, after completing the cleaning of the catch basin during cleanup operations, workers were installing concrete covers on the catch basin. At that time, one of the two lifting hooks used for the sling came loose on the victim's side, causing the concrete cover to fall from a height of 15 cm onto the victim's right foot (not wearing safety shoes), resulting in injury (fracture of the distal phalanx of the right third toe).

- After KY activities, conduct finger-pointing confirmation for each subcontractor to verify that all personnel are wearing appropriate protective gear. The prime contractor's confirmation shall be performed after KY activities and during safety inspections.

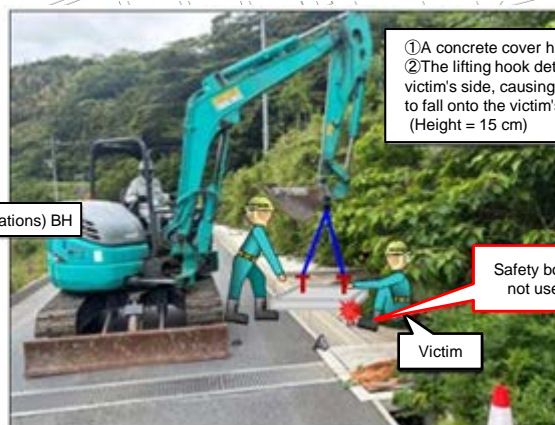
▼ Accident Occurrence Situation

Because it wasn't held securely, the hanging hook rotated and one side came loose.

- The handling procedures for the lifting hooks were not sufficiently communicated.
- The victim held a slinging qualification but lacked experience in civil engineering work and did not fully understand the use of the lifting hooks.
- Protective gear (safety boots) was not worn.
- The victim's medical diagnosis results were not adequately verified.

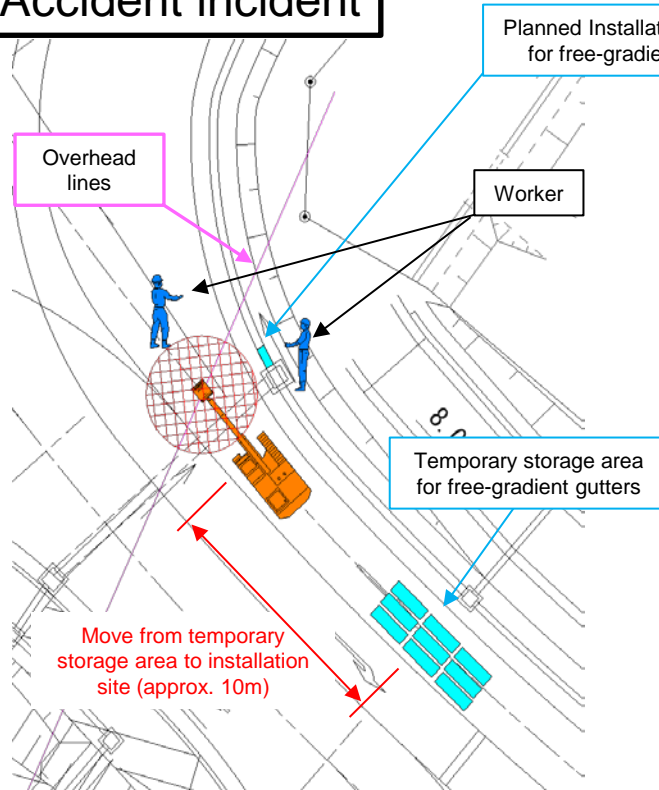
During drainage structure construction for road improvement construction, When the backhoe lifted and swung the free-gradient gutter, its arm contacted overhead lines (NTT) and the bundling hangers used to prevent wire detachment. The detachment of the bundling hangers caused the overhead lines (NTT) to lose support, causing them to sag approximately 1 meter.

< The backhoe arm came into contact with overhead lines >

- ① Despite being aware of overhead wires at the work site, no height restriction measures using gates were implemented before or after the lines.
- ② Despite the need to minimize heavy machinery operations beneath overhead lines, unnecessary work was performed.
- ③ The supervisor designated in the construction plan failed to verify the overhead lines.

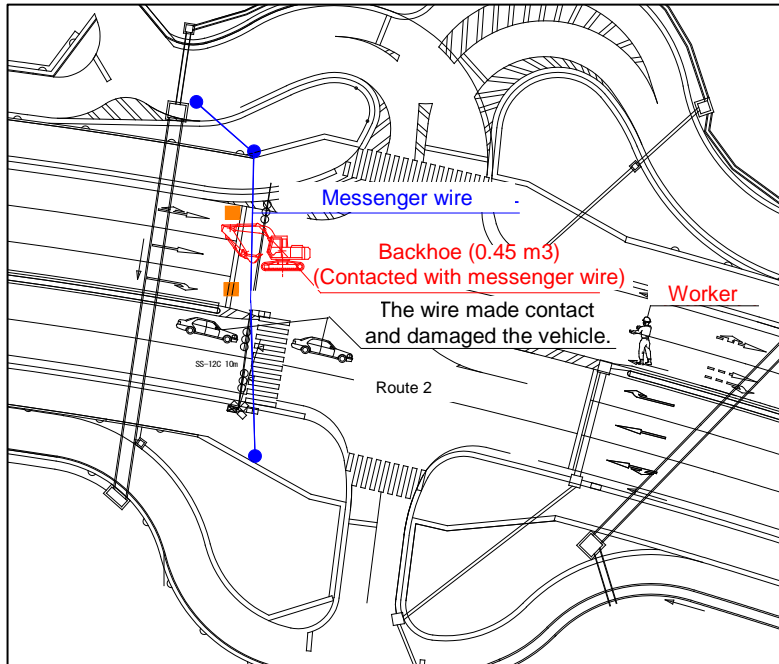
【 Floor plan 】

During tidying-up operations, a curb was being lifted and rotated using a mobile crane (backhoe with crane, 0.45m³ class). The backhoe arm came into contact with an NTT messenger wire (H=5.8m) located overhead, severing the messenger wire. The resulting vibration caused a Chugoku Electric Power cable to become entangled. The messenger wire fell onto the roadway, striking two general vehicles traveling on the national highway and causing scrape damage to the vehicles.

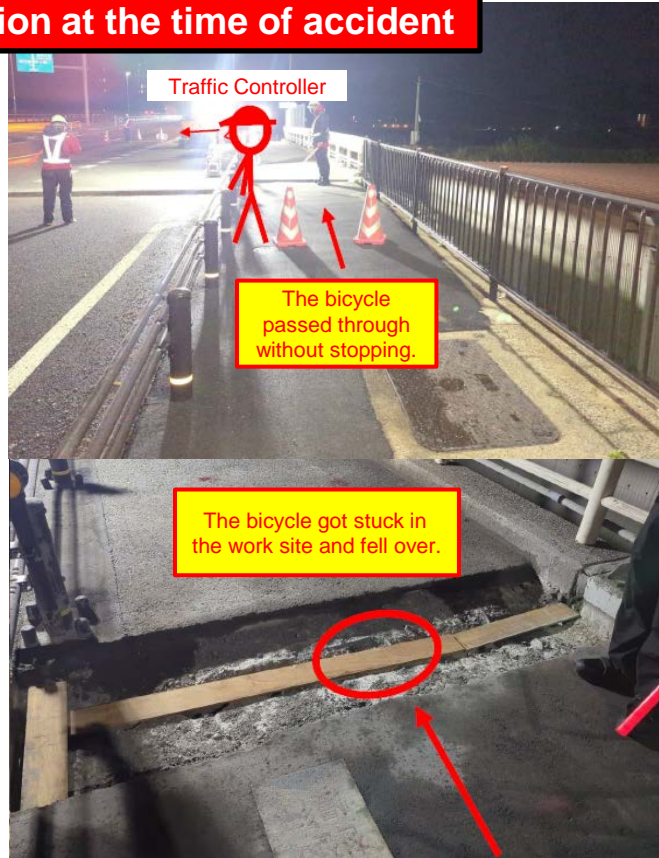
Situation at the time of accident

During bridge repair construction, while pedestrian walkways were restricted for the removal of expansion joints, a bicycle entered the work site. The cyclist fell over the uneven surface created by the removed expansion joint and sustained injuries.

※Sidewalk detour available

- ① Strengthen the system for checking alignment between construction plans and site conditions, as well as change procedures.
- ② Ensure safe pedestrian walkways by separating work areas and passageways using color cones and cone bars.
- ③ Enclose sidewalks completely with color cones and cone bars to prevent gaps, implementing strict no-entry measures for the general public.
- ④ Install additional lighting to ensure visibility for traffic controllers from a distance.
- ⑤ Install illuminated warning signs and rotating lights to alert pedestrians and cyclists.

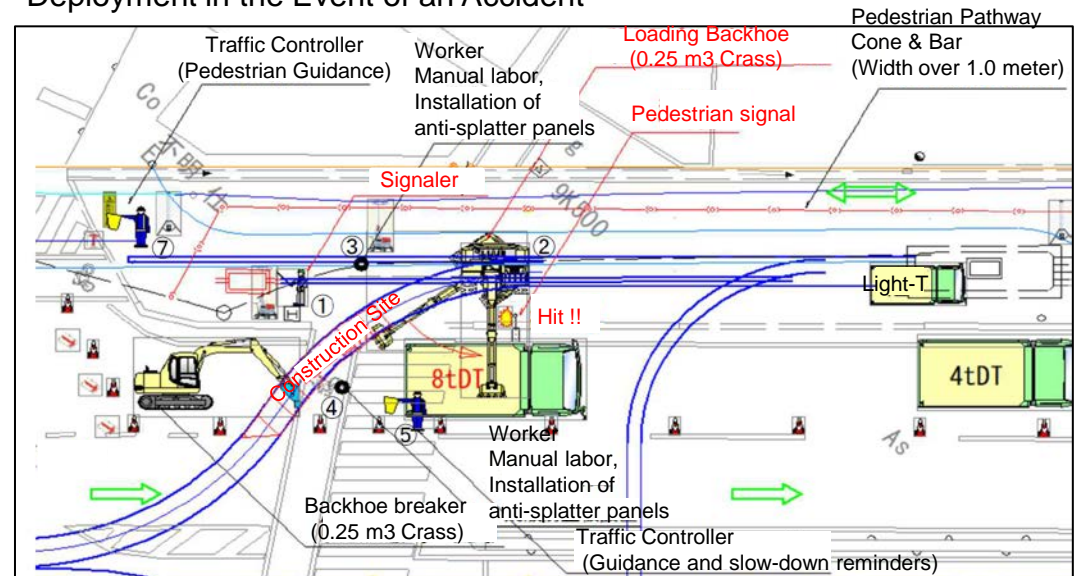
Deployment in the Event of an Accident

While loading As shells onto a dump truck, a backhoe's boom struck and damaged a pedestrian signal luminaire fixture during a swing maneuver.

- ① Specific construction instructions (equipment placement, monitoring procedures, etc.) were inadequate.
- ② The signaler looked away from the backhoe without giving the stop signal and was monitoring other work.
- ③ The pedestrian signal light was in the signaler's blind spot from their standing position.
- ④ The backhoe operator rotated the backhoe without receiving instructions from the signaler.
