The damage to Chugoku region in "the heavy rain disaster in July 2018."

# Historic heavy rain that we have ever seen

# Flood Disaster in five prefectures, Chugoku region

# Sediment-related mass movement disaster

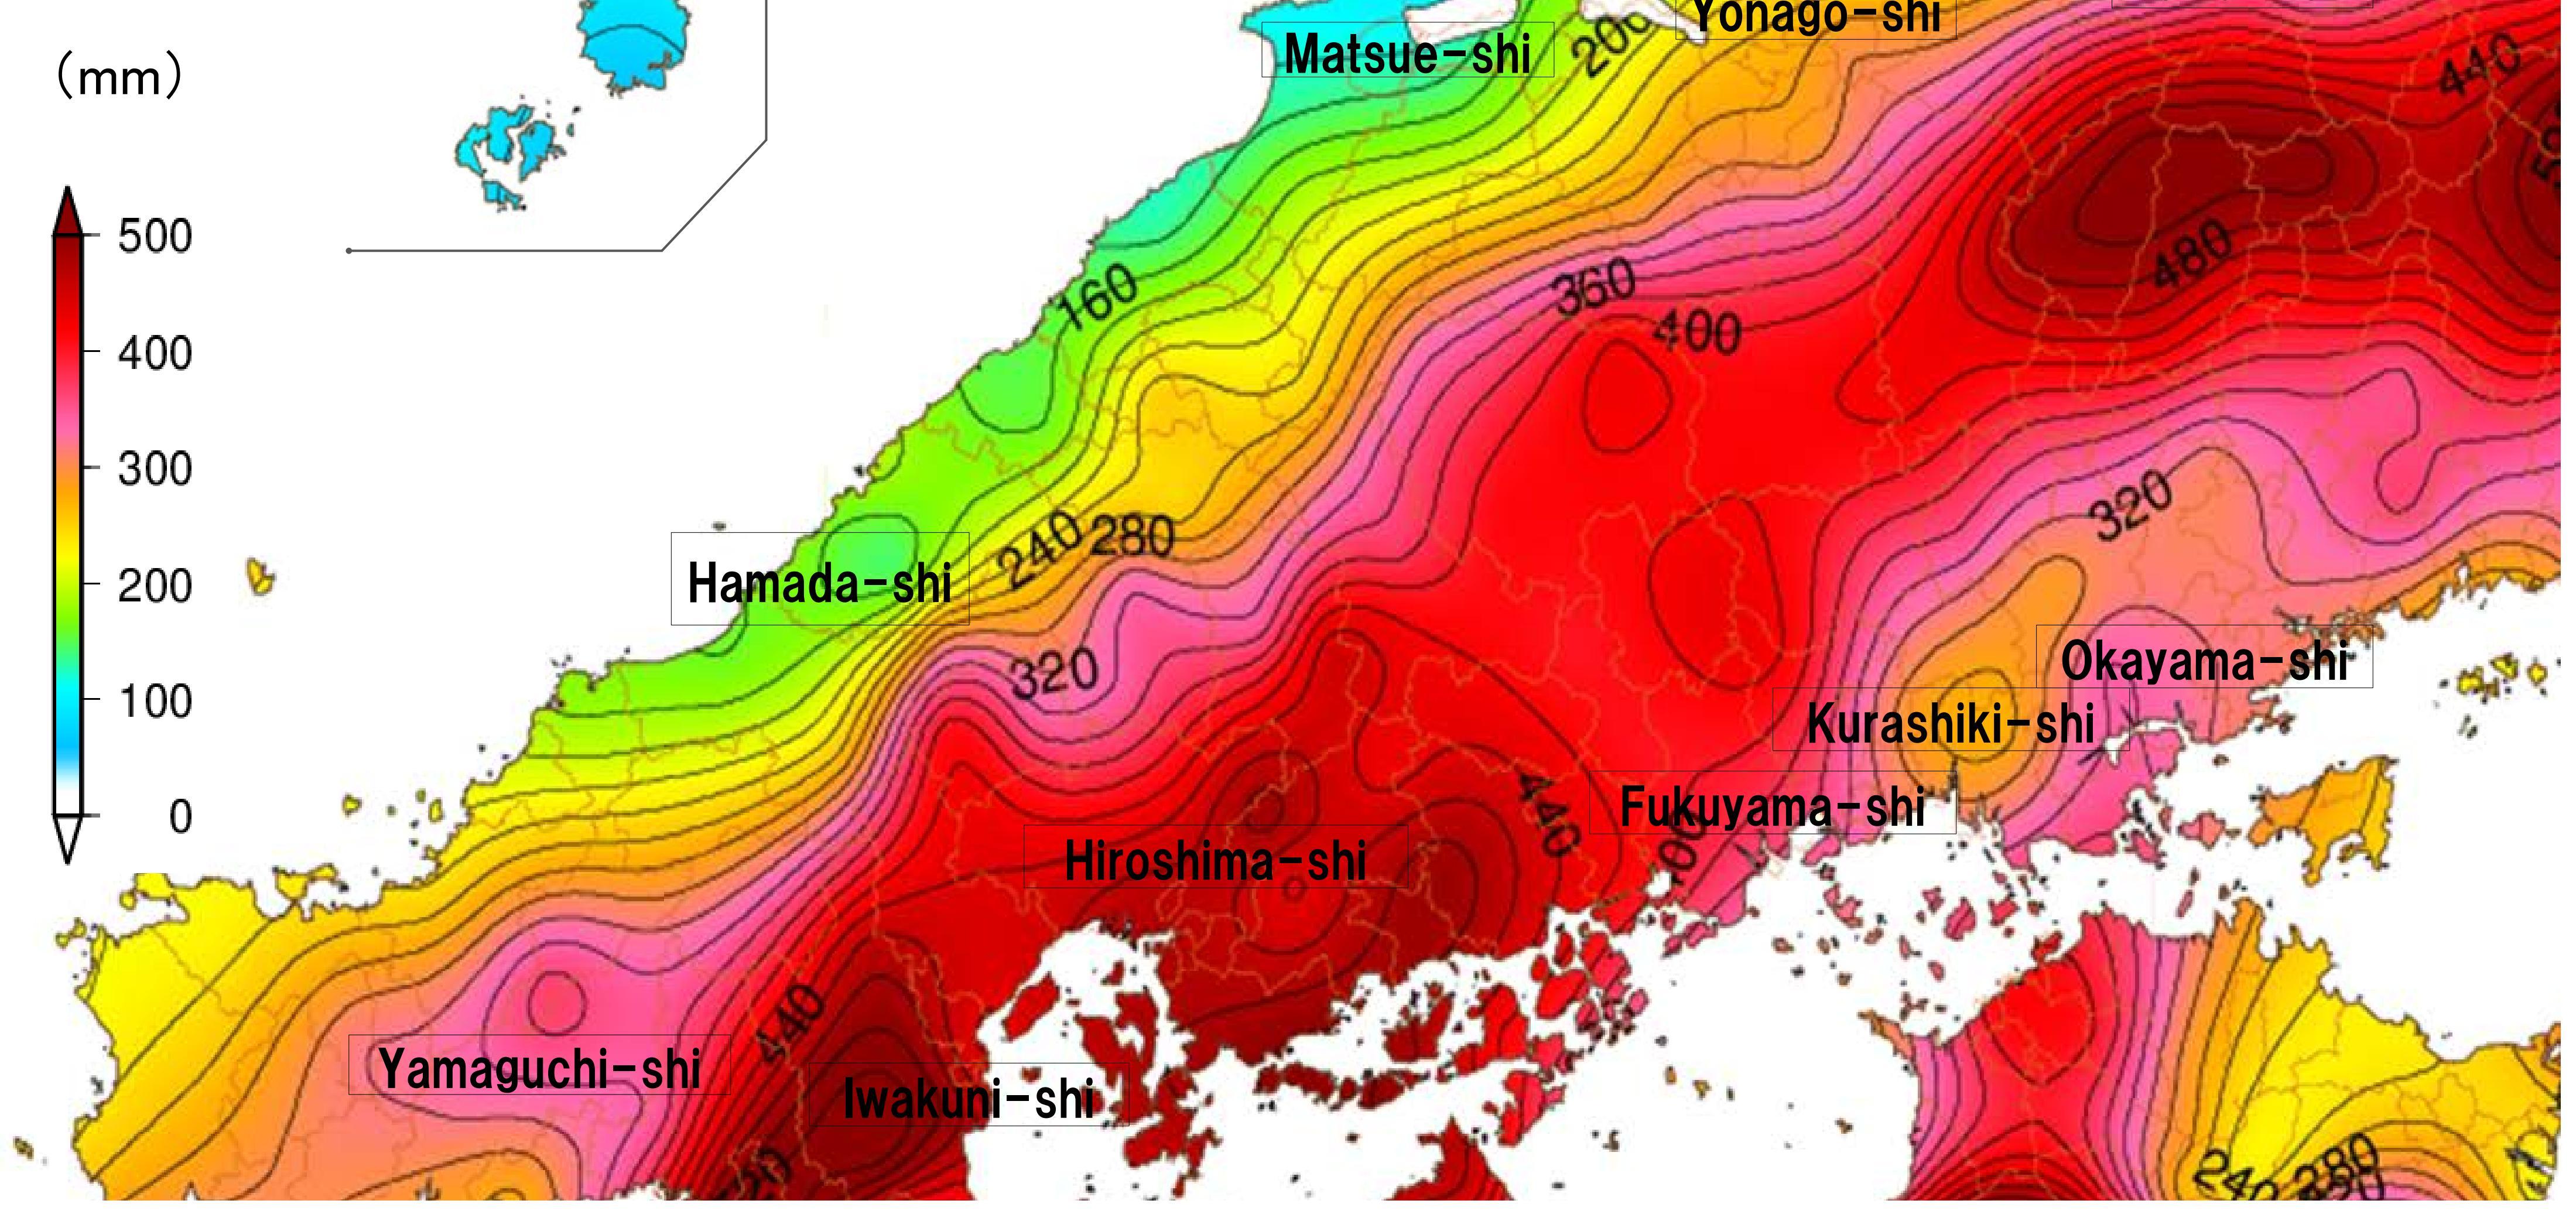
Rainfall records in a 24-hour period, a 48-hour period, and 72-hour period were passed at tens of observation points around Okayama and Hiroshima. On this downpour, "Special heavy rain warnings" were issued in three prefectures : Tottori, Okayama and Hiroshima.

平成30年7月3日0時~8日12時までの期間降水量:気象庁より

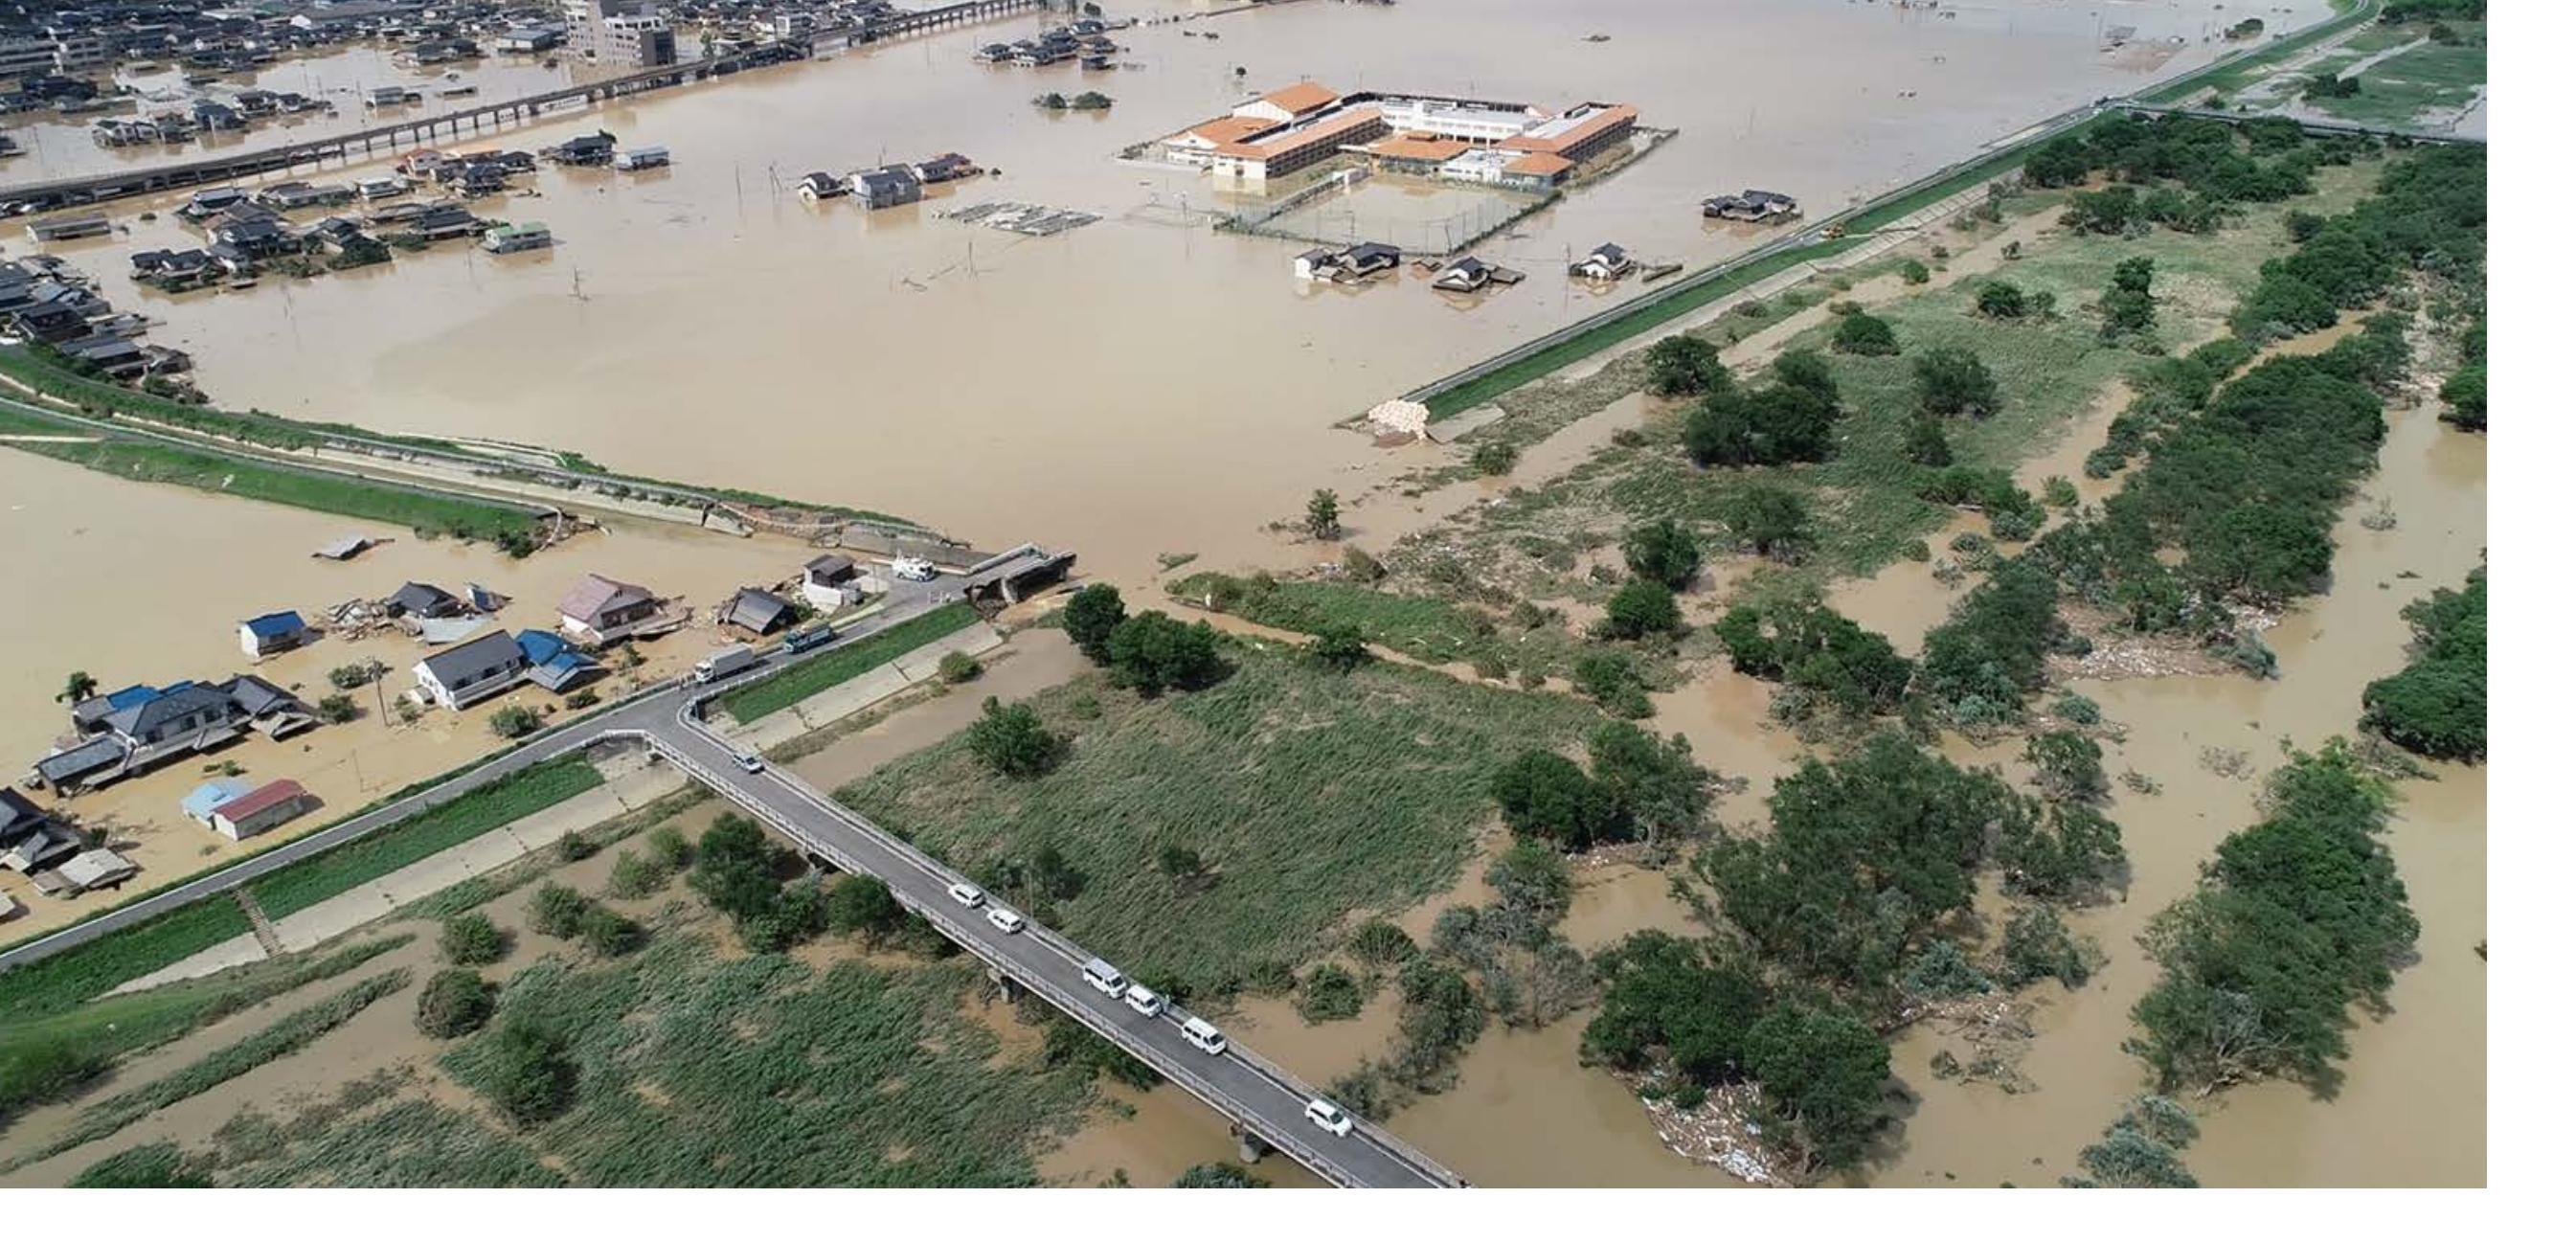
### [Places of burst levees in Chugoku region]

(Number of burst levees)		
Shimane	Yato River(1)		
Okayama	Asahi River(2) Takahashi River(15)		
Hiroshima	Ashida River(3) Hongo River(1) Nuta River(8) Kamo River(1) Noro River(3) Kurose River(1)		
Yamaguchi	Shimada River(1)		
(Source: MLIT Japan, as of September 5, 2018 at 15:00)

### Levees succumbed at 36 sections of 10 river system 4 prefectures in Chugoku region.

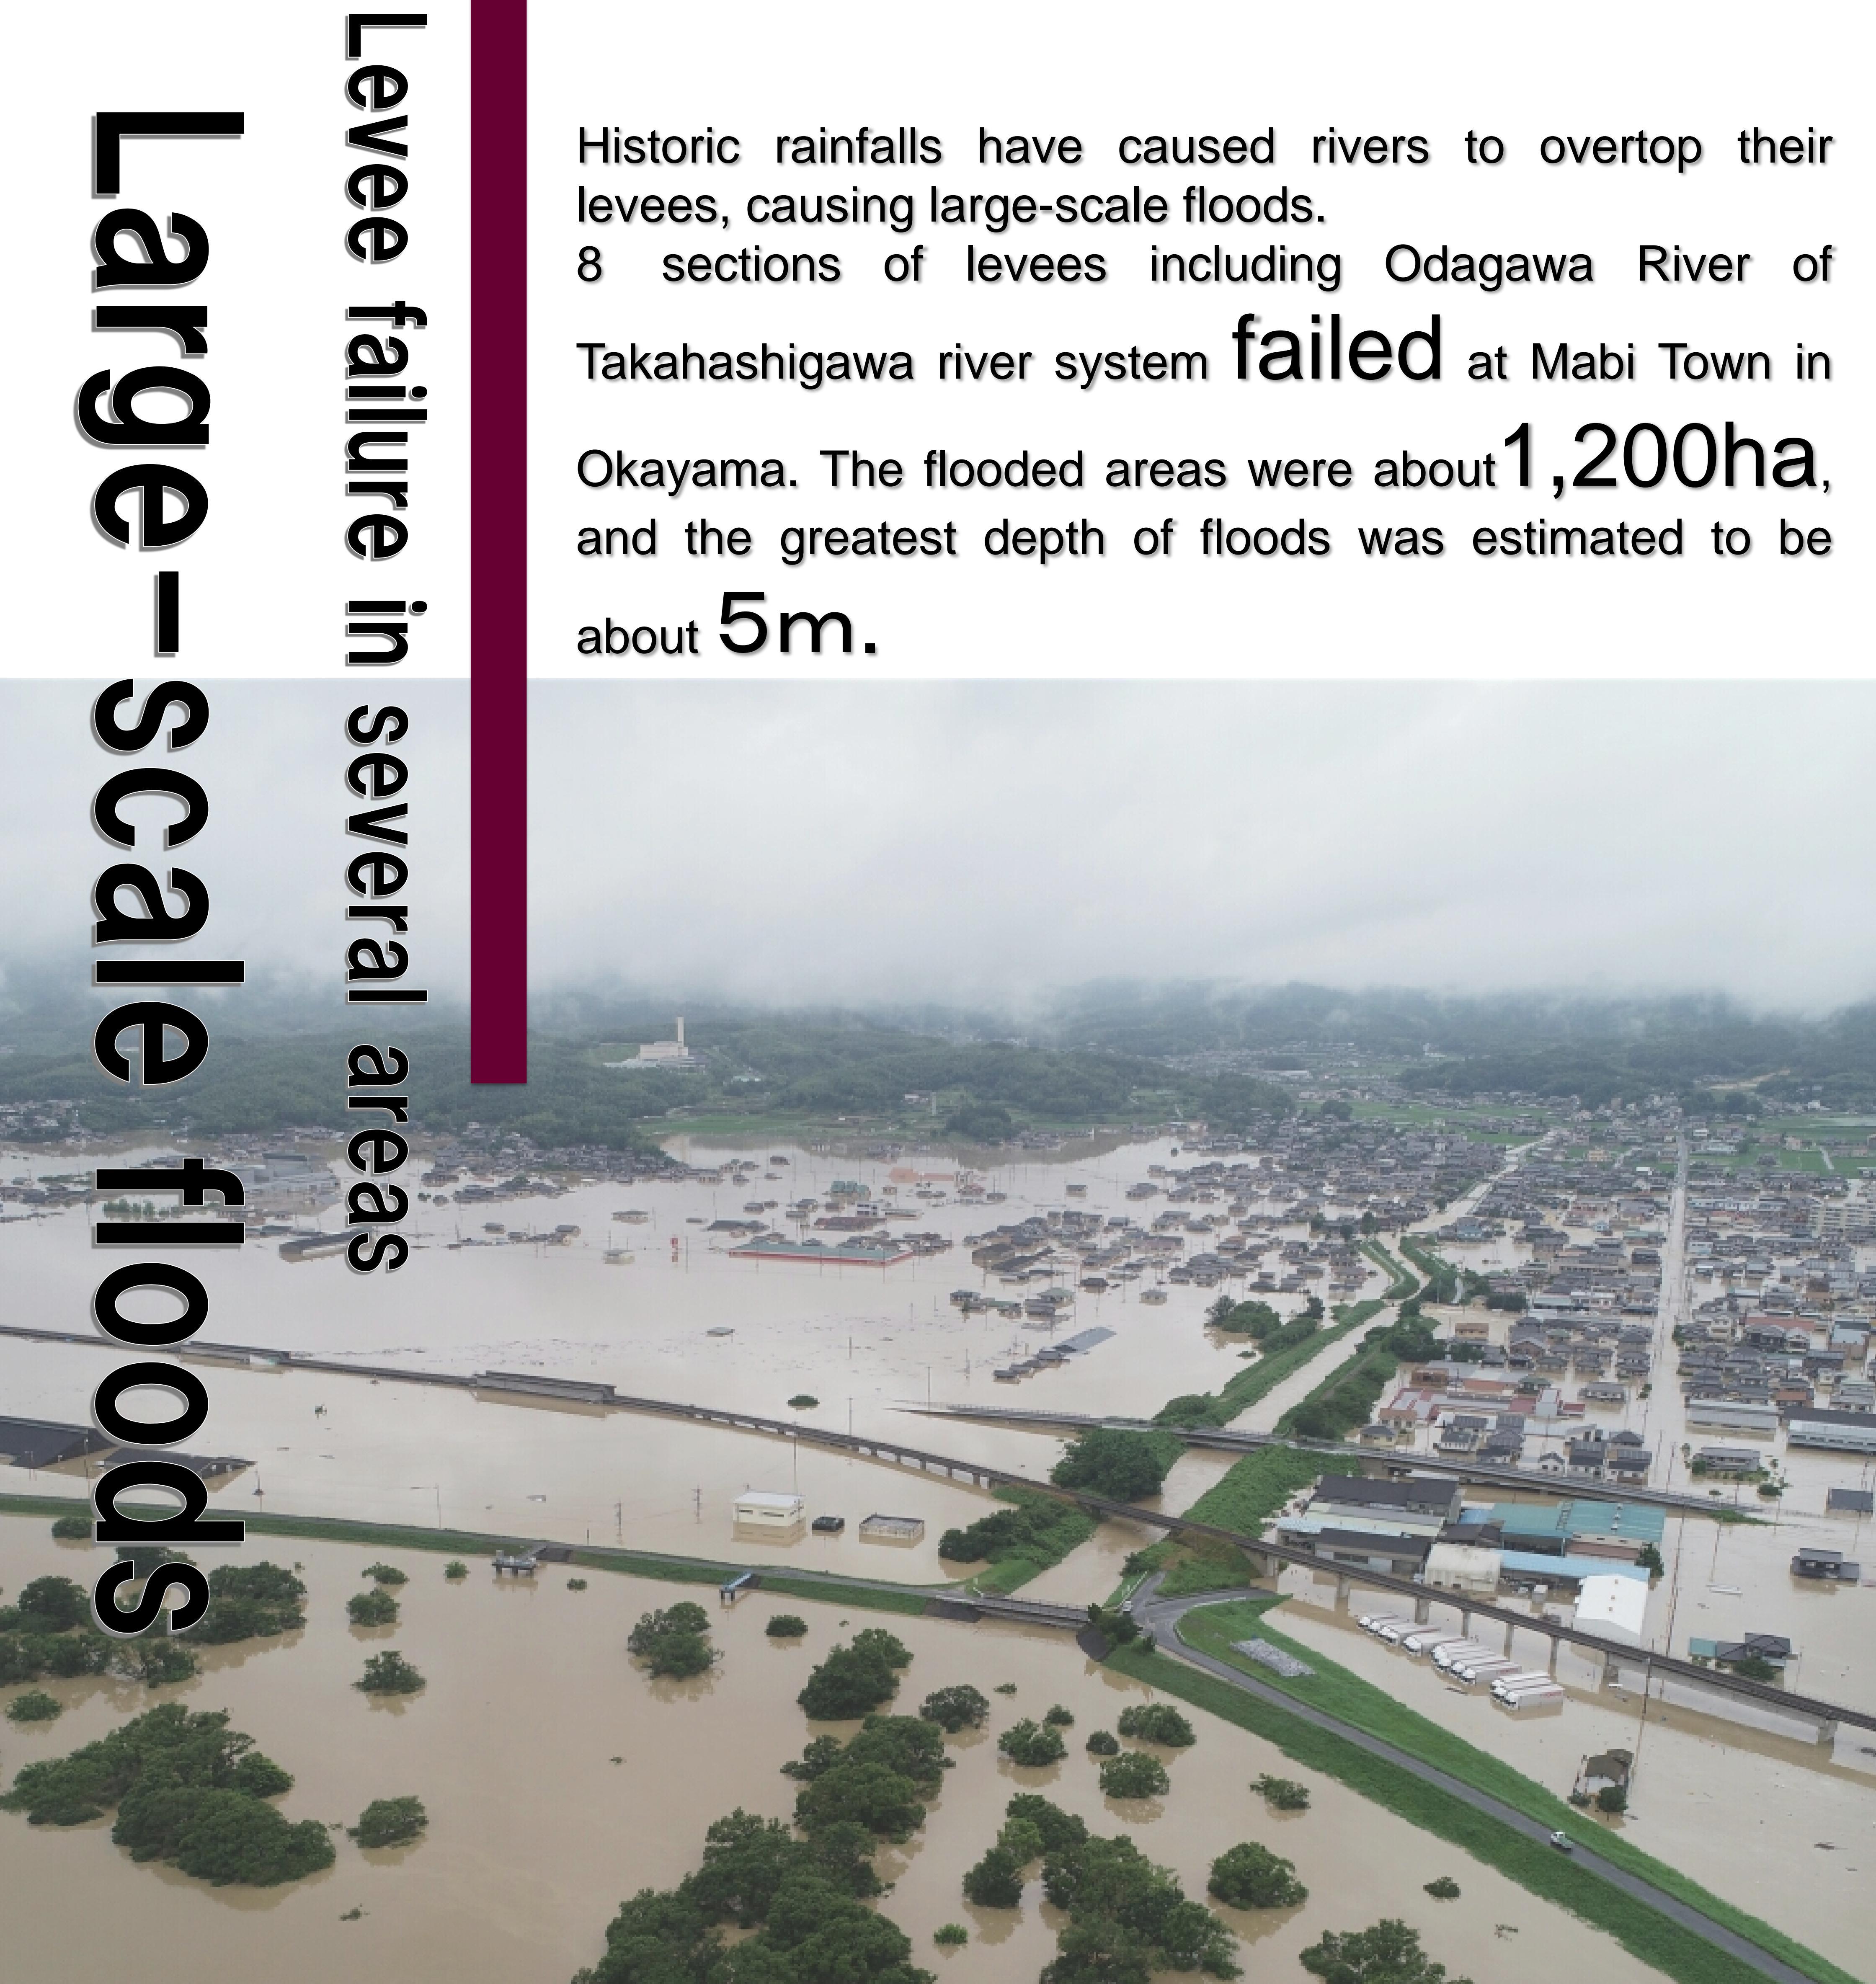
Flood situation, at Mabi Town, Kurashiki City, Okayama

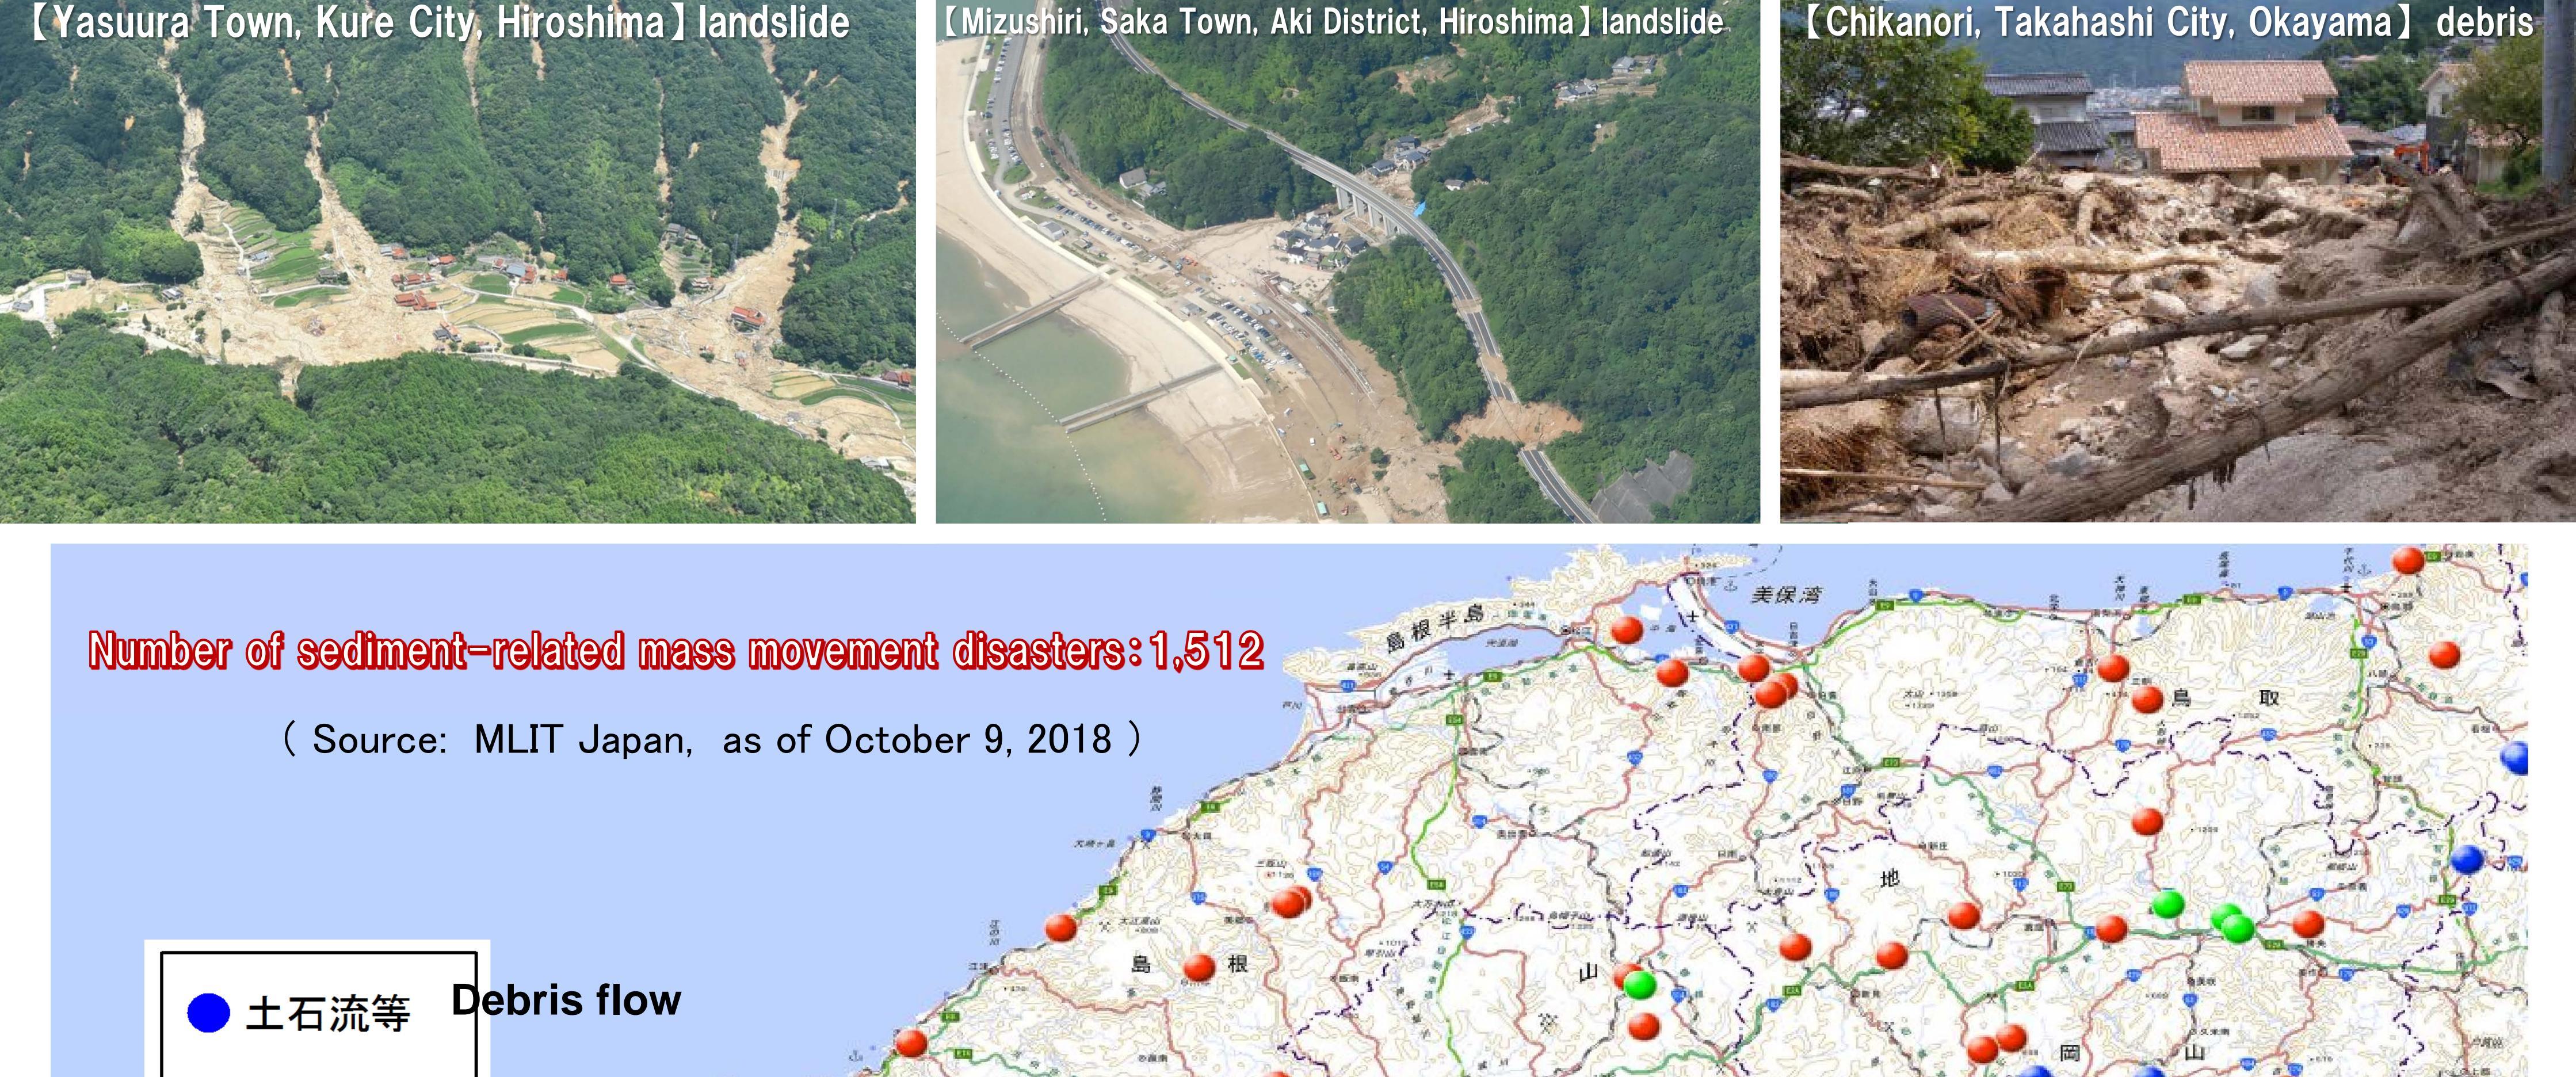
Mass movements and landslides in various parts of Chugoku region have recorded the highest death toll in Japan since 1988. About 1,500 mass movements were seen. The road was terribly damaged, affecting commercial distribution and regional economy. Significant sediment wash-out has reached downstream hillside business and residential areas. The damages were worsened due to scattered sedimentation.

[Yasuura Town, Kure City, Hiroshima] landslide

[Mizushiri, Saka Town, Aki District, Hiroshima] landslide

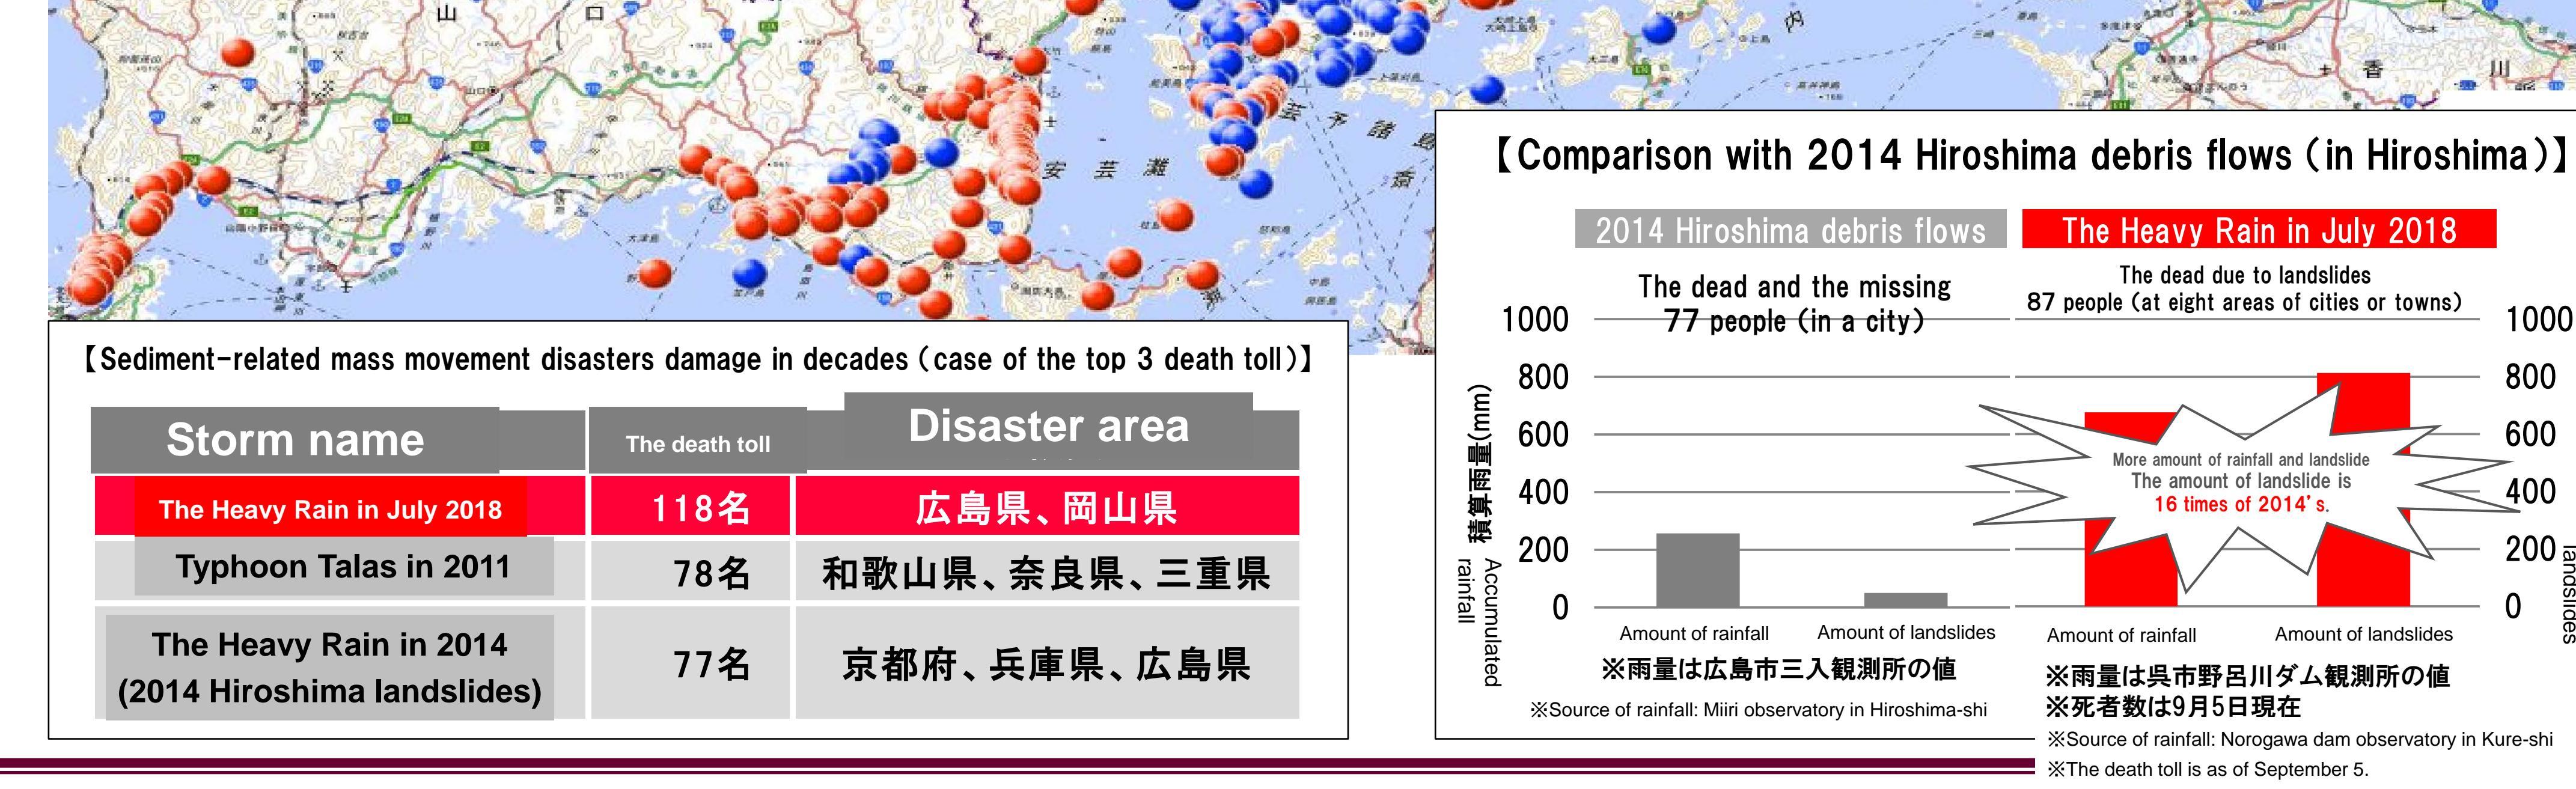
- がけ崩れ Hillside failure
- 🔵 地すべり Landslide

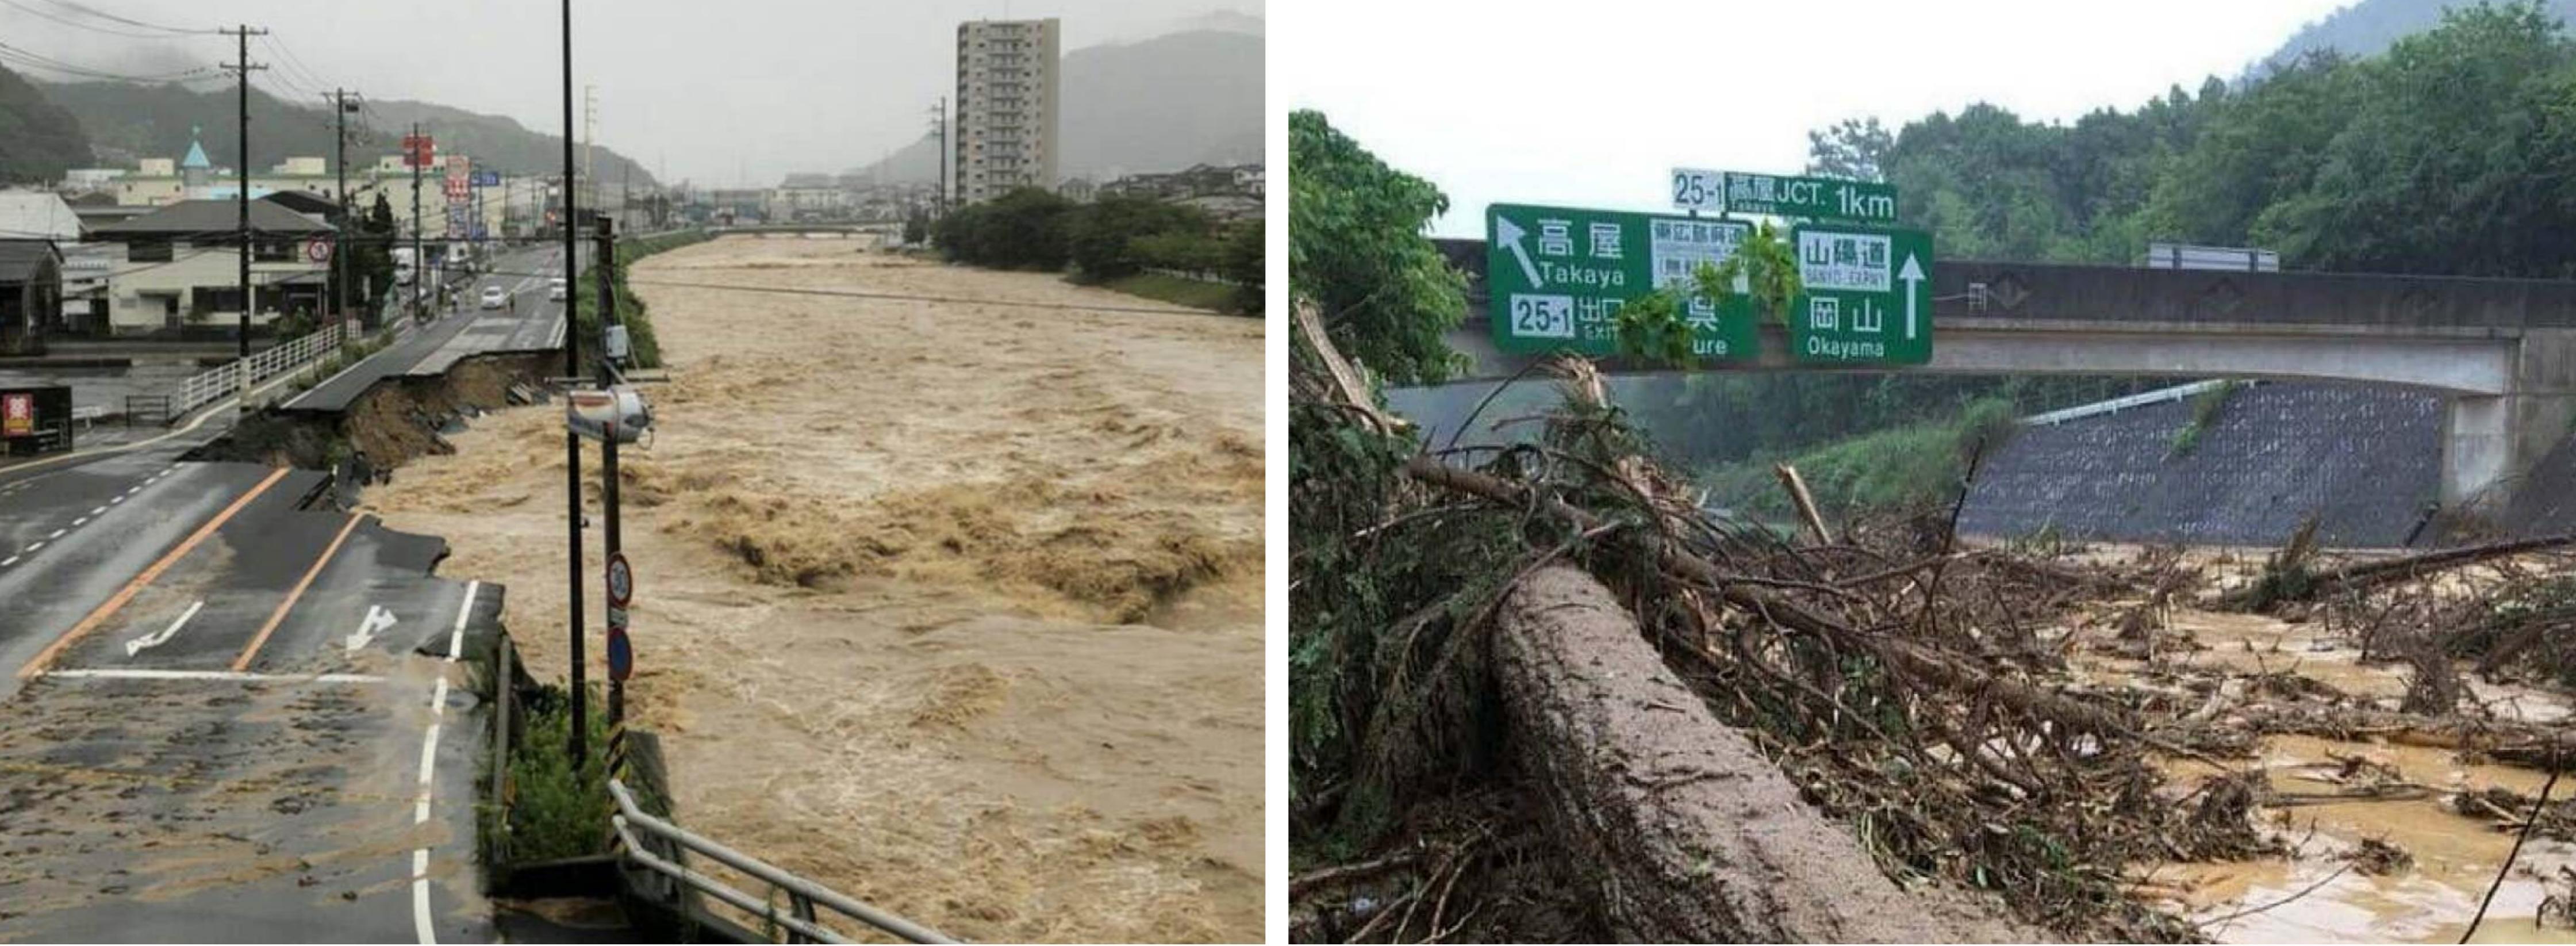
Traffic closed due to the loss of riverbank protection [Aki Ward, Hiroshima City, Hiroshima] (National Highway 2)

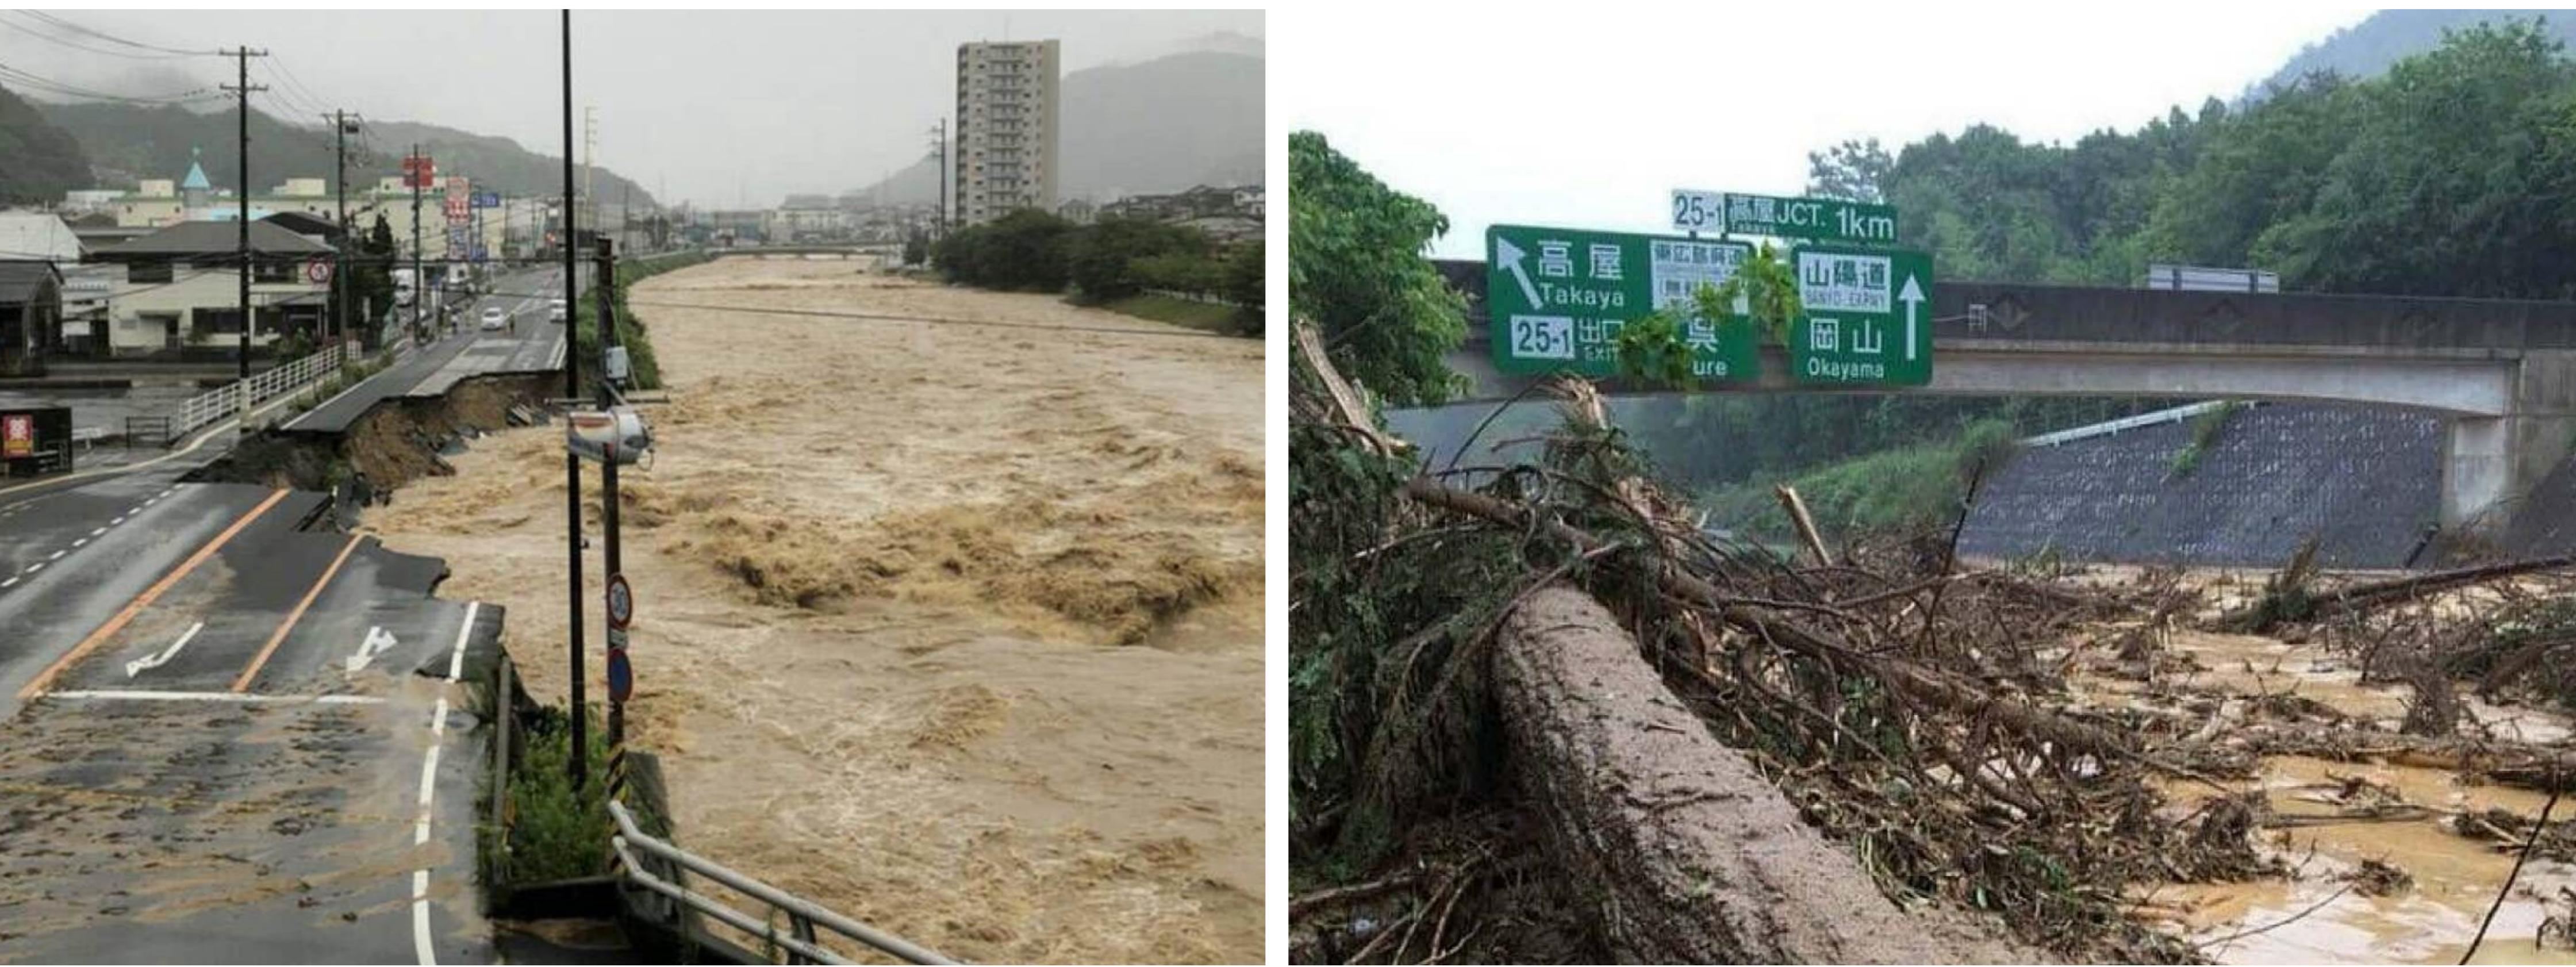
Mass washout and driftwood inflow out of the road [Higashihiroshima City, Hiroshima] (Sanyo Expressway (Around Takaya IC, JCT))

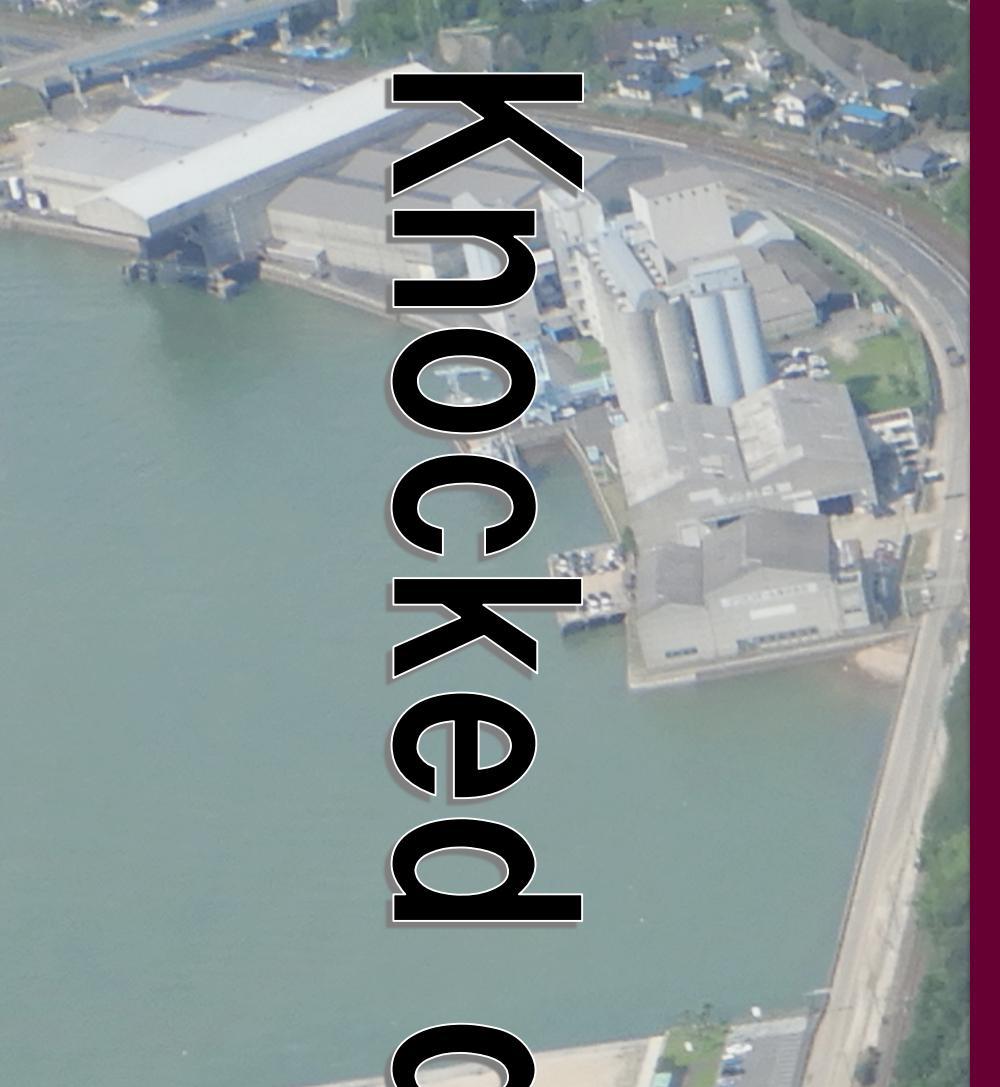
Hillside failure at Mizushiri (Saka Town, Aki District, Hiroshima) knocked down "Hiroshima-Kure road," "Kure Line (JR West)," and "National highway 31" at the same time that transportation infrastructures links between Hiroshima and Kure were lost.
